50 YEARS Hanover Engineering

RE: Inspection Conducted on January 7, 2021
IESI Bethlehem Landfill
Hanover Project LS90-7

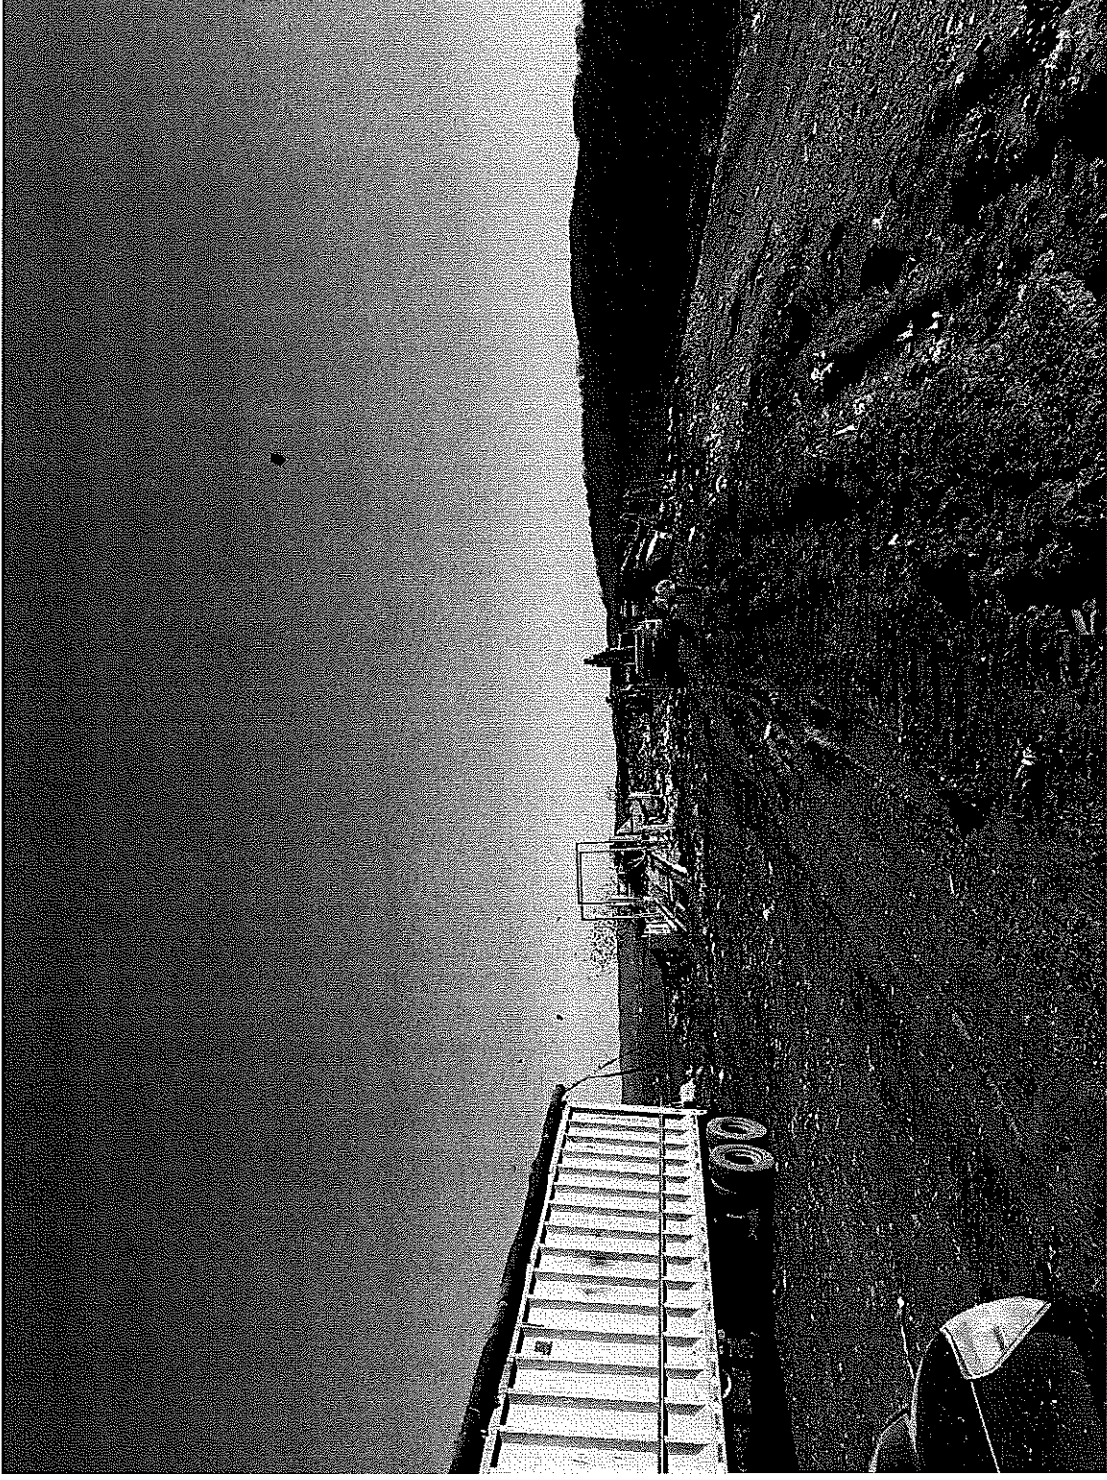
Photo 1

8. Garbage was being disposed at the top of Cell 1B, see photo 1. The approach to and departure from the working face was stable and passable. The trailer tipper was in use. Trucks were also unloading waste conventionally. One (1) compactor was working in the garbage. One (1) dozer was spreading soil to spread cover on the south face near the working face. Very slight intermittent garbage odor was detected while we were at the top of the landfill observing the daily operation two hundred (200) yards west of the working face. The working face continues to be minimized as a result of the planned reduction in the waste acceptance until the new cell 2A/B, Phase 1 construction is completed and certified. Cell construction should be completed, and the final documents submitted to DEP for certification of the cell with the temporary sump in the next day or two.

9. No pickers were observed working on site to remove blown litter from the north slope of the working face. Temporary litter fence was in place at several locations around the working face, see photo 1 for fencing.

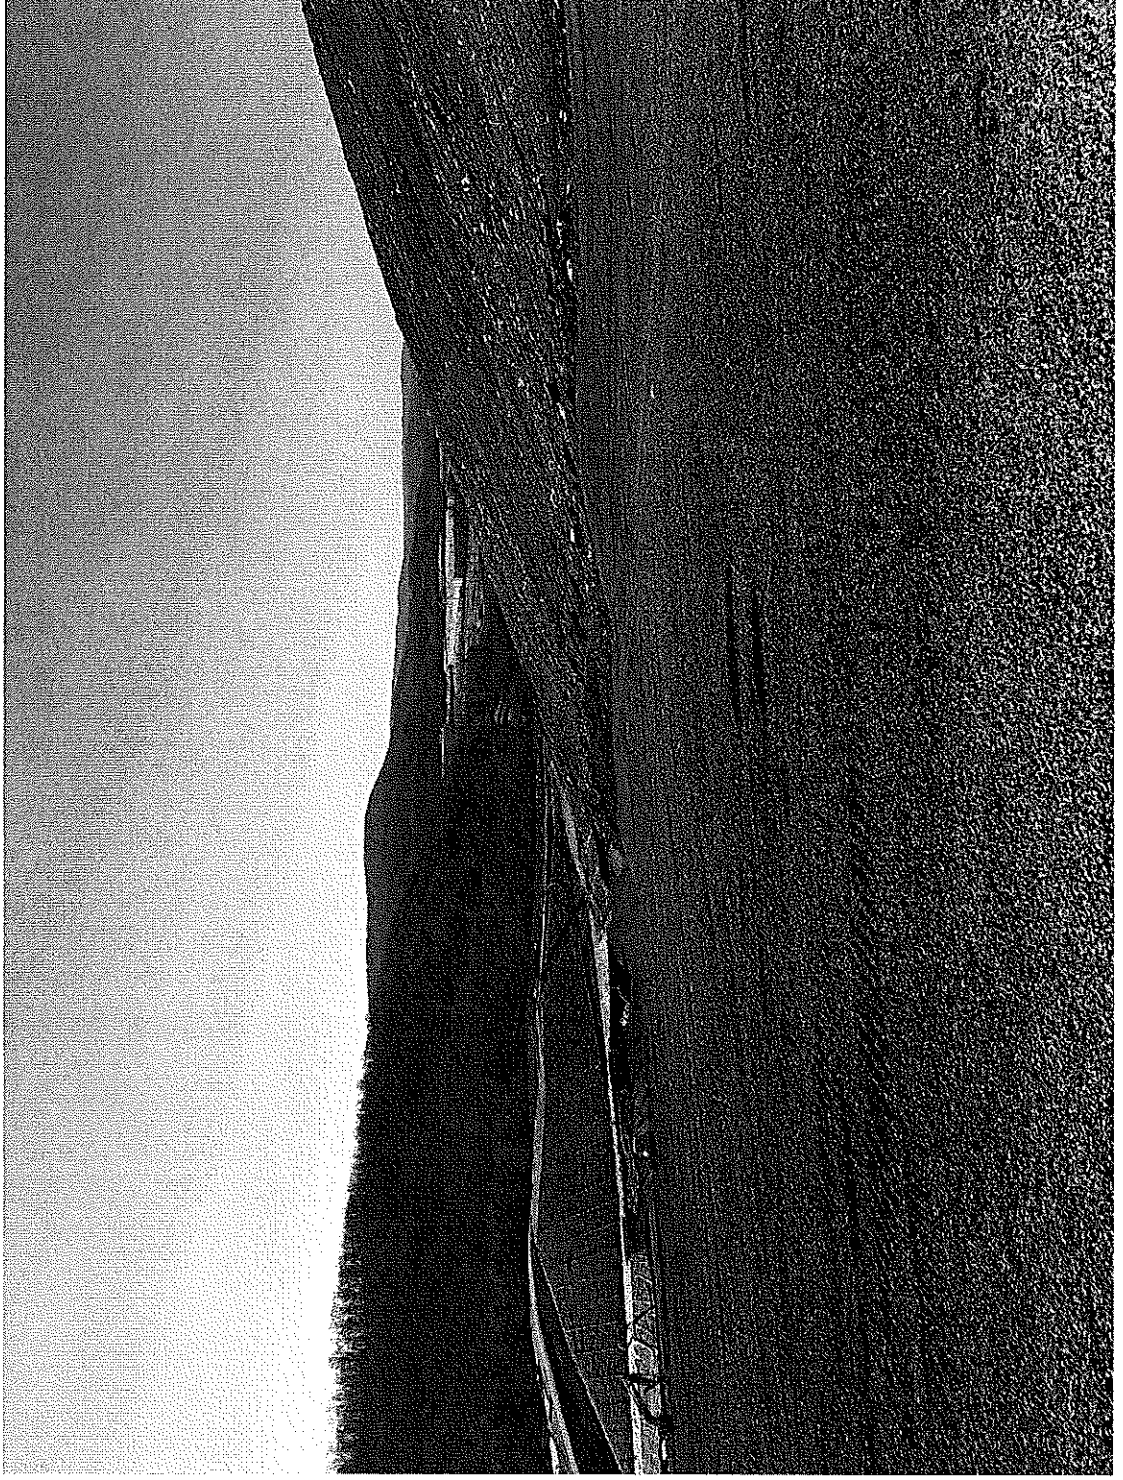
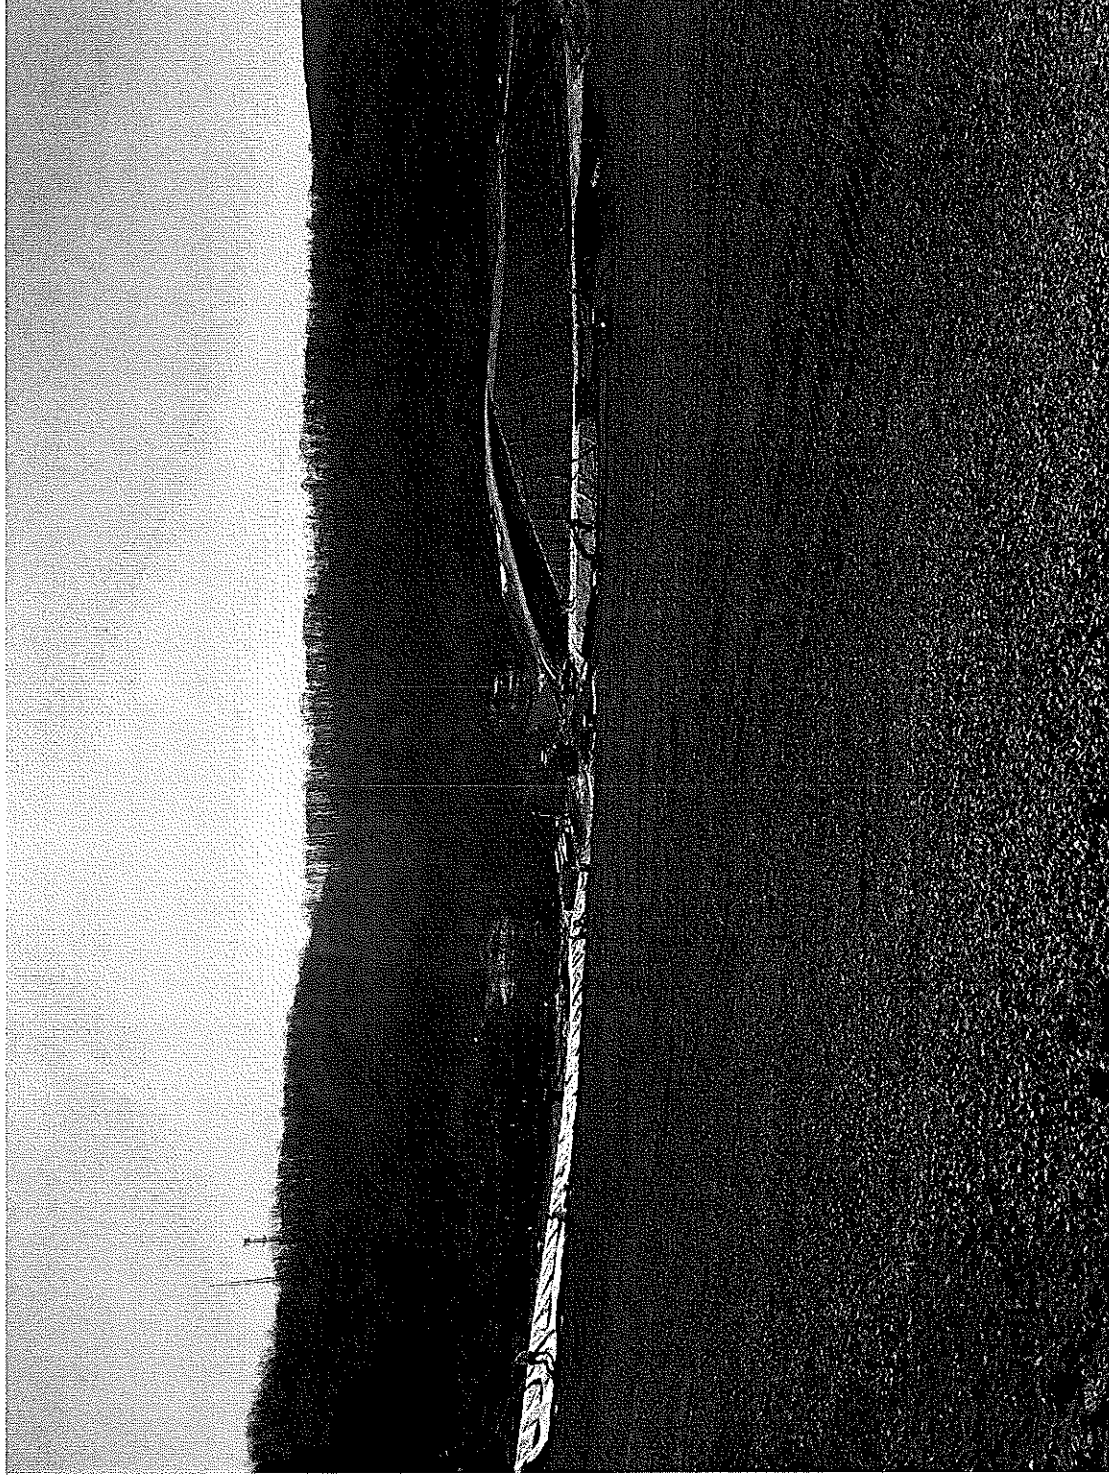
16. Cell 2A/B Phase 1 is under construction (See photos 2 and 3) and completion is anticipated by the next day with certification documents to be submitted to DEP the following day.

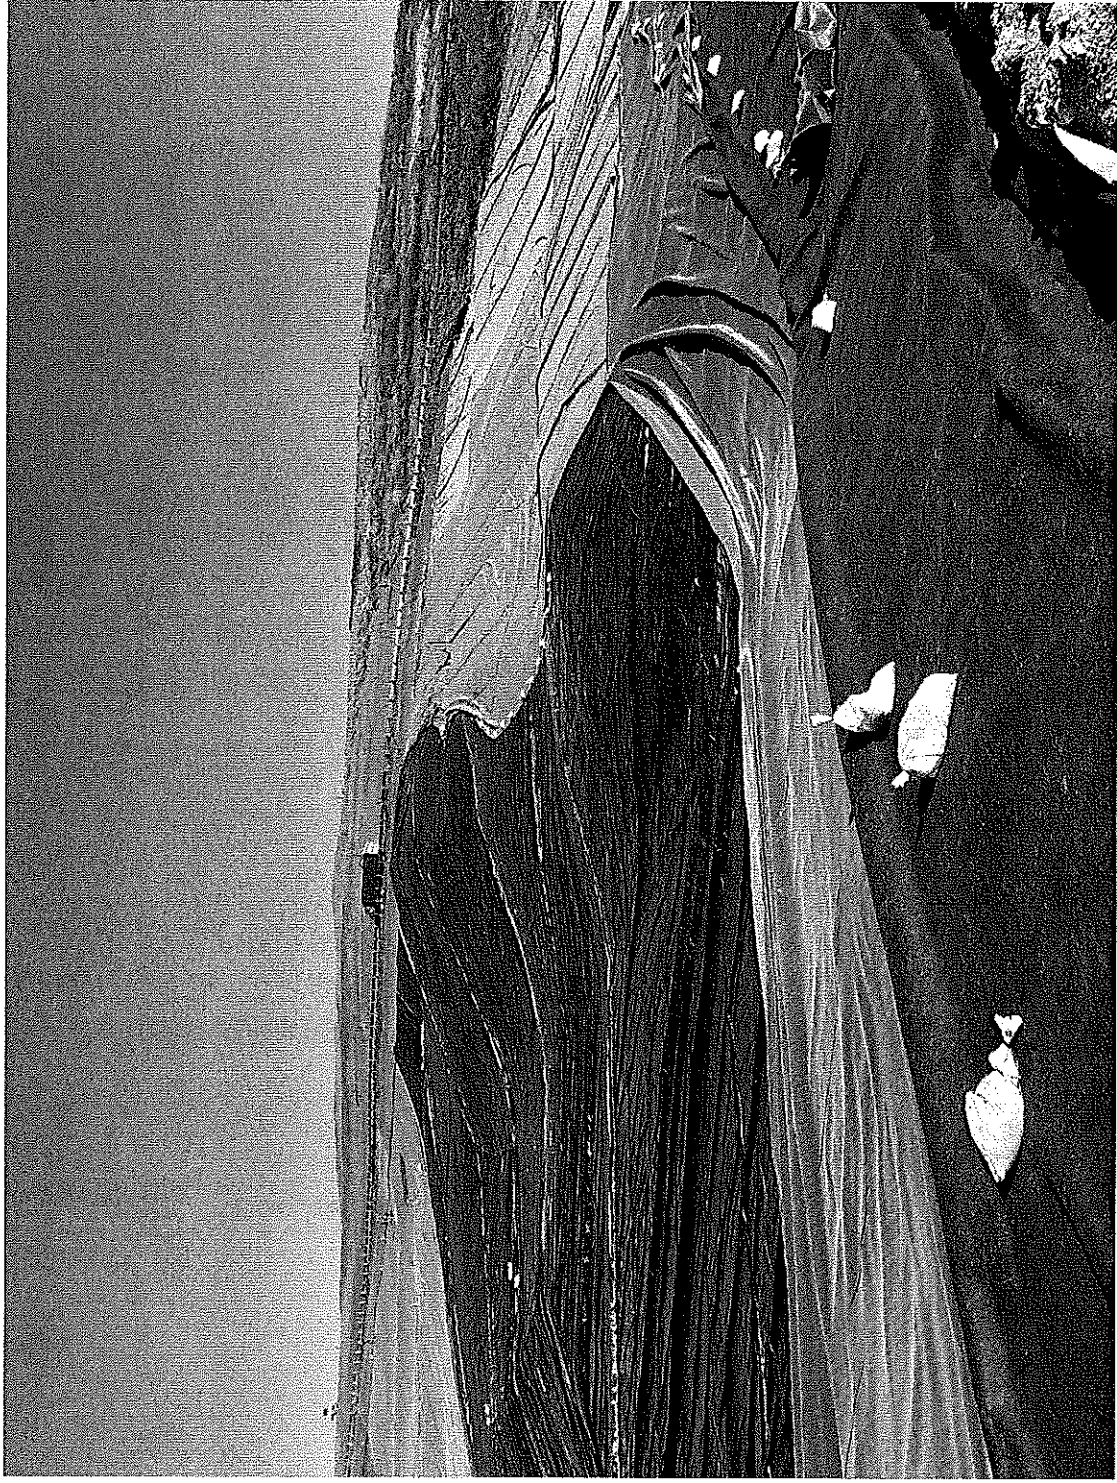
Photo 4

12. The west high wall area of cell 4E was observed and the placement of the intermediate cap over the western portion of cell 4E is almost complete. See photo 4.
