HanoverEngineering

June 14, 2024

RE: Inspection Conducted on June 6, 2024
Bethlehem Landfill
Hanover Project LS90-7

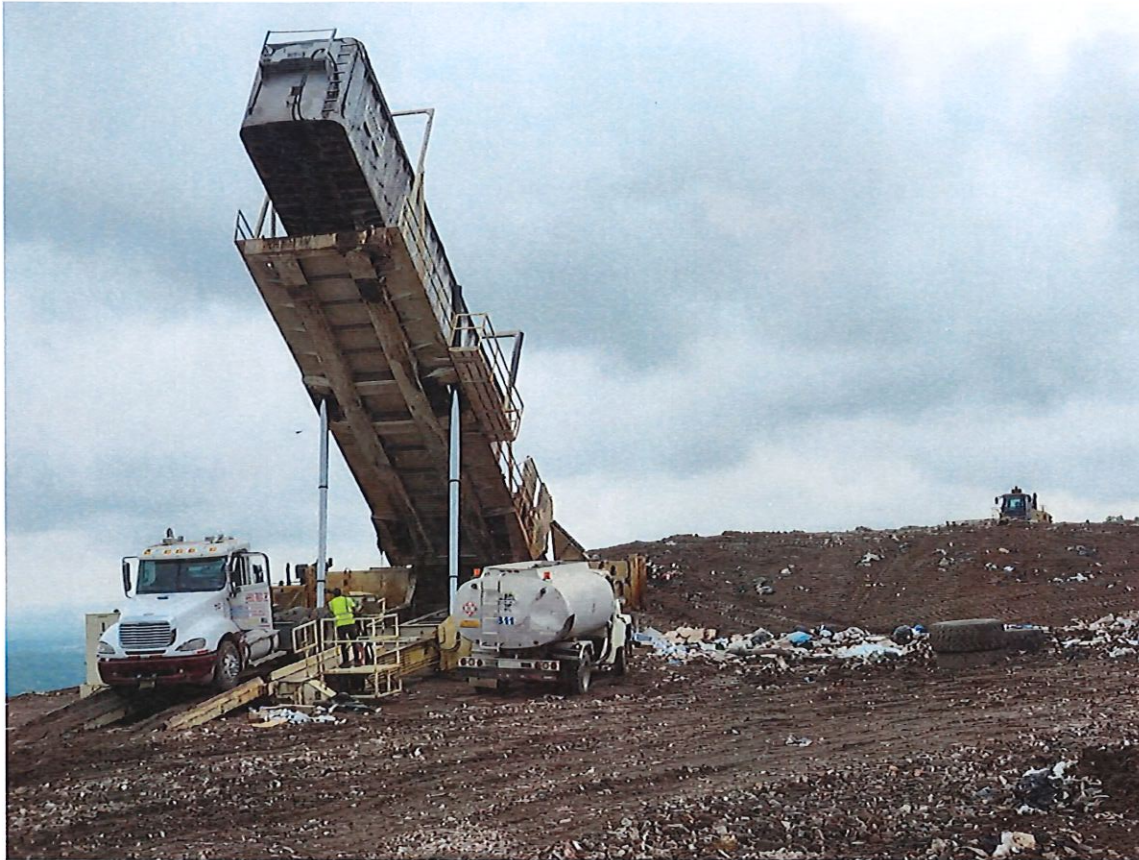
Photo 1

7. The working face remains in the northern most portion of cell SE2-AB Phase II along the southern slope in an area that needs additional waste to bring the waste up to the design grades (see Photos 1, 2, 3, and 4). The trailer tipper and garbage trucks are offloading waste. Temporary litter fencing is in place around portions of the working face. The permanent litter fence is clean. The permanent odor misters were in use at the southern edge of cell SE-2AB and along the western side of the permit boundary. The portable misters were not in use at the time of inspection. The new, larger portable double blower mister system was delivered and is being set up for operation. No leachate seeps were observed. BL is keeping a close watch for leachate seeps and will continue to repair them as they occur.

Working face looking east.

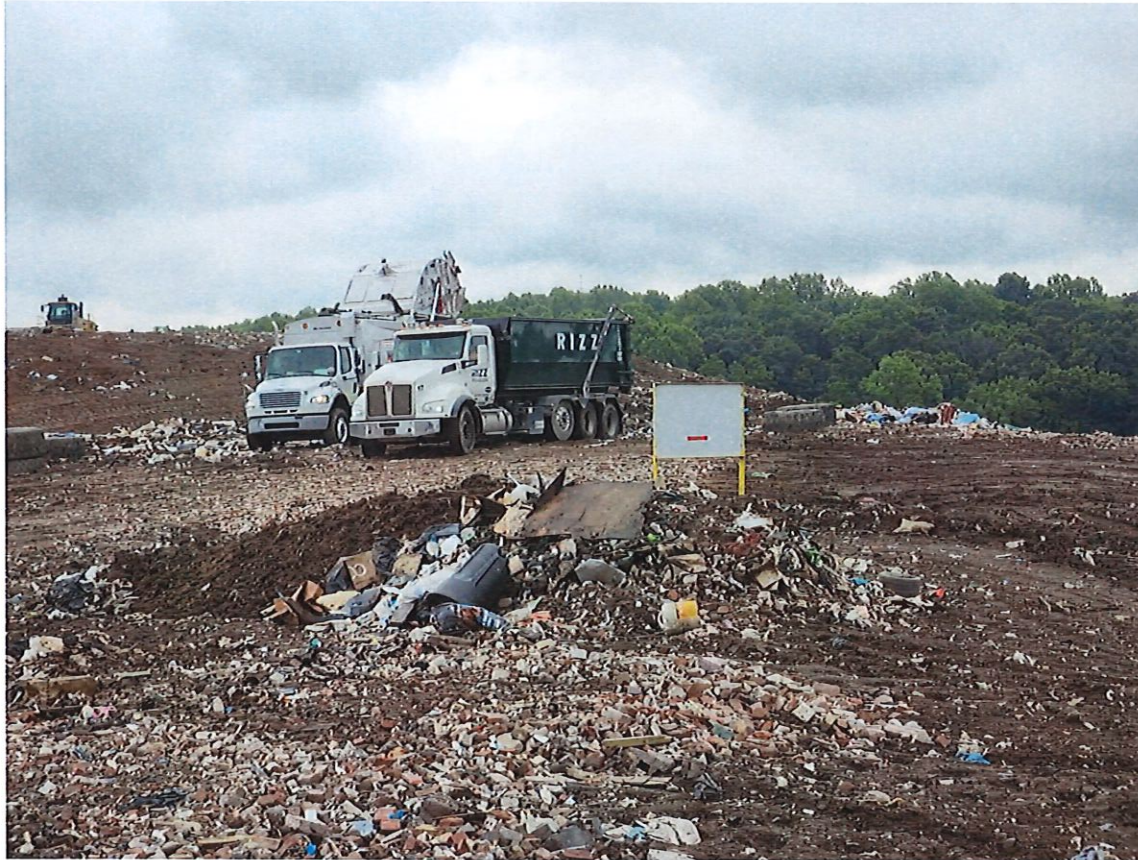
Photo 2

Working face, view of the top of the south slope.

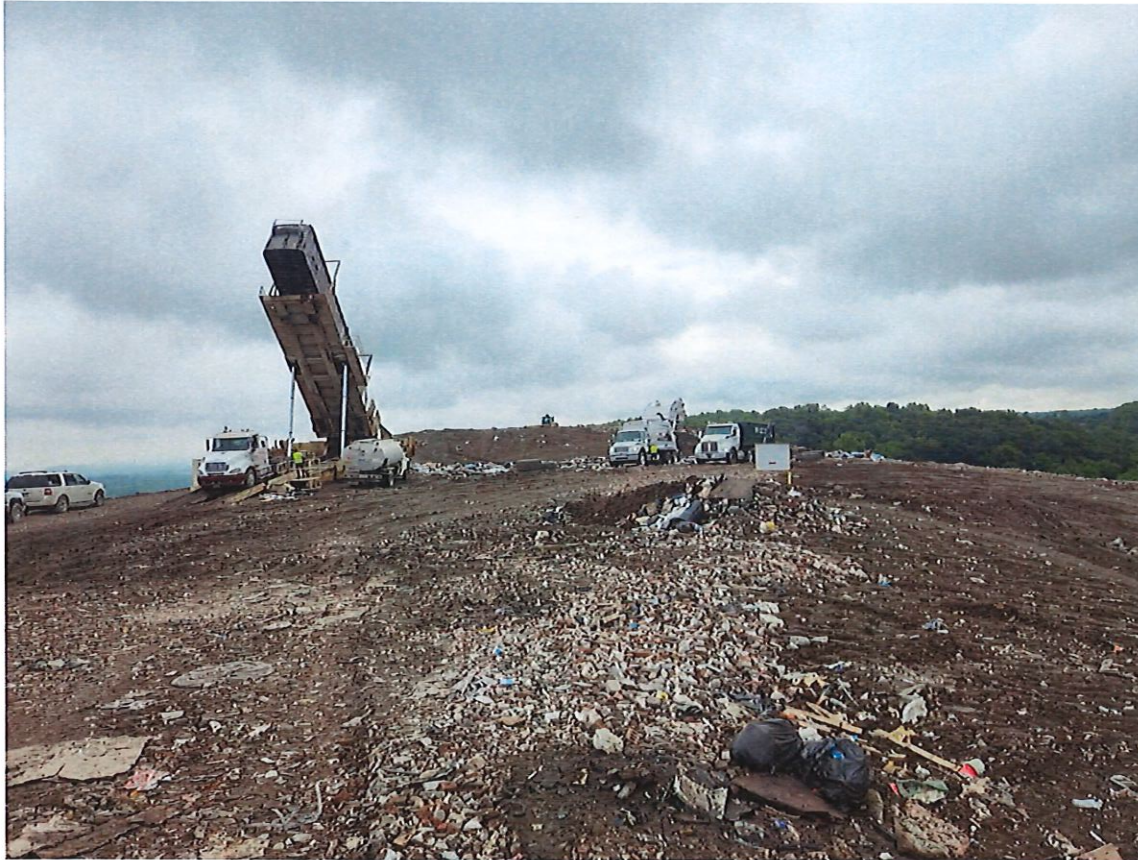
Photo 3

Working face looking east.

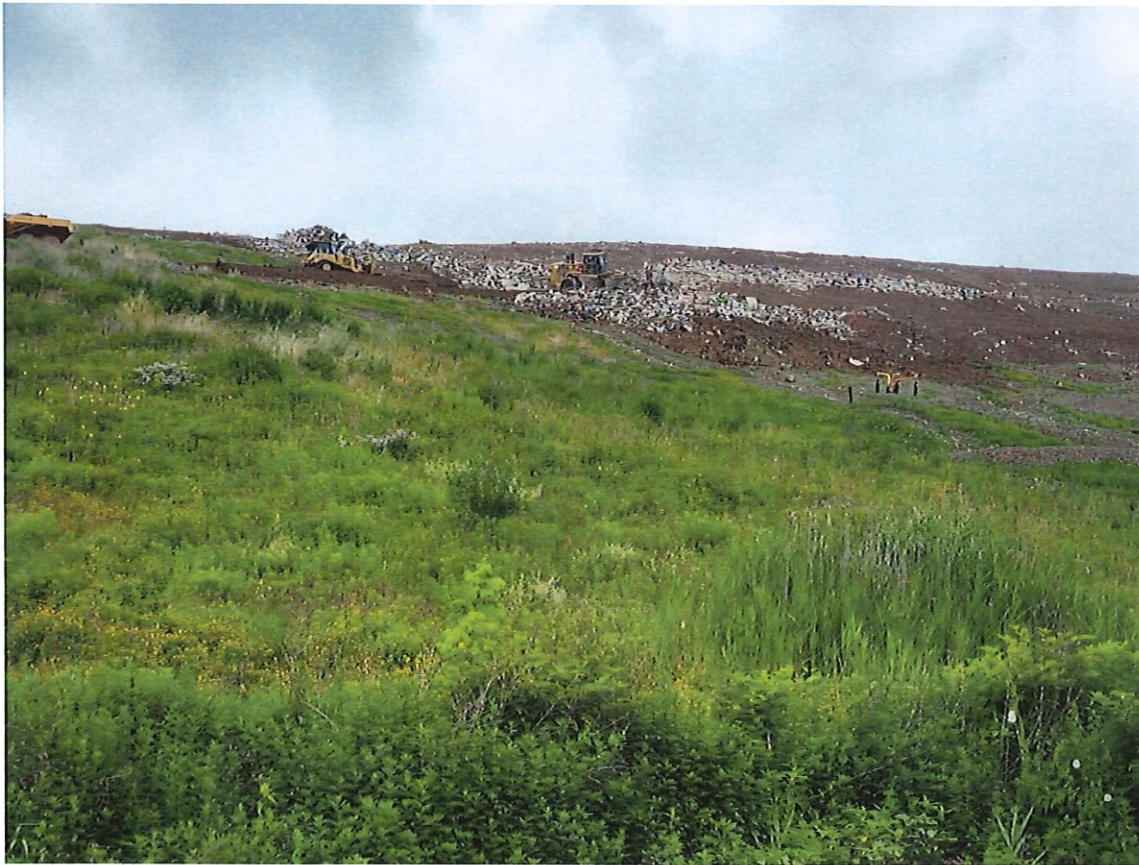
Photo 4

Working face on the south slope of cell SE-2AB.

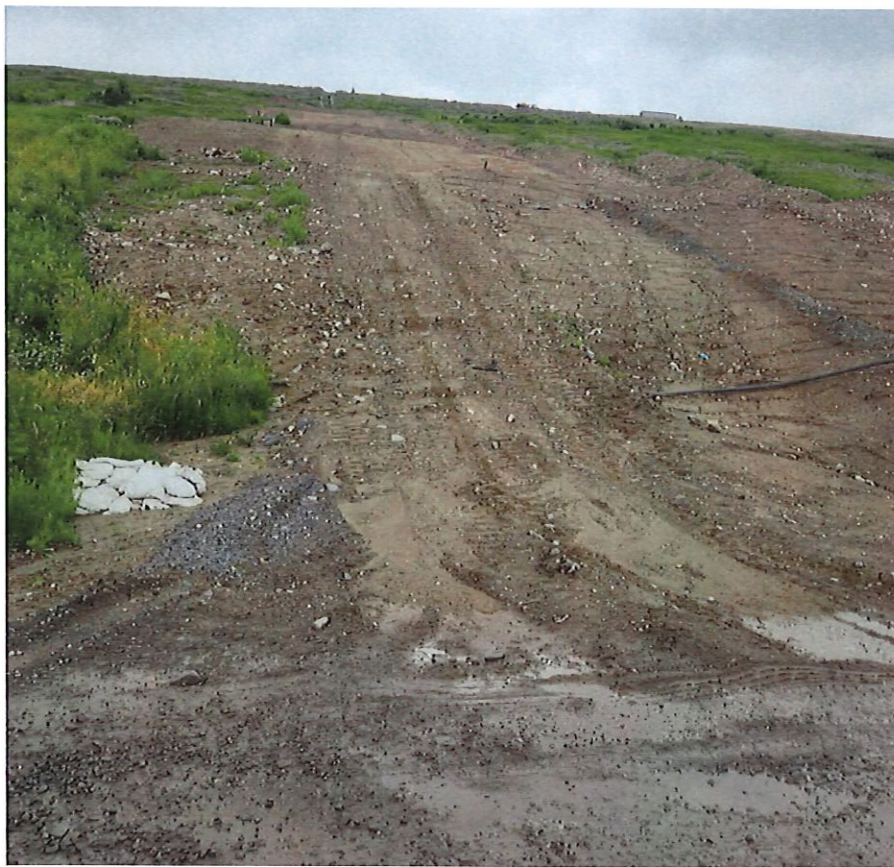
Photo 5

17. Construction of the stormwater channel north of Sedimentation Pond 4 has been completed (see Photos 5 and 6).
18. Construction Certification of the PFAS Treatment System located in the former BRE Energy Facility has been submitted. DEP has submitted comments to BL.

Completed stormwater drainage channel north of Sedimentation Pond 4.

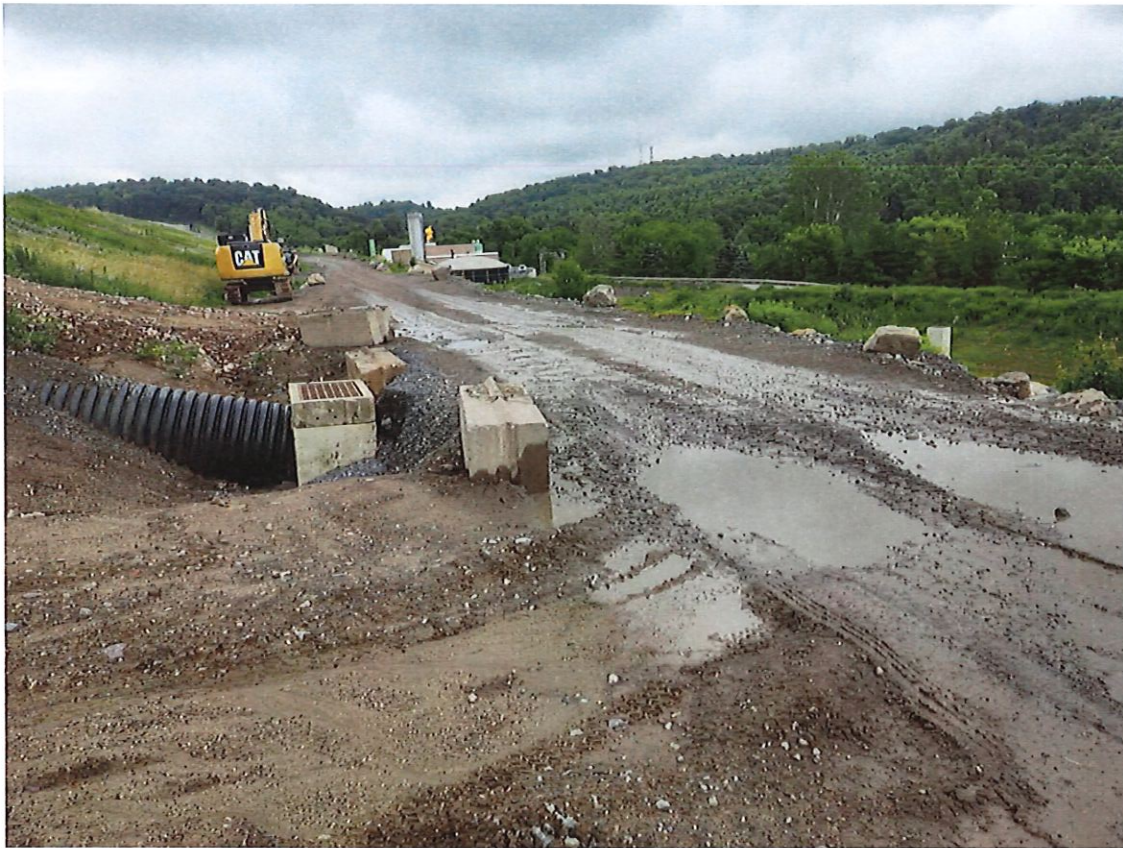
Photo 6

Inlet box and 30-inch HDPE pipe at bottom of the stormwater drainage channel north of Sedimentation Pond 4.

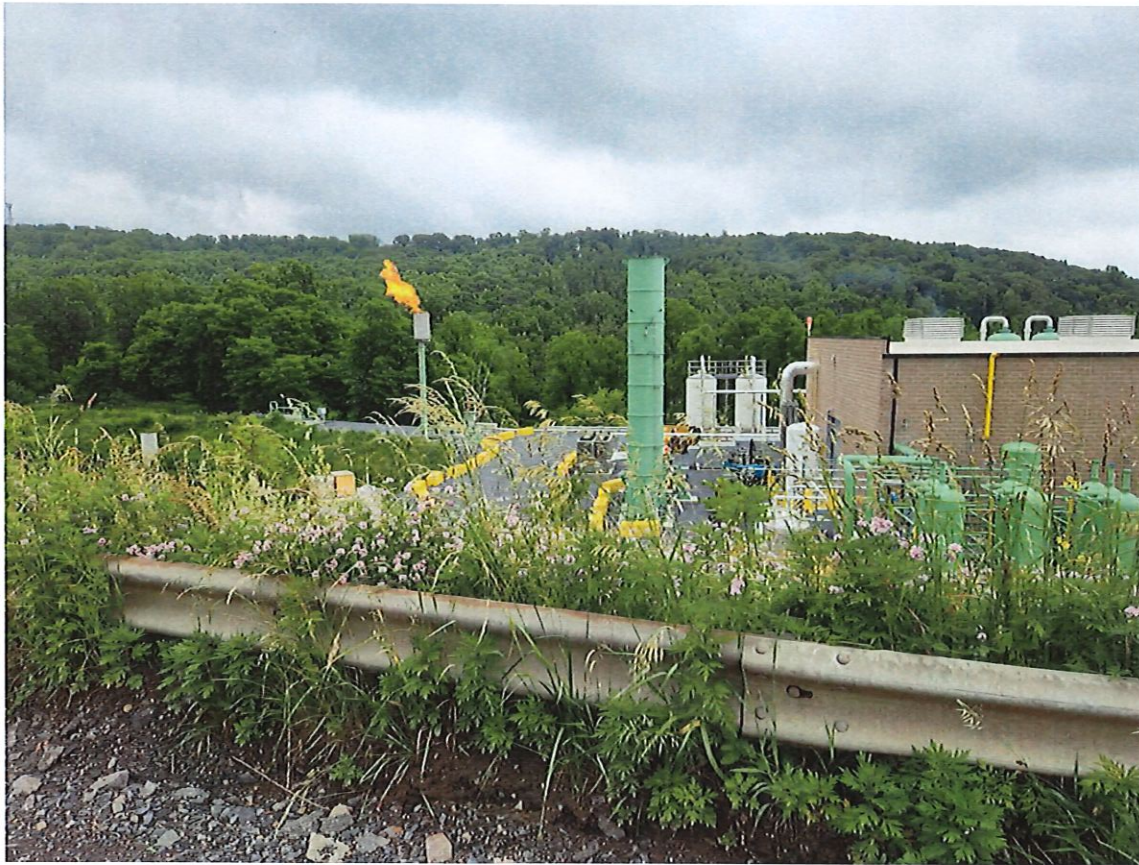
Photo 7

4. The flare was not in operation because the LF gas was being sent to the Archaea Energy Plant. The Energy Plant started receiving gas on June 5, 2024 to test the equipment operation. During the testing operation, Archaea's candlestick flare will be burning the gas whenever the flow to the processing equipment is shut down. BL's flare will be utilized to burn excess LF gas if the Archaea Energy Plant is not able to process (see Photo 7).

Complete Archaea Energy Plant and the plant's candlestick flare.
