Engineering Associates Inc

June 30, 2015

RE: Investigation of Undermined Area of
Riverside Drive at PennDOT Repair Location
Hanover Project LS90-7

SITE PHOTOGRAPHS OF AREA OF UNDERMINING

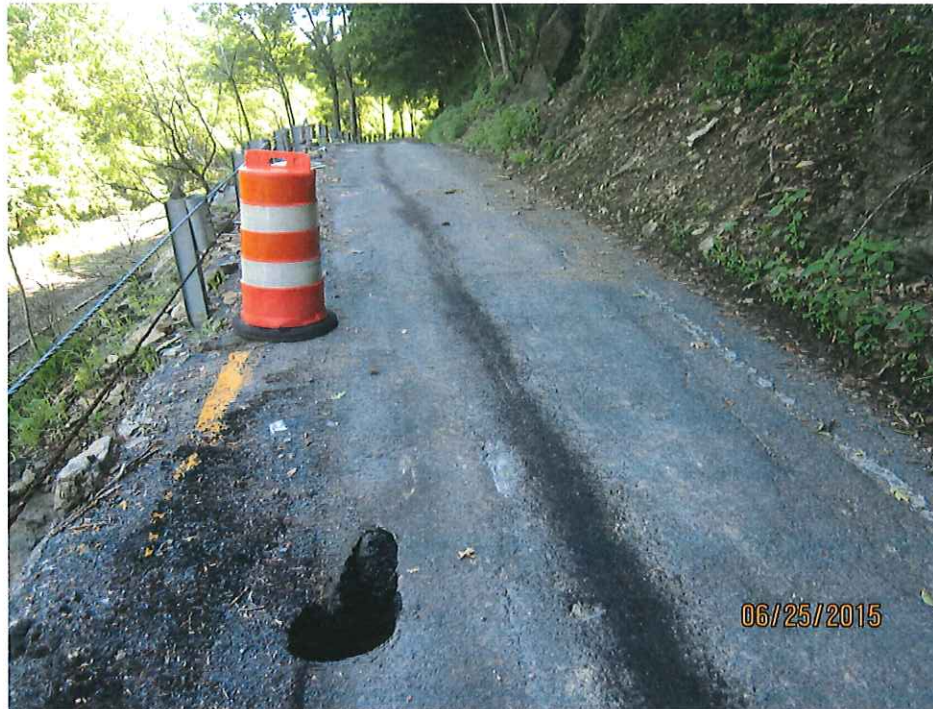
The conditions around this area were observed and photographed (see Attachment 2 for photographs). As can be seen, the undermining has created a small hole in the pavement surface, approximately one by two feet (1' x 2') in size, which opens to the bank below. The southern side of Riverside Drive in this area is bordered by a near-vertical wall of competent bedrock. A very small amount of soil and rock debris on the road surface was observed, approximately twenty-five feet (25') east of, and upslope of, the undermining.

2-1. Overall view of Riverside Drive in the area of undermining, showing hole in road surface (foreground) and small amount of outwash onto roadway (background).

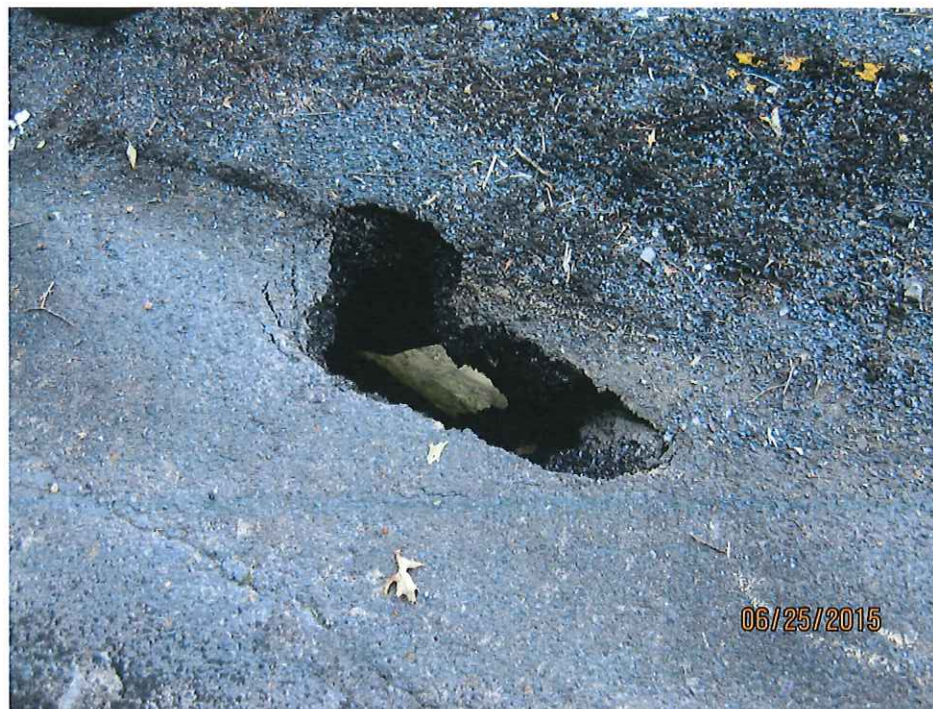
2-2. Close-up of hole in road surface, showing that it extends to daylight below.

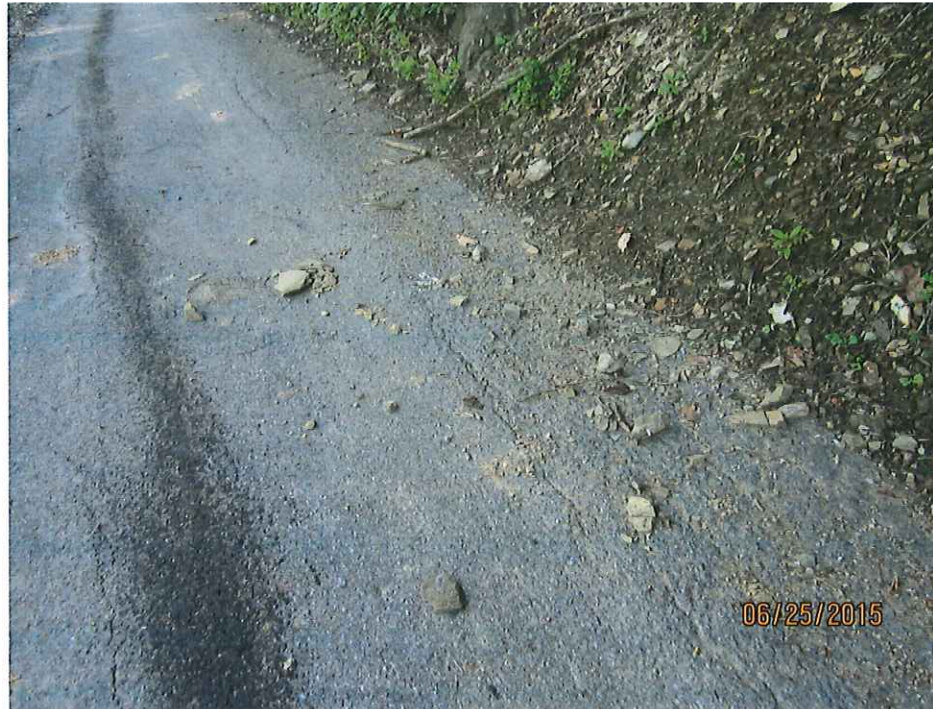
2-3. Close-up of small amount of outwash onto road surface just upslope of area of undermining.

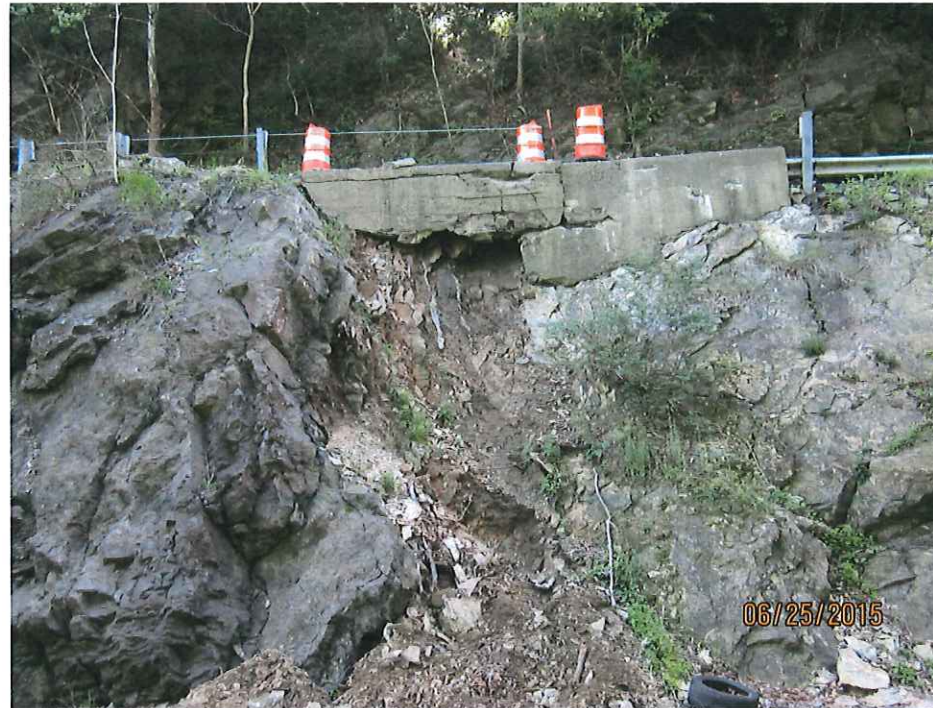
The northern side of Riverside Drive in this area is bordered by a steep bank that drops down to the adjacent Norfolk Southern Railroad right-of-way. This bank was observed from the railroad bed. An outcrop of dolomite bedrock was observed at the face of the bank in this area. A distinct fracture zone in this bedrock was observed directly under the undermined area of the road bed. This fracture zone consisted of thinly-bedded, shaly dolomite which was highly weathered and eroded and contained a large amount of soil in the fractures. By comparison, the bedrock on either side of this fracture zone was thickly-bedded, competent, and only slightly weathered. A concrete wall was built along the road bed, spanning the fracture zone and anchoring to the competent bedrock on either side of it.

Based on all of the above, it is my professional opinion that the undermining of the roadway is due to a soft fracture zone in the underlying bedrock, which is being eroded by stormwater runoff

2-4. View of northern bank of roadway at undermined area. Note outcrops of competent dolomite bedrock on either side of undermining and concrete wall anchored to competent bedrock and spanning fracture zone of weathered bedrock.

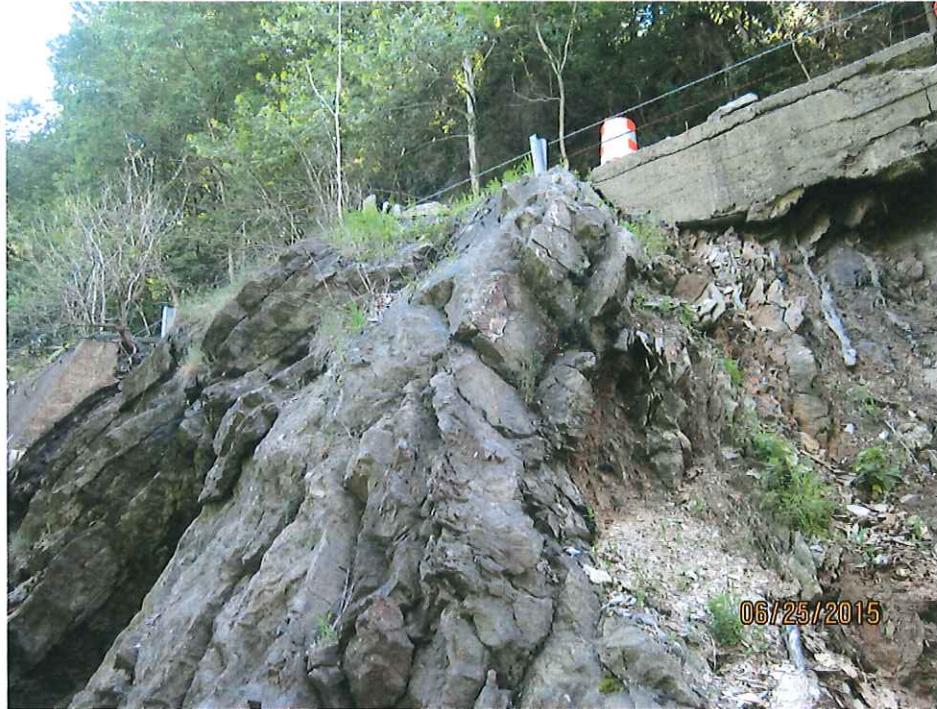
2-5. Close-up of outcrop of competent bedrock on east side of fracture zone.

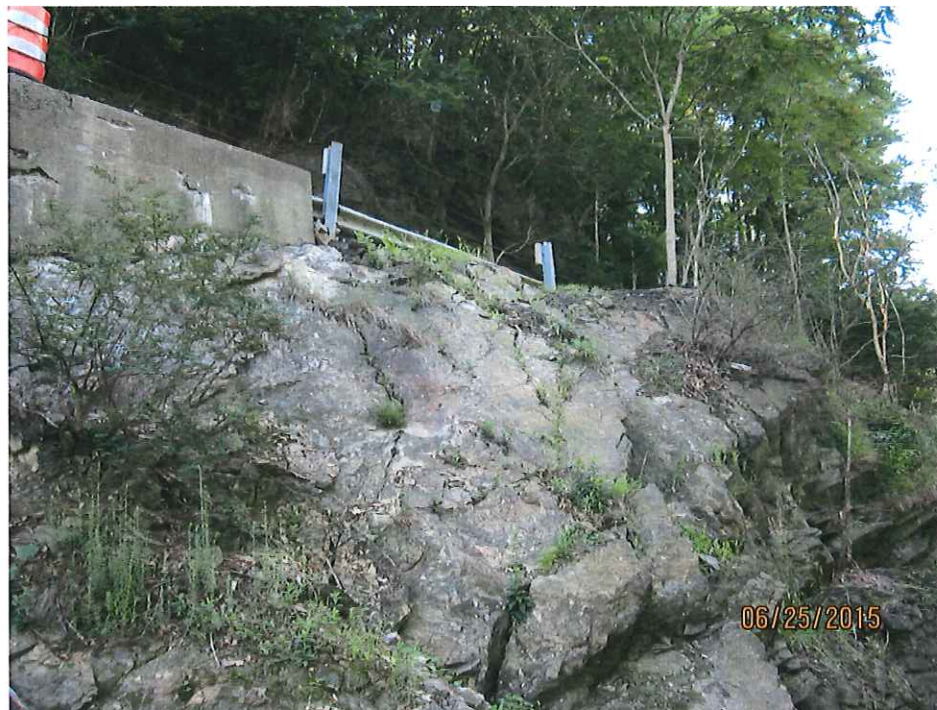
2-6. Close-up of outcrop of competent bedrock on west side of fracture zone.

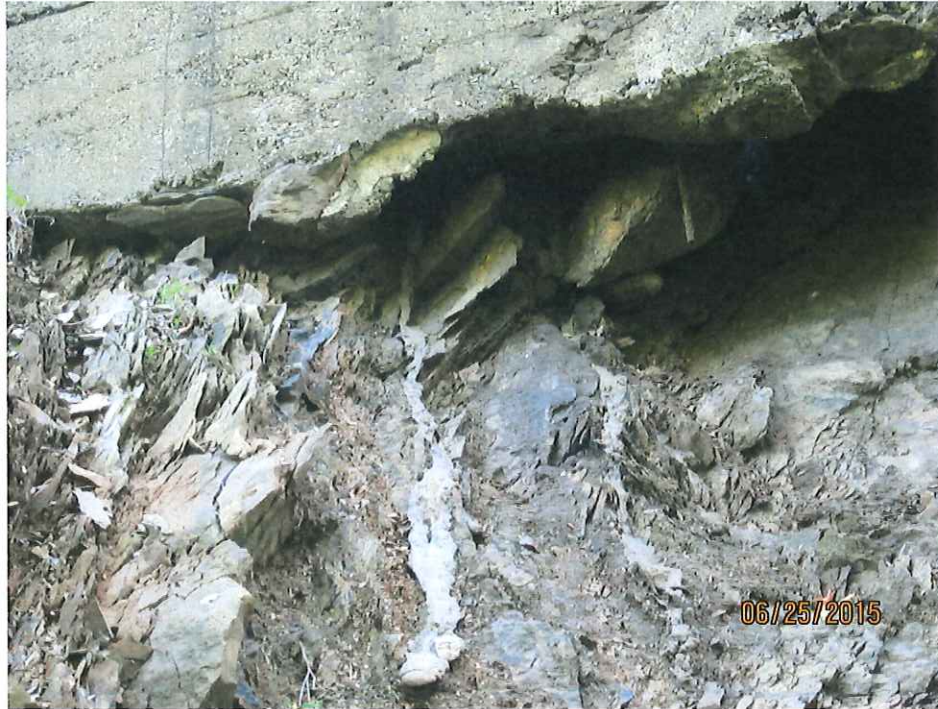
2-7. Close-up of fracture zone in bedrock and undermining of concrete wall constructed to span it. Note thin-bedded and highly weathered nature of the bedrock in the fracture zone.

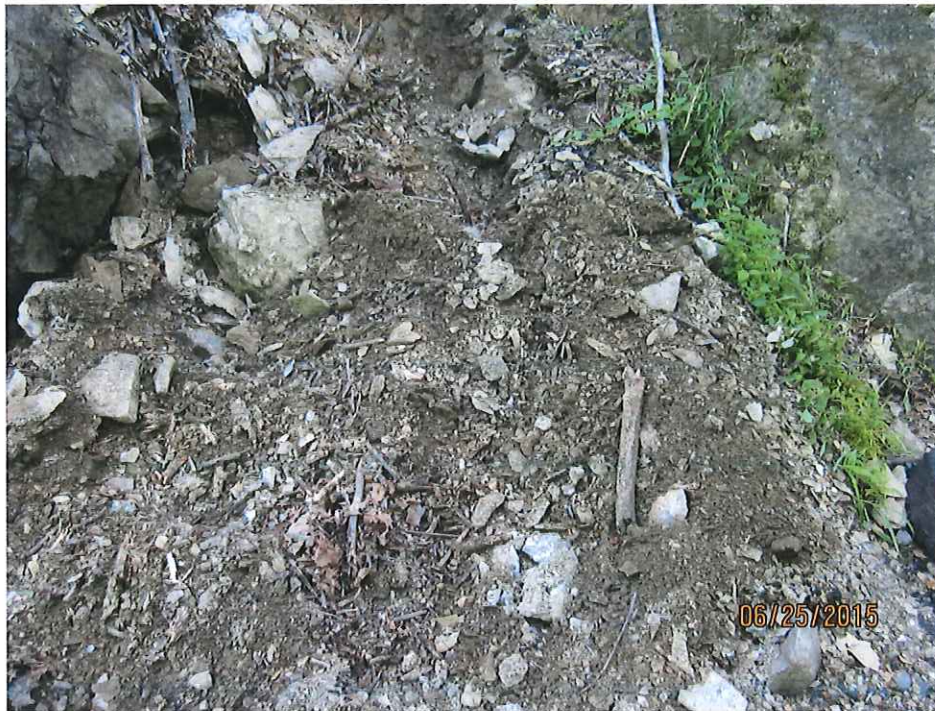
2-8. Close-up of soil and soft rock material eroded from the fracture zone and lying on the railroad bed at the base of the roadway bank.

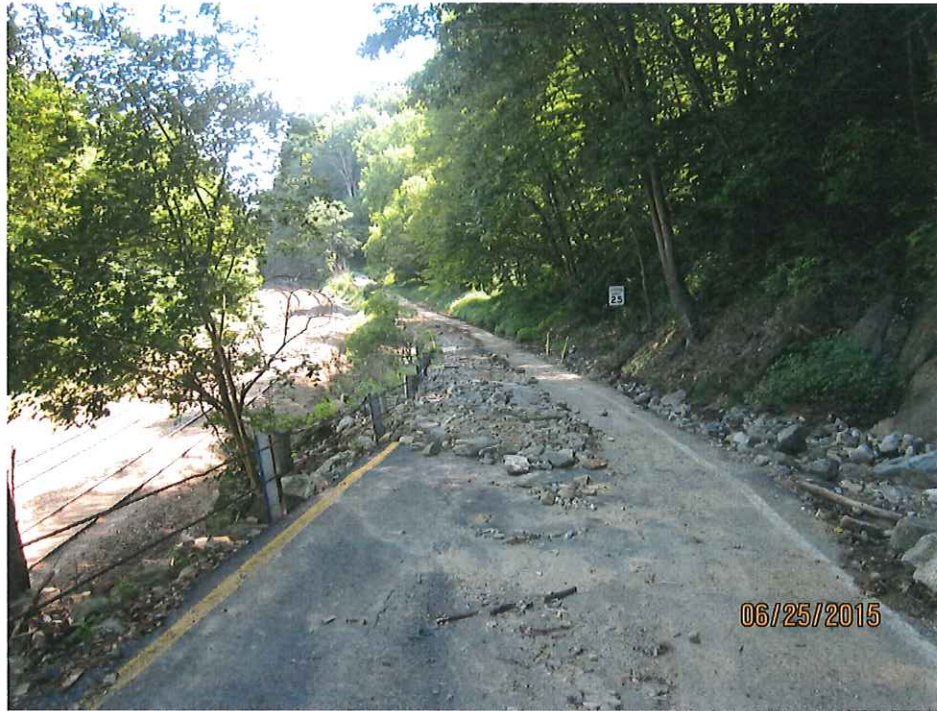
3-1. Overall view of Riverside Drive in the area of washout. Note relation of area to speed limit sign and hazard markers next to speed limit sign.

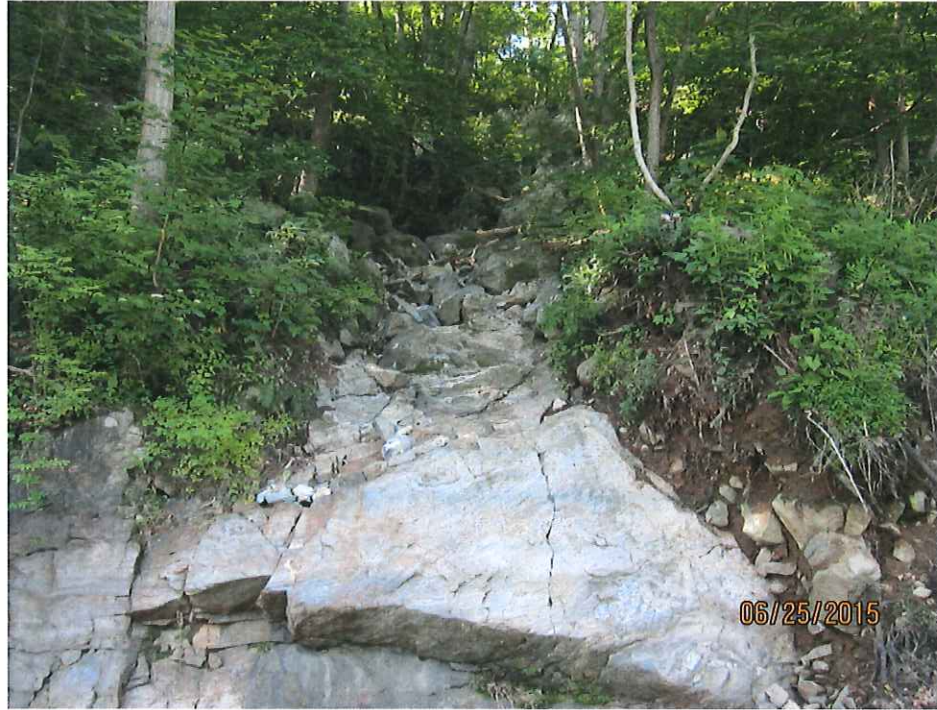
3-2. Looking south from Riverside Drive at the washout location, showing the eroded channel on the slope heading southward.

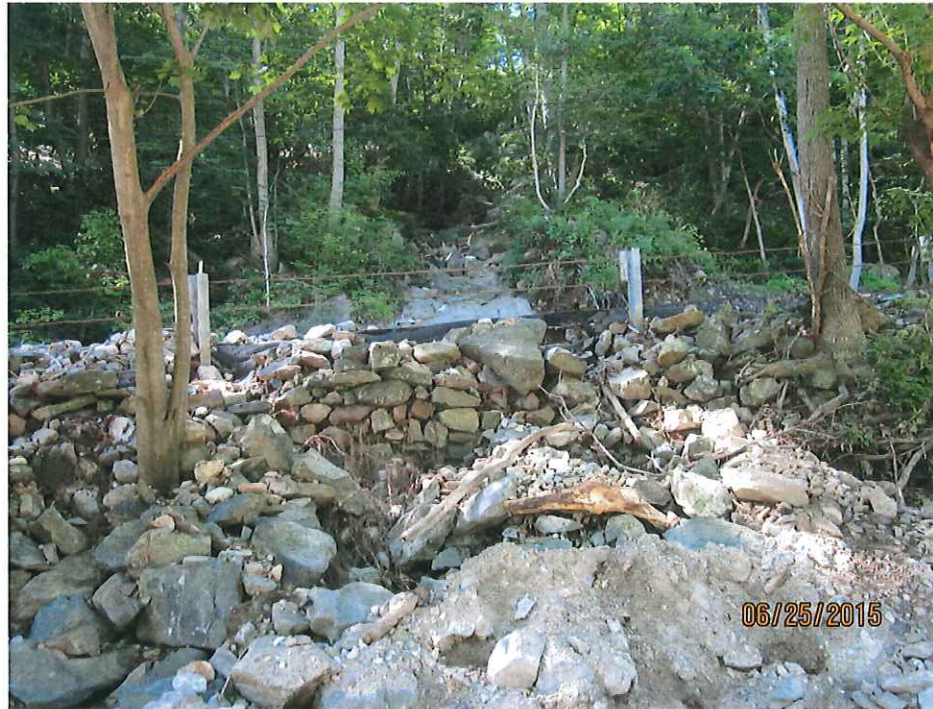
3-3. Looking south from the railroad bed across Riverside Drive at the washout location, showing soil and rock material deposited on the north bank of the roadway.

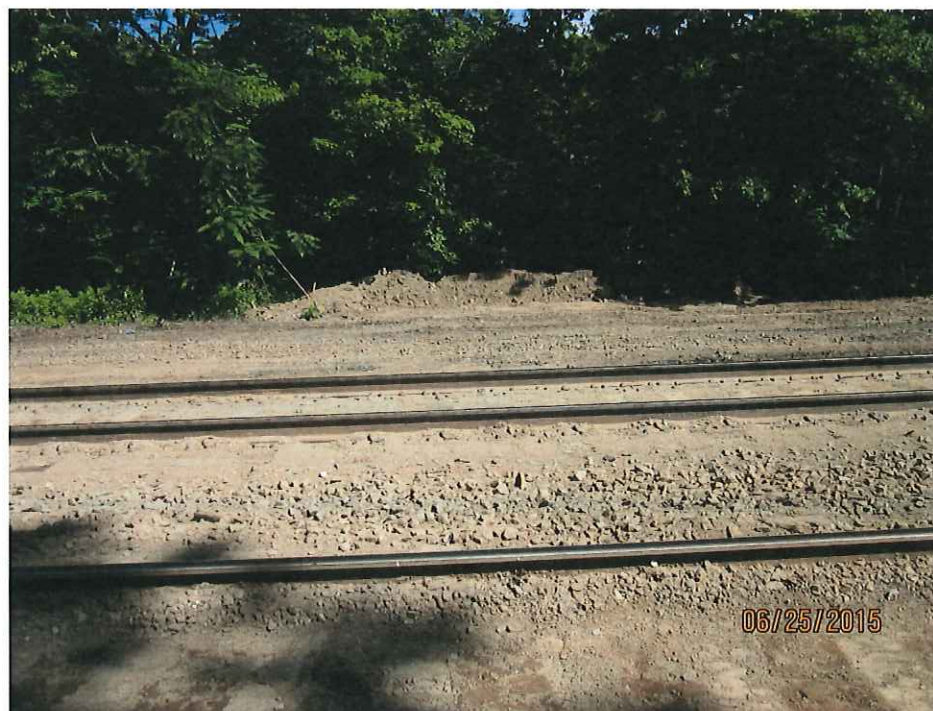
3-4. Looking north across the railroad bed at the washout location, showing soil and rock material deposited across both sets of tracks. Note large pile of soil and rock pushed up by machinery on the far (north) side of the rail bed.

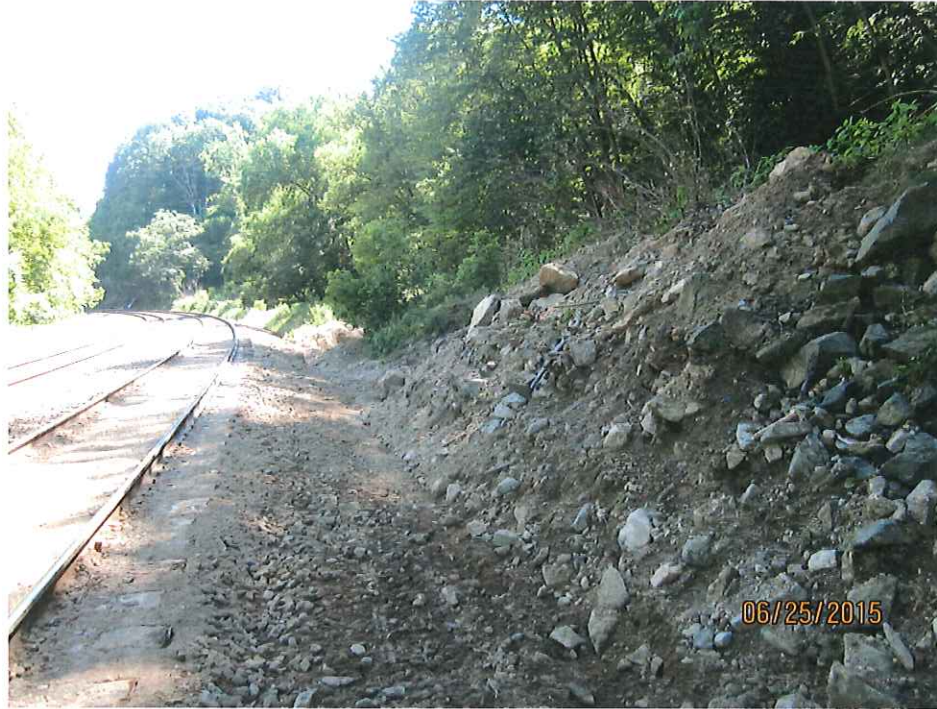
3-5. Looking east along juncture of railroad bed and road bank at outwash location, showing soil and rock material deposited.

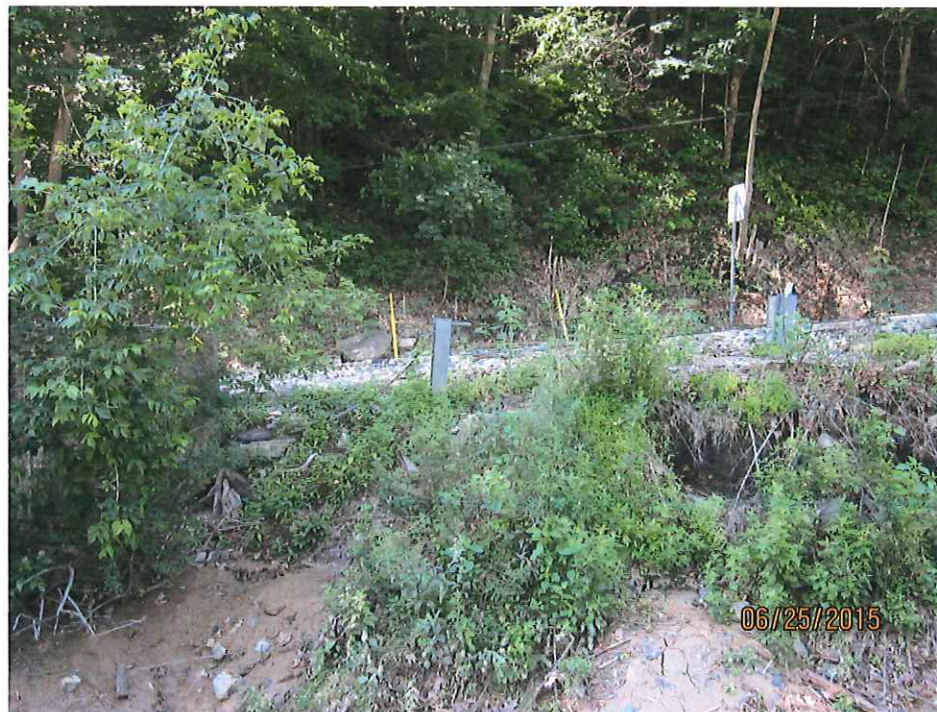
3-6. Looking south across Riverside Drive at location of hazard markers that may mark a culvert or inlet along the south side of the roadway.

In the area of the speed limit sign, there are hazard markers along the southern edge of the roadway and a sump filled with sediment in the roadside ditch. Opposite this to the north, there is a sump in the ditch along the railroad tracks. Finally, there is the outlet of a twenty-four inch (24") square concrete culvert on the north bank of the railroad bed, above the Lehigh River. This evidence seems to indicate the presence of inlets along Riverside Drive and along the railroad bed, which are filled and clogged with sediment. I suggest that, while PennDOT and Norfolk Southern are collaborating on the repair of the undermined area (as indicated in Mr. Young's e-mail), they should also conduct work to find, clear and reopen these inlets.

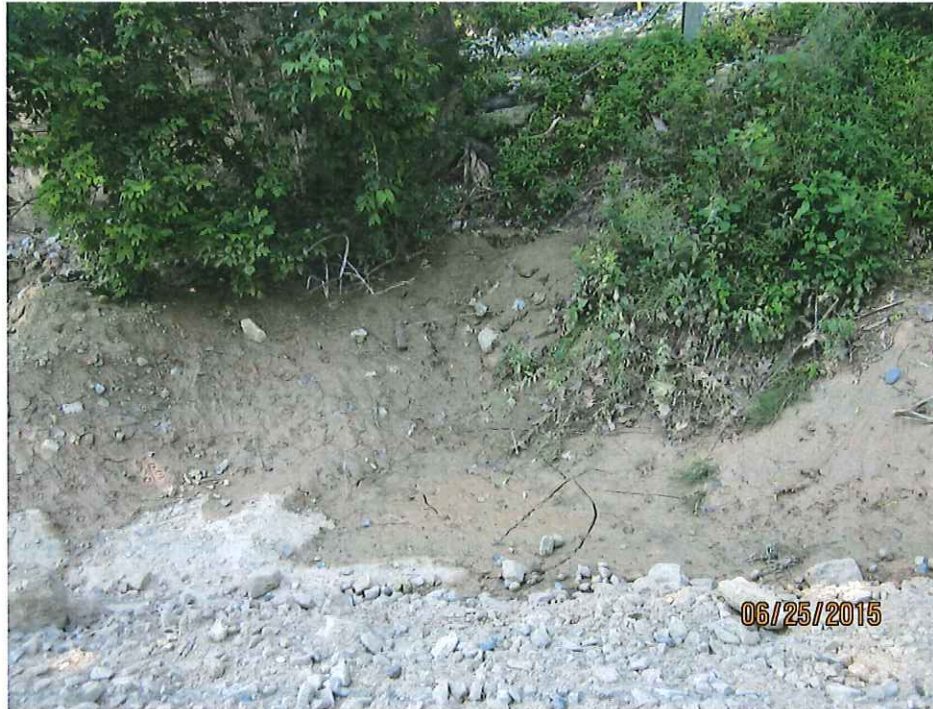
3-7. Close-up of “sump” in ditch along rail bed at bottom of roadway bank. This is opposite the location of the hazard markers on Riverside Drive and may indicate the presence of a culvert or inlet at this location.

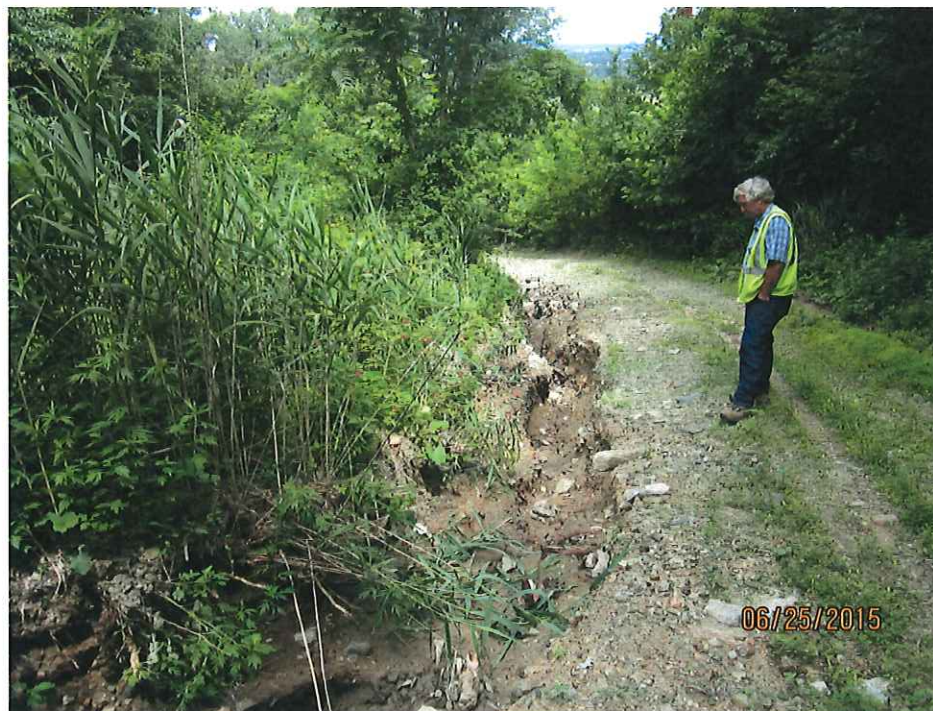
Following the investigation described above, I conducted my regular monthly inspection of the landfill facility. As part of this, I conducted an inspection of the north slope road. I observed a large amount of recent erosion along the entrance to this road, continuing along the western leg of the road. I observed a concrete "sluice" along the north side of the road which physical evidence indicates served to direct stormwater runoff northward, toward a natural swale that was observed in the field and which is depicted on the topographic plan. This swale starts at the northern property line of the facility, and proceeds down the slope (northward) across the neighboring properties. The area of the washout along Riverside Drive is directly down slope of this swale. Based on the above, I conclude that a large amount of the stormwater runoff that caused the washout on Riverside Drive originated from the northwest portion of the landfill facility, an area which does not have detention basins to control and slow the rate of runoff.

3-8. On the IESI landfill property, looking north along entrance to north slope road, showing erosion channel in road bed cause by stormwater runoff.

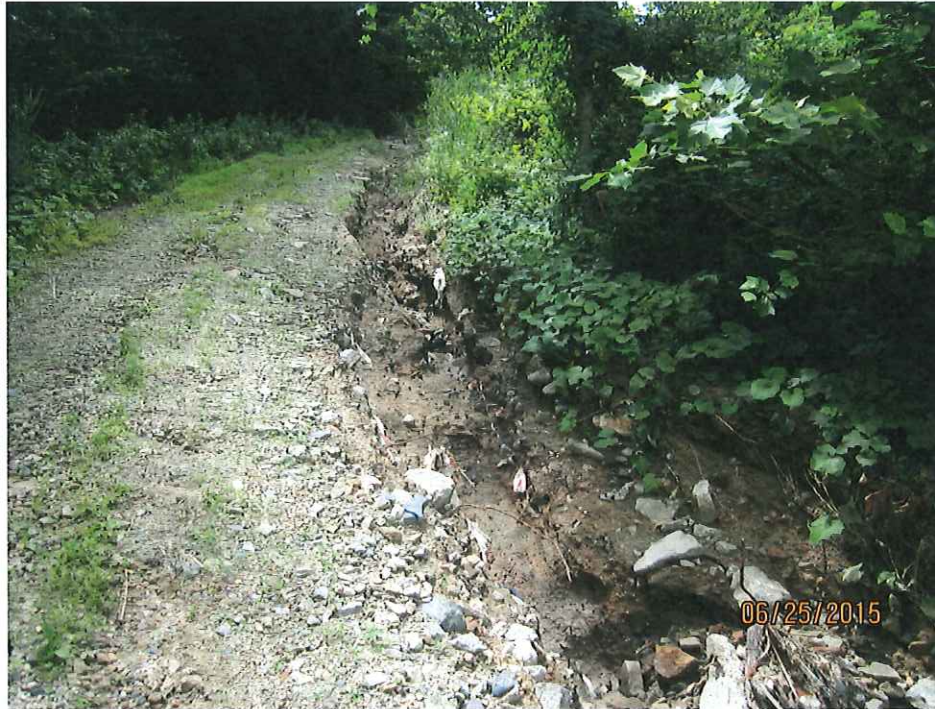
3-9. Close-up of erosion channel on north slope road on IESI property.

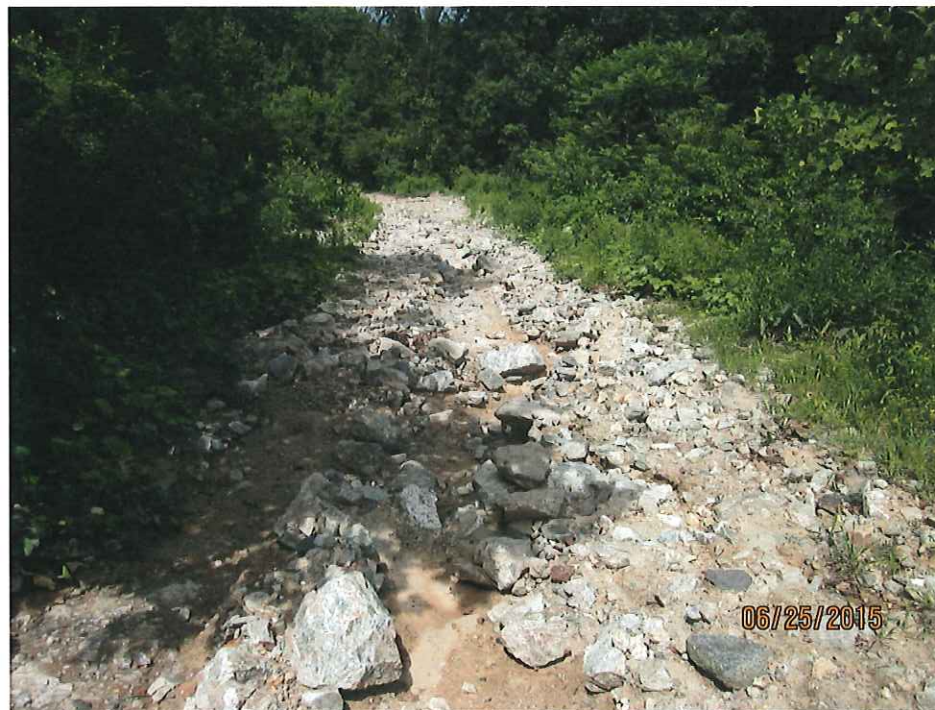
3-10. Looking east along western leg of north slope road, showing rock material deposited by stormwater runoff.

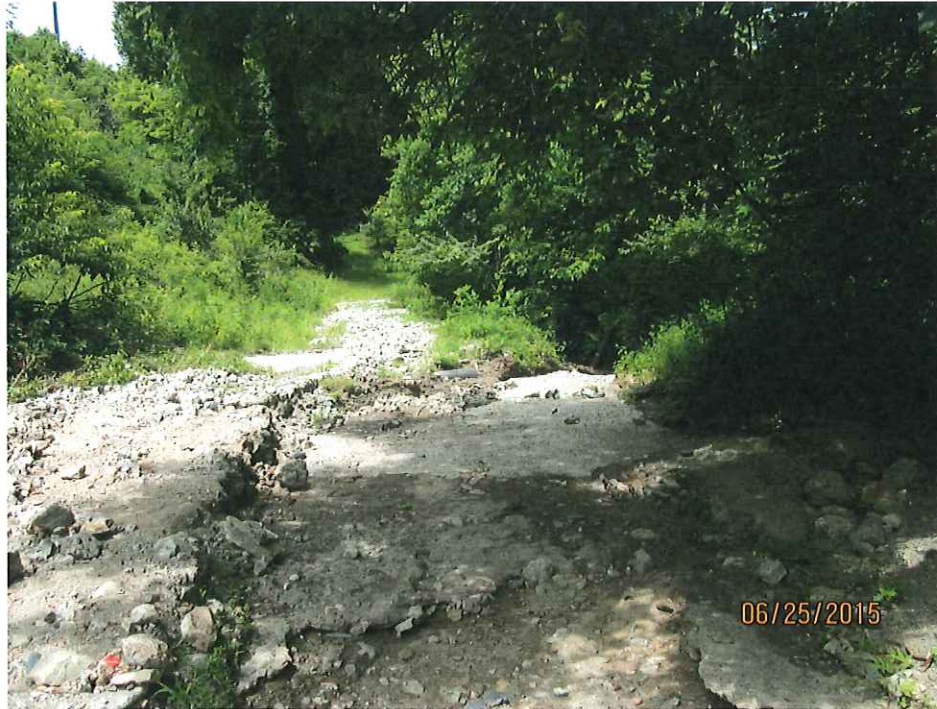
3-11. Looking west along western leg of north slope road, showing beginning of concrete "sluice" which directs stormwater runoff to the north toward a natural swale on the north slope.

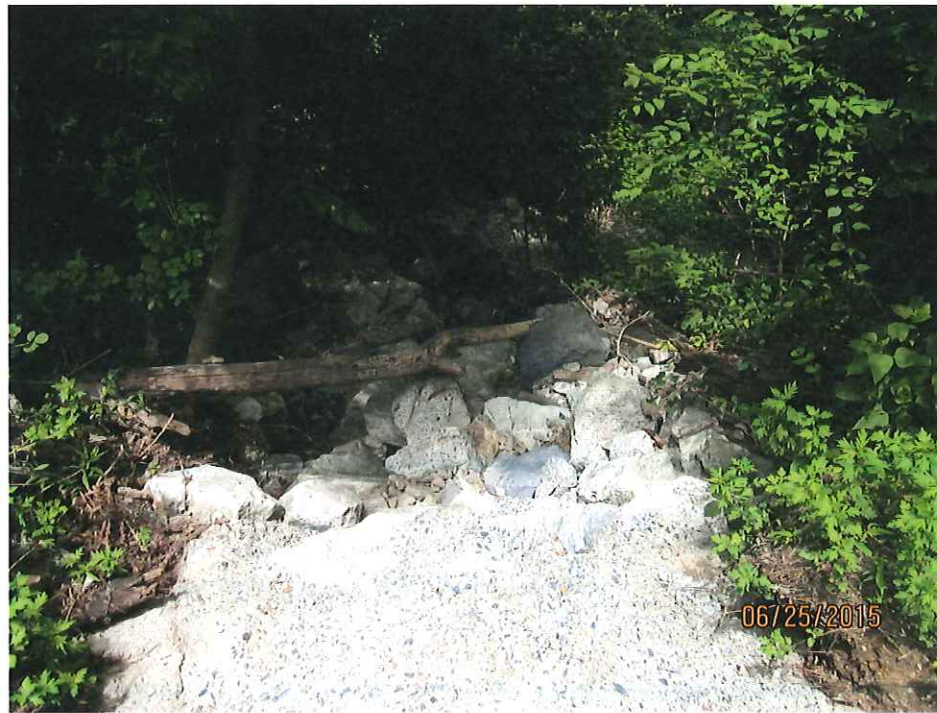
3-12. Close-up of end of concrete sluice and beginning of natural swale on the north slope.

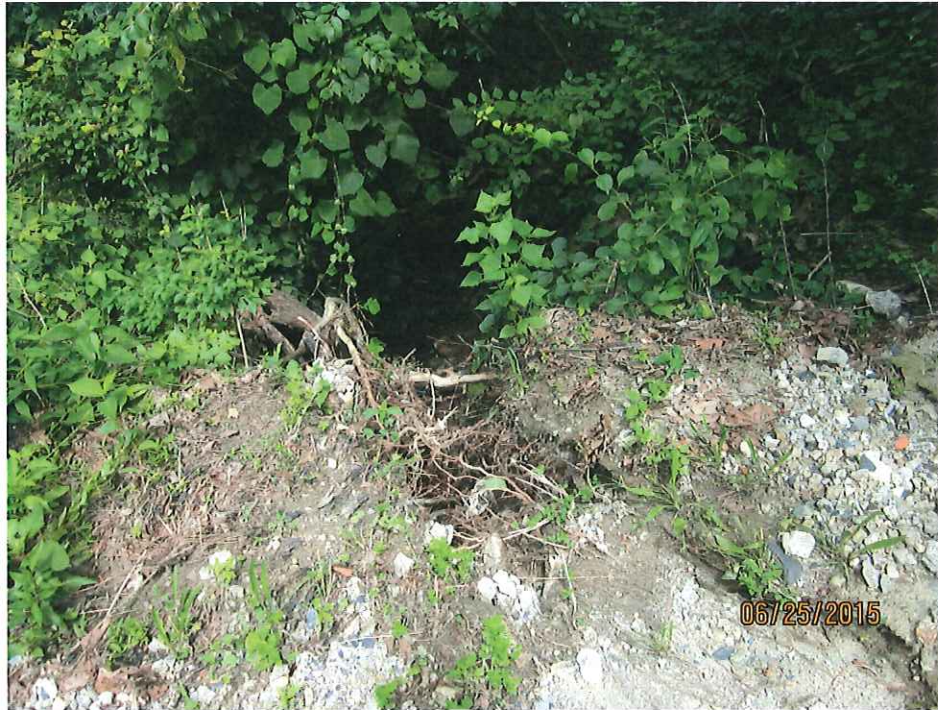
3-13. Showing second location where stormwater leaves north slope road and runs northward toward natural swale.

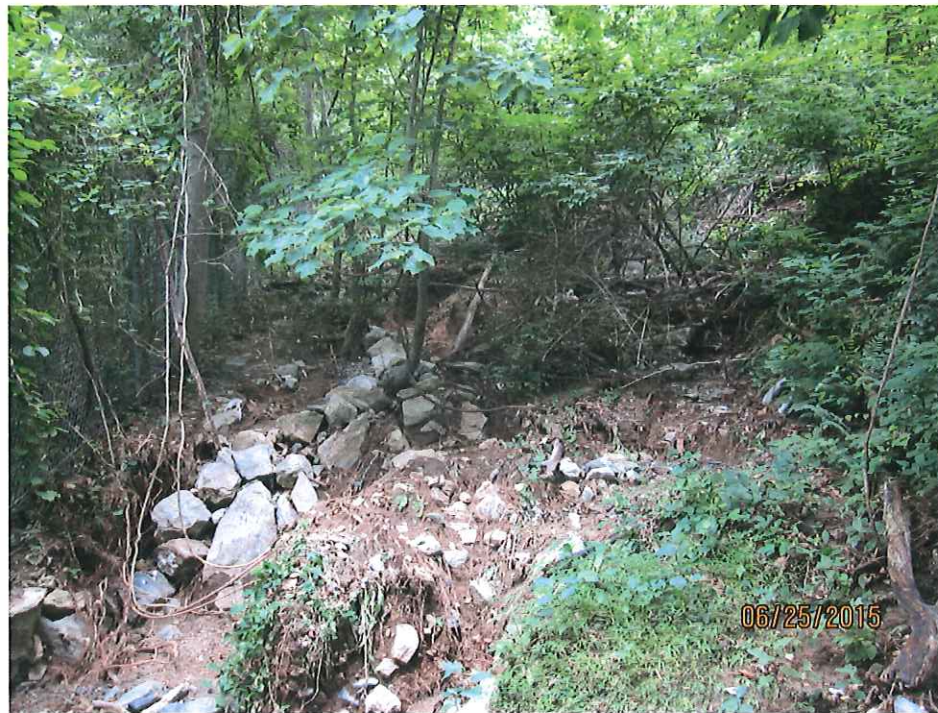
3-14. View downhill of the concrete "sluice", showing soil and rock material eroded by stormwater runoff coming from north slope road.

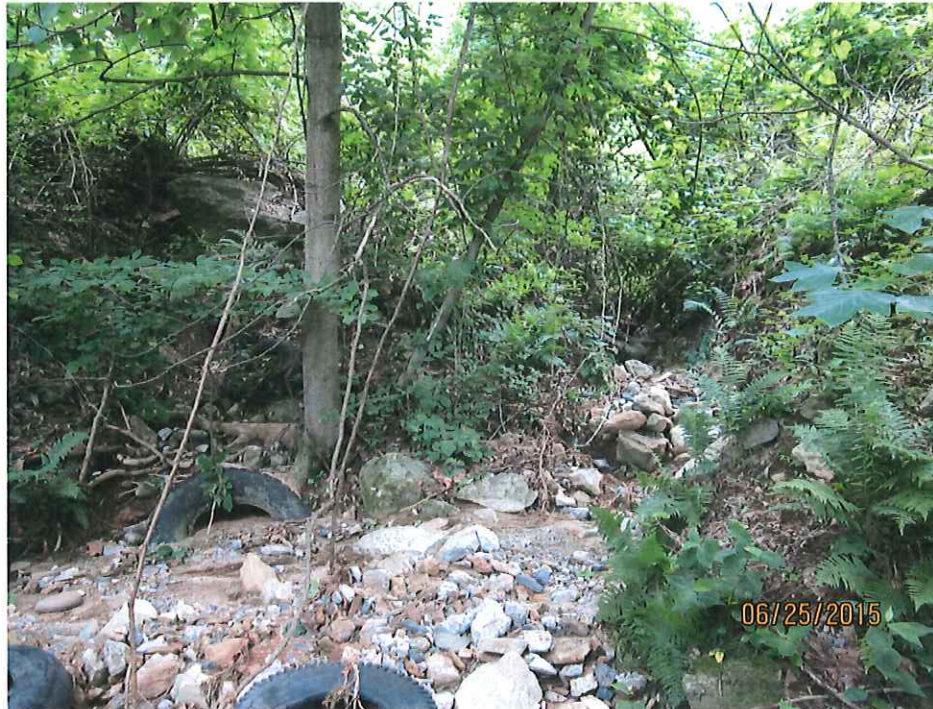
3-15. View downhill of second runoff location, showing soil and rock material eroded by stormwater runoff coming from north slope road.

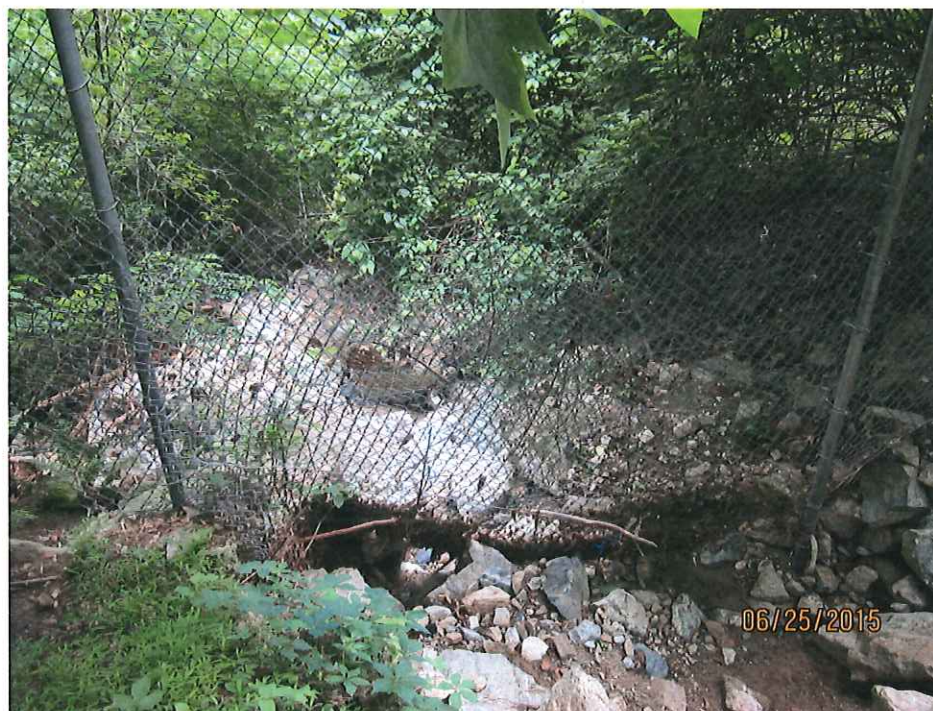
3-16. Looking north across IESI property line showing natural swale running northward toward Riverside Drive. Stormwater runoff from the north slope road concentrates at this location.
