DETERMINATION OF ELIGIBILITY NOTIFICATION
National Register of Historic Places
National Park Service

Redington Historic District
Name of property: (PA 33 Extension Project)

REDINGTON HISTORIC DISTRICT: ADDITIONAL INFORMATION

PENNSYLVANIA HISTORIC RESOURCE SURVEY FORM BUREAU FOR HISTORIC PRESERVATION Box 1026 PA HISTORICAL & MUSEUM COMMISSION Harrisburg, PA 17120		7. Local survey organization		1. County Northampton County

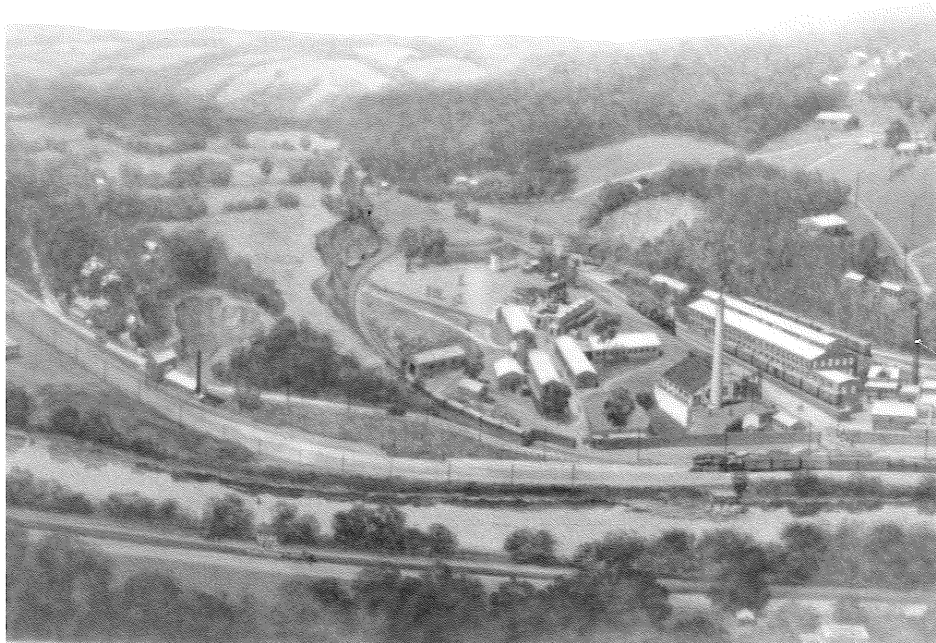
Center Section of Redington Site, ca. 1910.

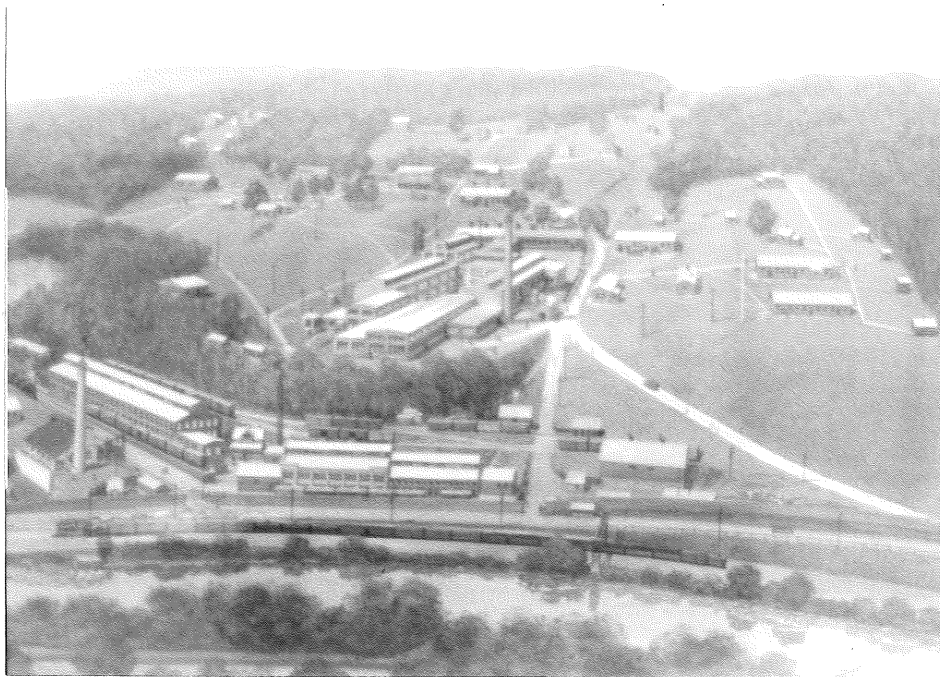
Western section of Redington Site, ca. 1910.
Photo of drawing at Bethlehem Steel Corp, Bethlehem, PA.

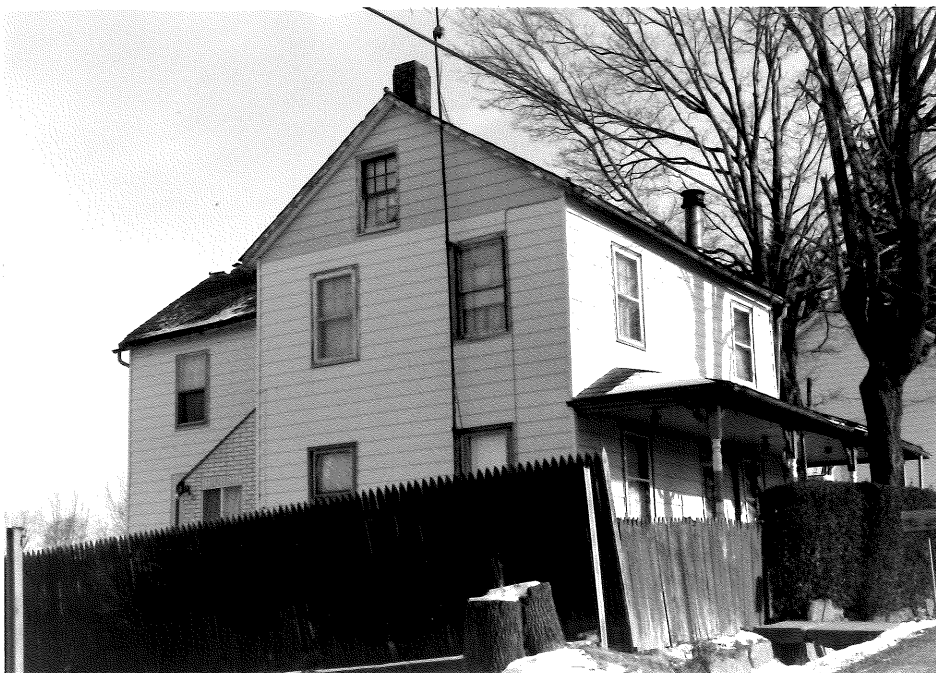
Building 5: Coleraine Iron Company worker house.

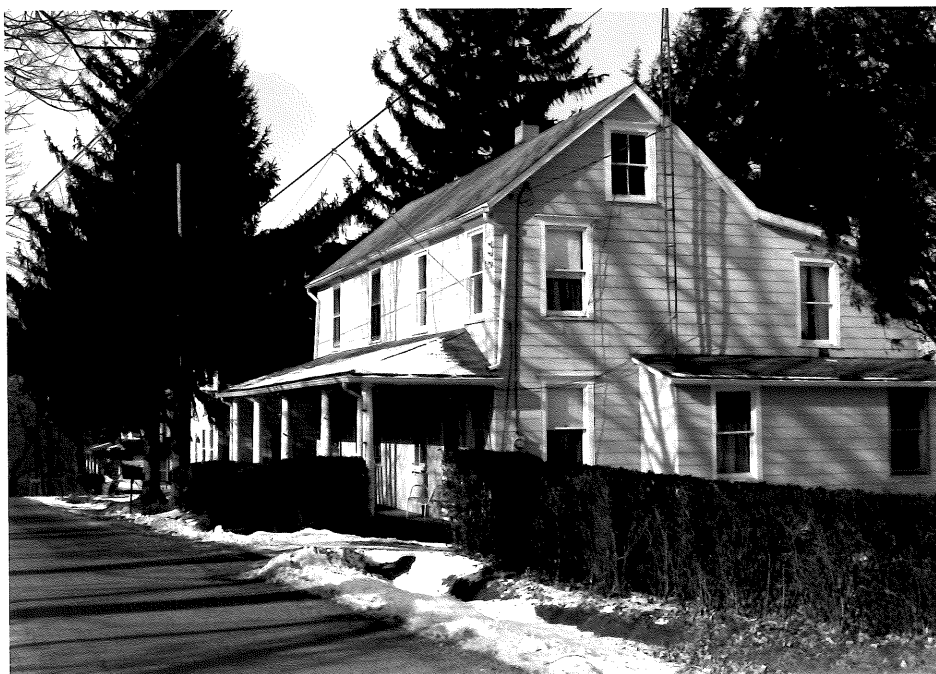
Building 6: Coleraine Iron Company, double worker house.

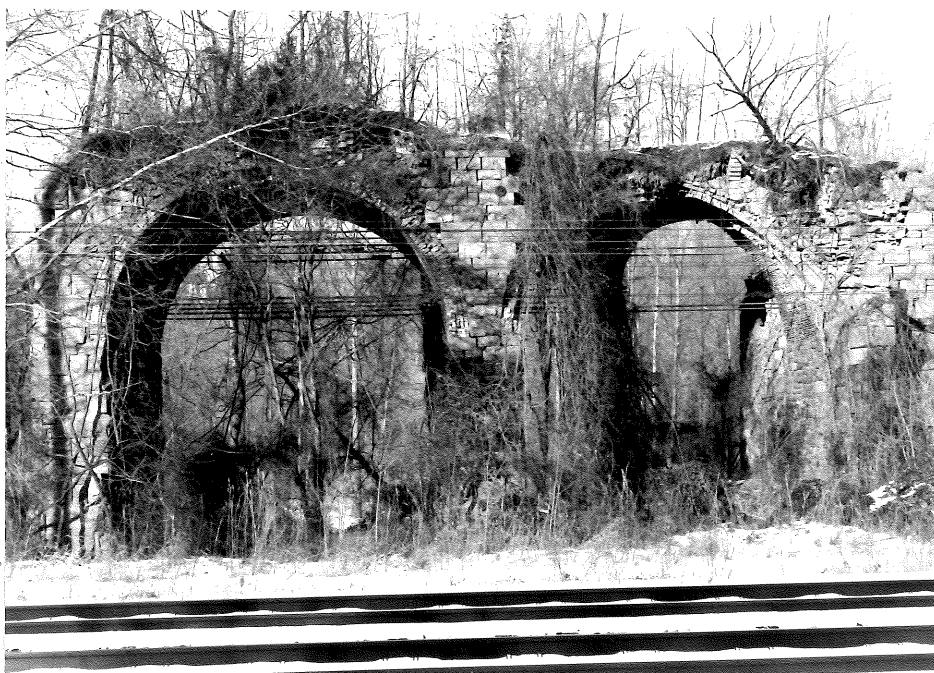
View of stone arches from Coleraine Iron Co., later part of the Redington Works.

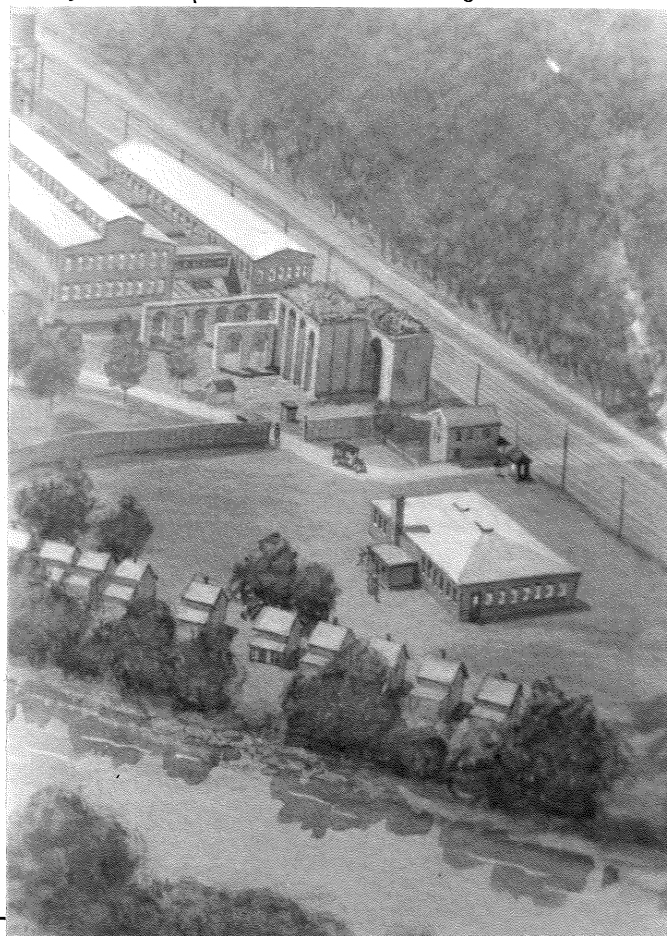
Close up view of stone arches as integrated into Works. Note worker houses constructed for the Coleraine Iron Company, but also used later.

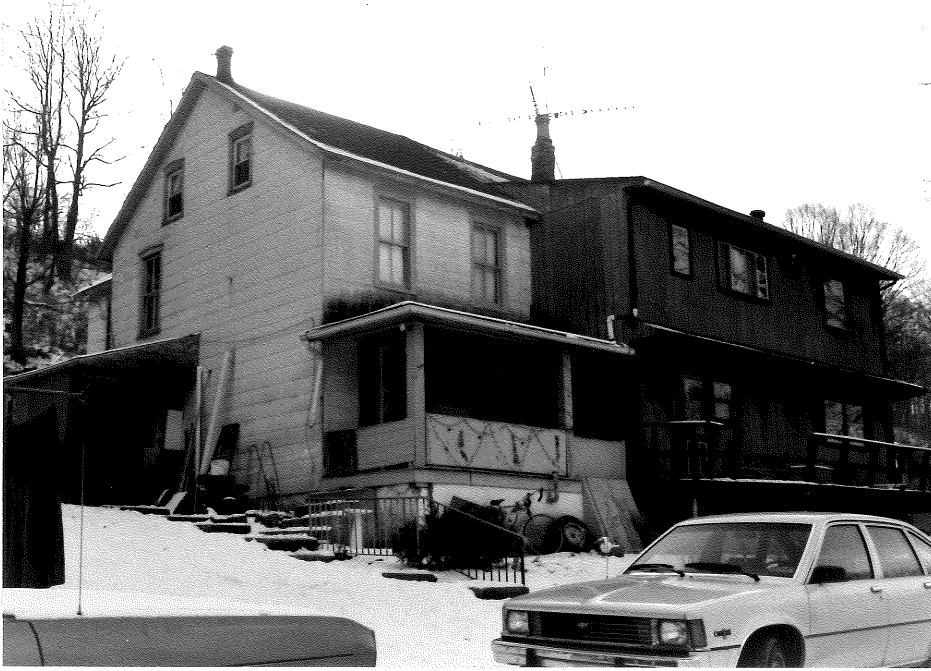
26) (cont.) roofed, frame dwelling; it has internal end chimneys and a modern, frame addition on its west side. The house, which has been sheathed in asbestos shingles, faces south and has a hipped-roofed porch on the main (south) facade. The windows are two/two, double-hung and have wooden frames. A one-story, shed-roofed storage structure is attached to the southern bay of the east facade. The second story of the east facade has one two/two, double-hung window in the southern bay, and a pair of two/two, double-hung, wooden windows let light into the attic. The roof has been sheathed in composition shingles. There is a two-story addition to the rear facade of the house. This two-bay by one-bay structure has a gable roof. Building One is in fair condition, but its integrity has been greatly diminished by the large addition on the west.

Building 1: Coleraine Iron Company House.

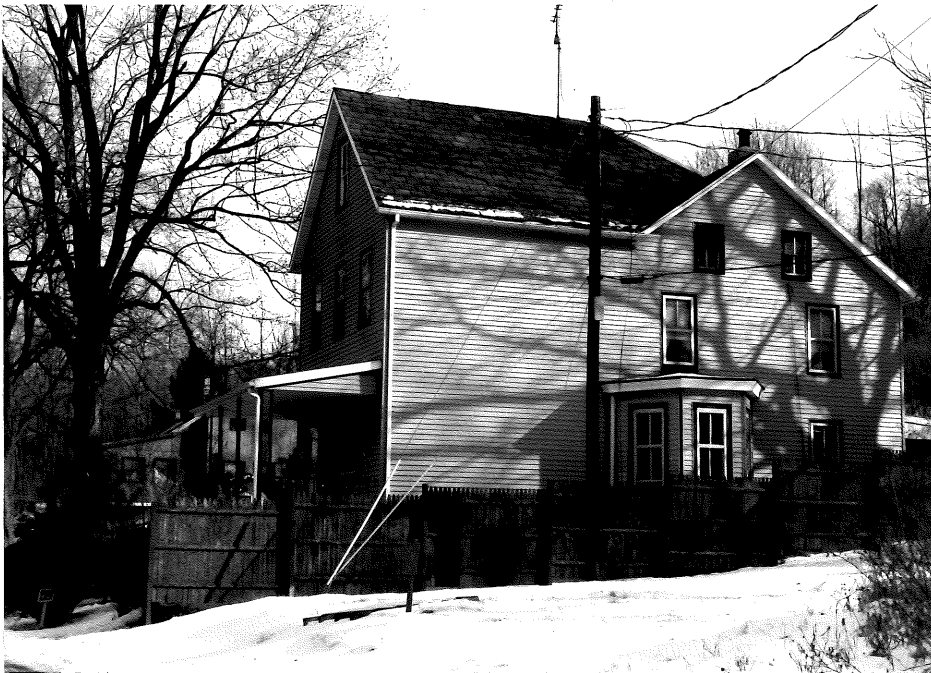
Building Two: Building Two is a two and one-half story, three-bay dwelling with a cross gable at the rear. Aluminum siding obscures the frame construction of the house. The front (north) facade has been altered on the first story, where there is a door at the eastern bay and a large, single-paned window has been added west of the door. The second story, which has three symmetrically placed bays, shows the historically correct fenestration of the house. In the gable is a full sized, wood-framed window; like most of the other windows on the house, it is two/two, double-hung. There is a shed-roofed porch on this facade. The cross-gabled section of Building Two, also two and one-half stories, has six symmetrically placed bays on the east facade. The bay window on the first story of the west facade appears to be original. All of the windows on this facade are wooden, two/two, double-hung. The roof of the house has been sheathed with slate shingles. This house is in good condition and has good integrity despite the recent aluminum siding.

Building 2: Coleraine Iron Company Worker Housing.

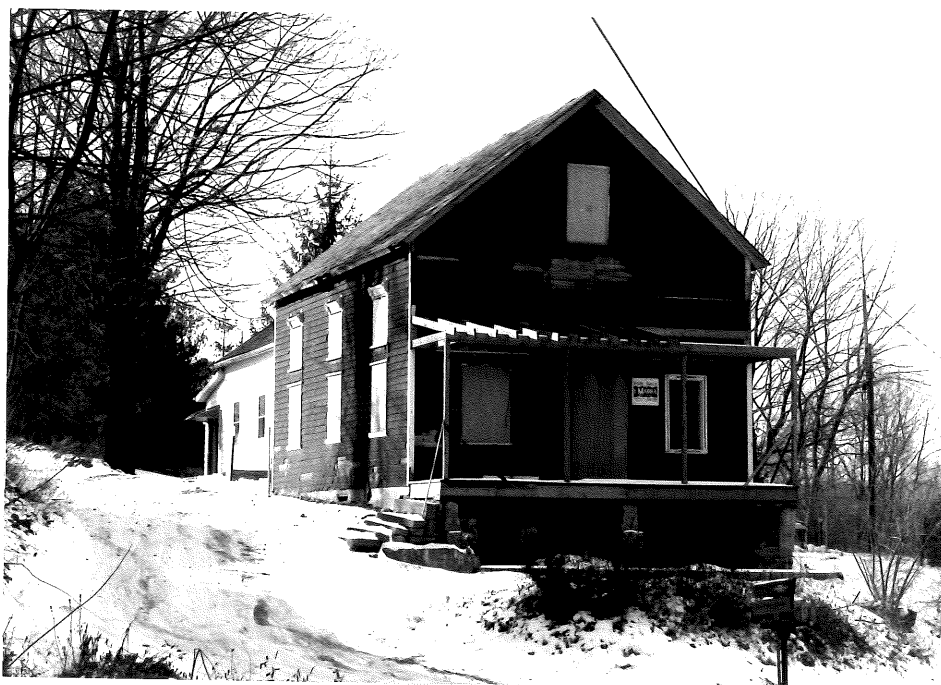
Building Three: The school-house/meeting house associated with the Coleraine Iron Company has been designated as Building Three. It is sited facing east on a rise above the former industrial complex. The frame building, a one and one-half story, three-bay, frame structure, sits with its gable running perpendicular to the road. The building rests on a fieldstone foundation. Its front (east) facade has a shed-roofed porch and a central door flanked by two windows. There is a window at the gable. The door and all the windows on this facade, like most on the building, have been sealed with wood boards. The south facade has three symmetrically placed bays with elaborately carved window moldings. The north facade is identical to the south facade. The building has a slate roof, is in fair condition, and is currently being stabilized.

Building 3: Coleraine Iron Company School.

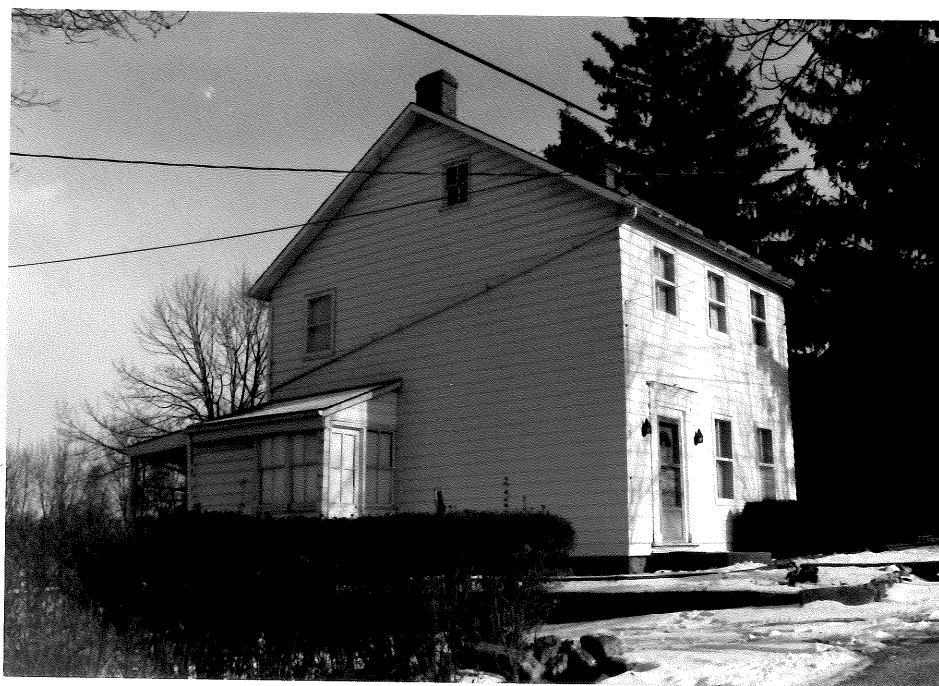
Building Four: Building Four within the Redington Historic District sits on the east side of Redington Road and faces west. This two and one-half story, three-bay, frame dwelling has a gable roof and brick interior end chimneys. The door of the front facade opens from the northern bay and has an elaborate pilastered enframing. The windows on this facade are two/two, double-hung and have wooden frames. The house, which has been covered in (cont.)

Building 4: Worker Housing.
