BETHLEHEM LANDFILL COMPANY

Phase V Expansion

LAND DEVELOPMENT AND LOT CONSOLIDATION PLAN SUPPORTING DOCUMENTATION

PHASE V EXPANSION

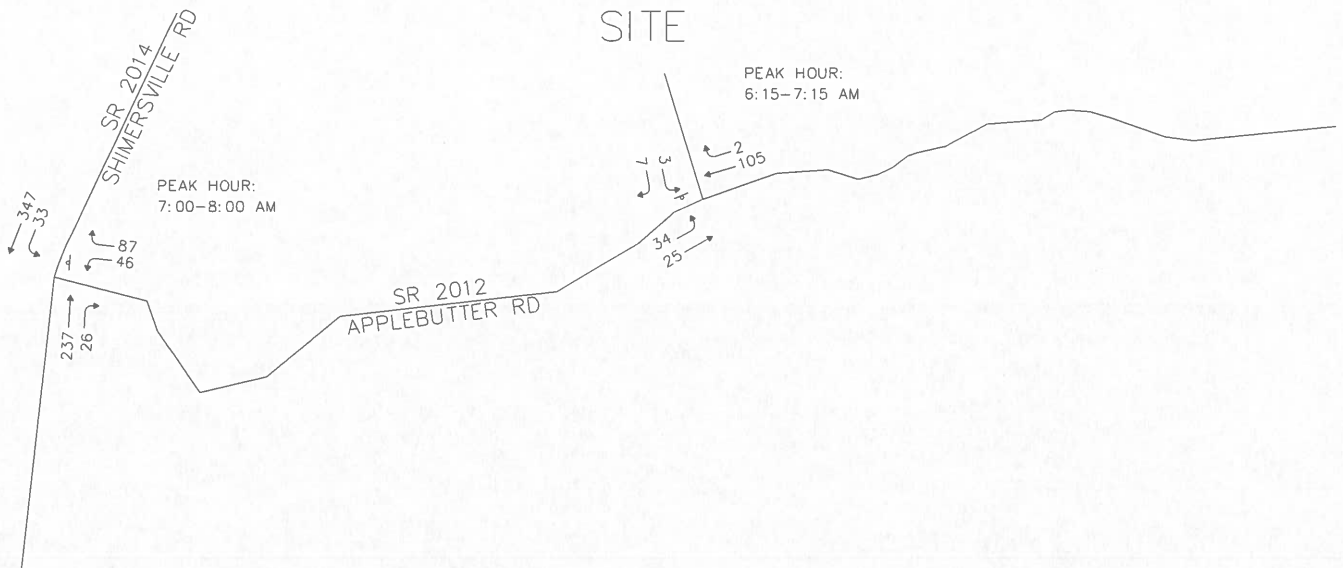
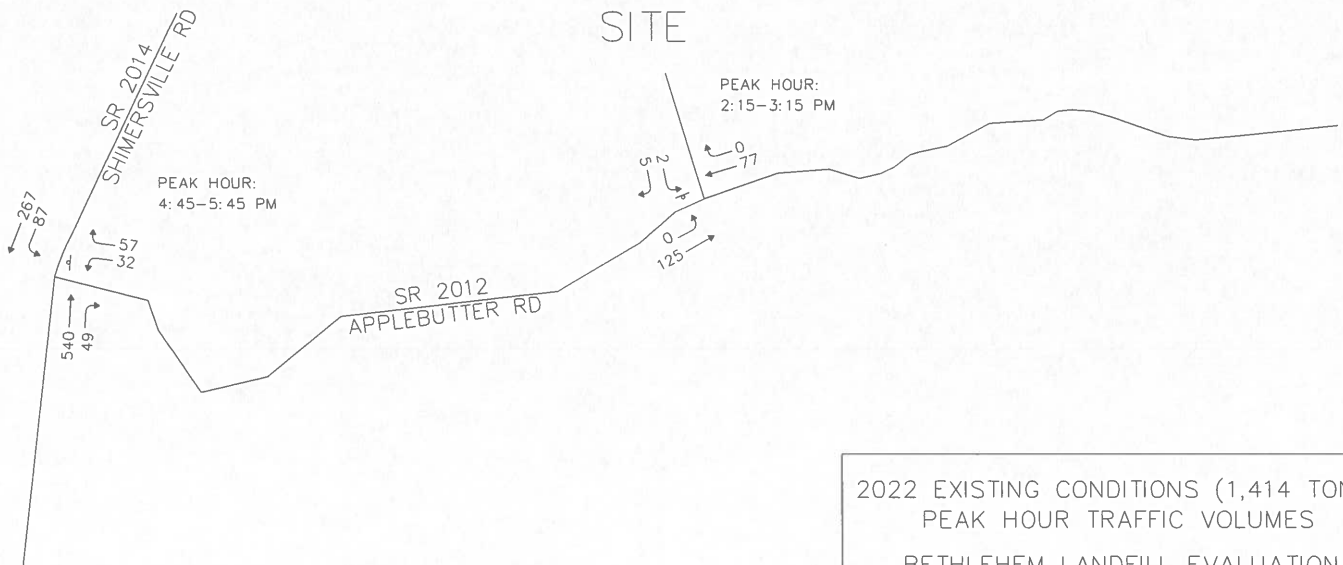
2022 EXISTING CONDITIONS (1,414 TONS)
PEAK HOUR TRAFFIC VOLUMES

FIGURE 2 – 2022 EXISTING CONDITIONS (1,414 TONS) PEAK HOUR TRAFFIC VOLUMES

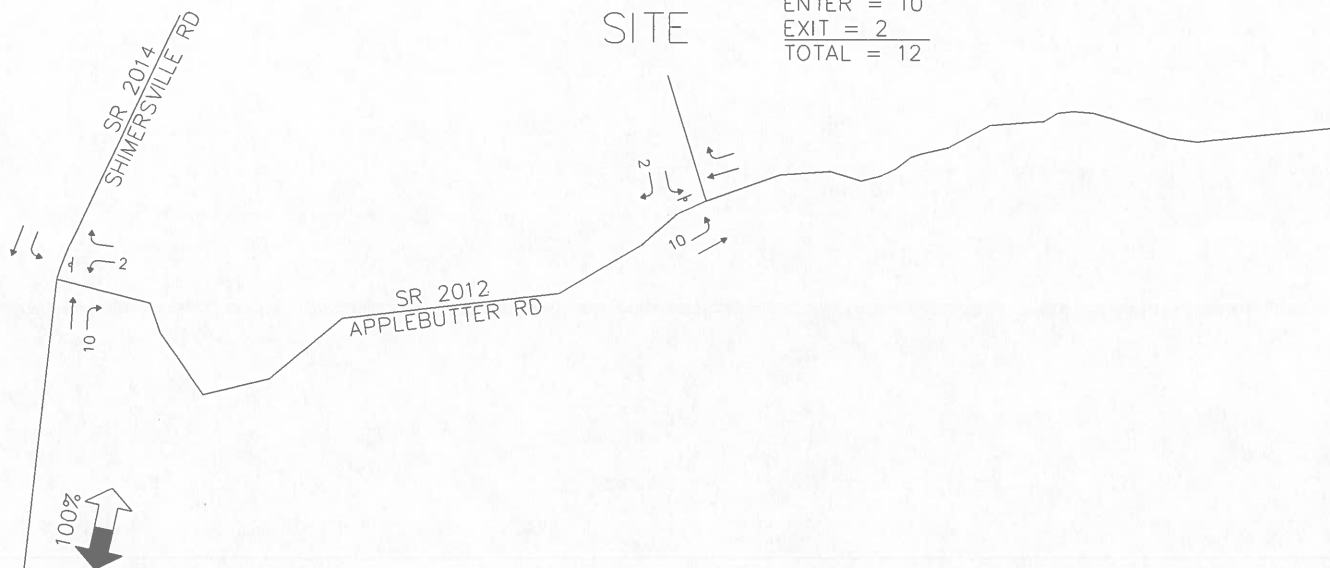
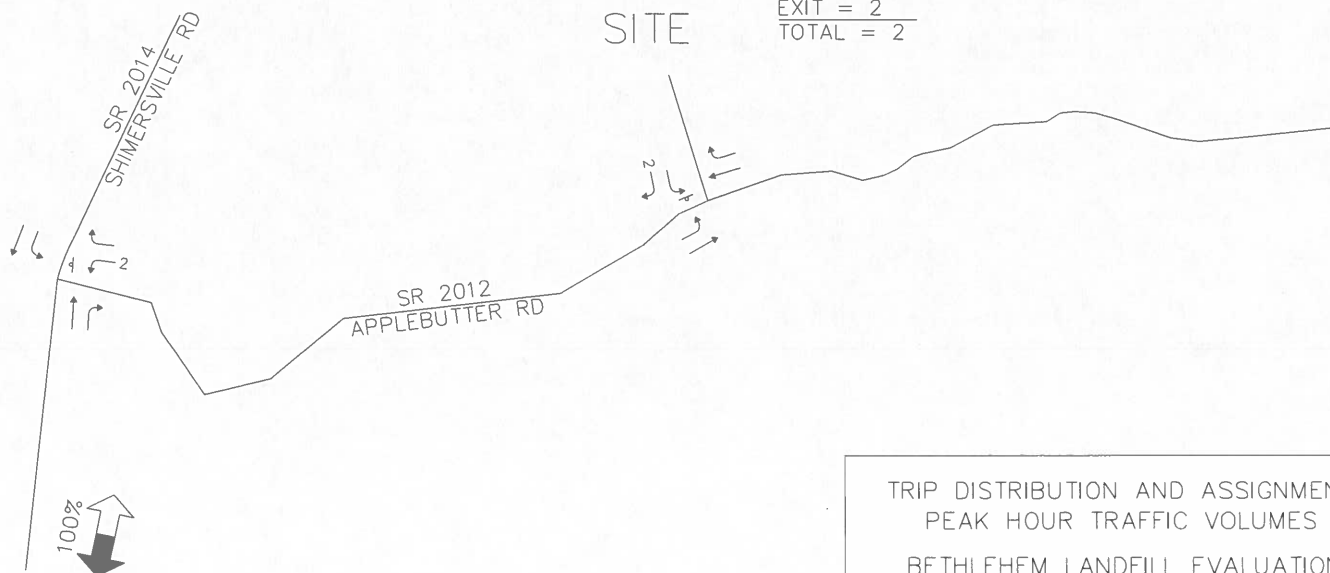
FIGURE 3

TRIP DISTRIBUTION AND ASSIGNMENT
PEAK HOUR TRAFFIC VOLUMES
BETHLEHEM LANDFILL EVALUATION

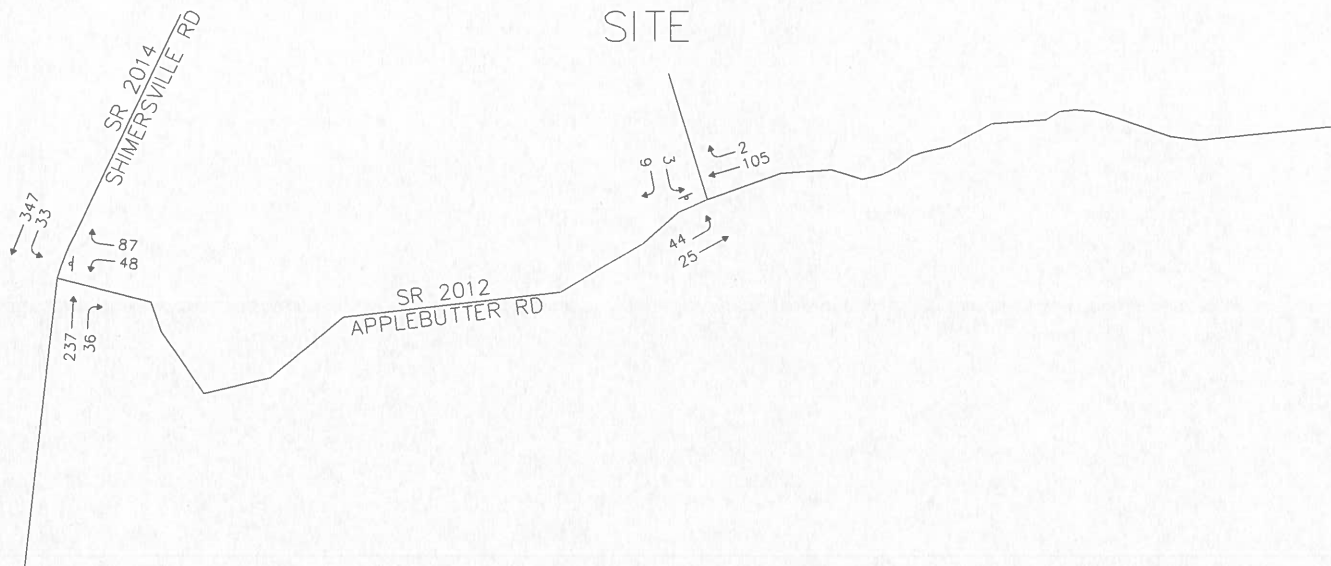
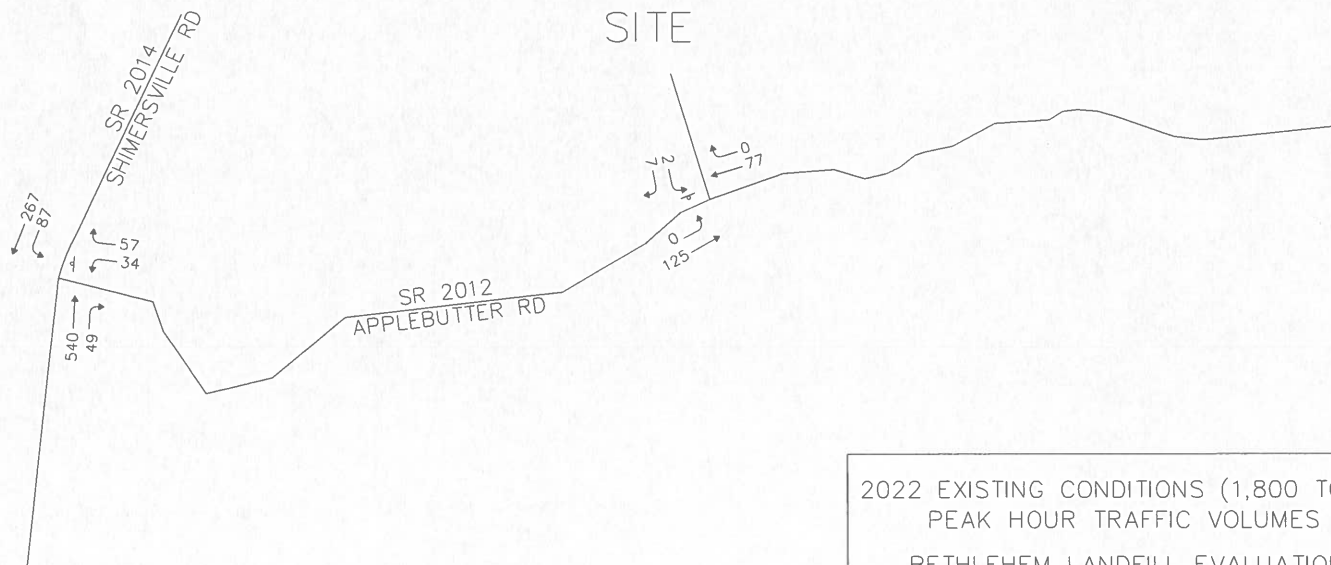
FIGURE 4

2022 EXISTING CONDITIONS (1,800 TONS)
PEAK HOUR TRAFFIC VOLUMES
BETHLEHEM LANDFILL EVALUATION

Maximum intake volumes were derived by adding the site generated traffic volumes to the Existing 2022 traffic volumes. Maximum intake traffic volumes for the 2022 Existing Conditions are shown in **Figure 4**.

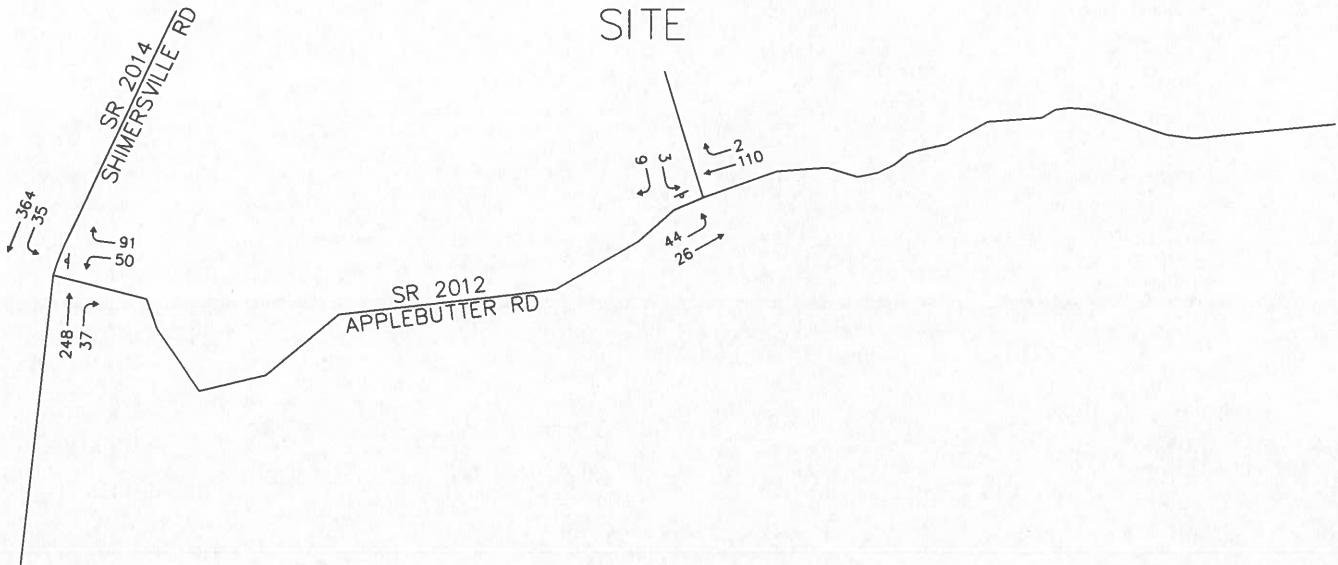
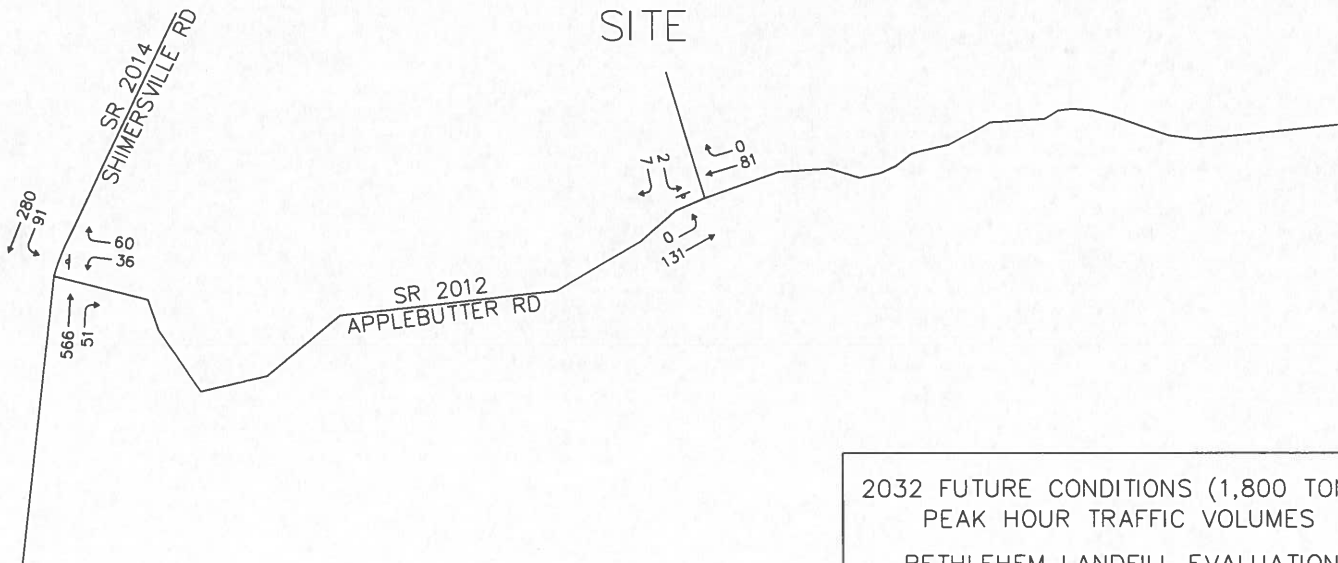
FIGURE 4A

2032 FUTURE CONDITIONS (1,800 TONS)
PEAK HOUR TRAFFIC VOLUMES
BETHLEHEM LANDFILL EVALUATION

A growth rate of 4.8% (0.47% compounded for 10 years) was used to calculate future traffic for the 2032 Future Conditions year. The rate was obtained from the current PennDOT Table, "Growth Factors for August 2022 to July 2023" for an urban non-interstate in Northampton County. Maximum intake volumes for the 2032 Future (1,800 MDV) conditions were derived by adding the additional site generated traffic volumes to the 2032 Future traffic volumes. Maximum intake traffic volumes for the 2032 Future Conditions are shown in **Figure 4A**.

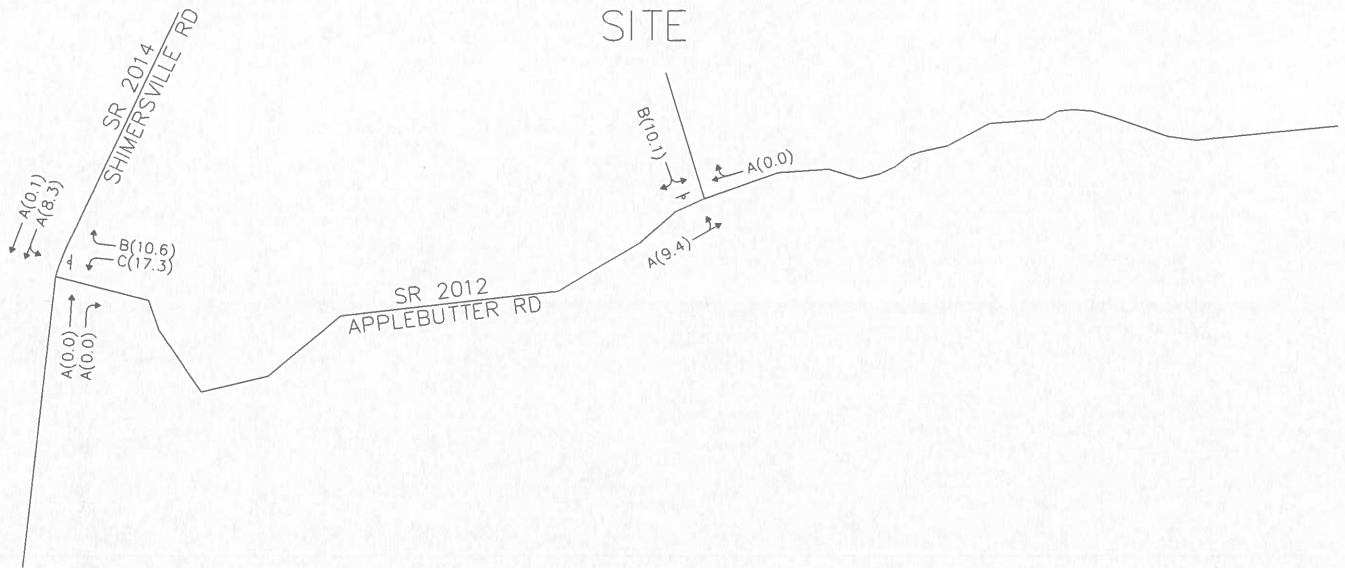
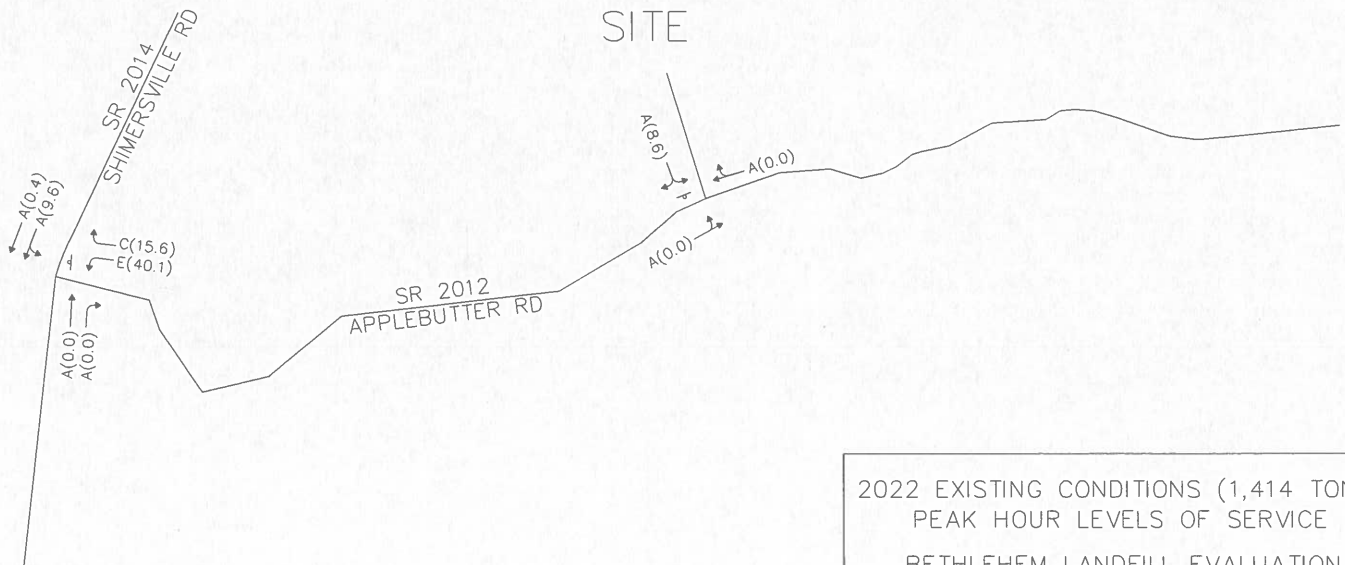
2022 EXISTING CONDITIONS (1,414 TONS)
PEAK HOUR LEVELS OF SERVICE
BETHLEHEM LANDFILL EVALUATION

The analyses were conducted for the weekday AM and PM peak hours. **Figures 5 through 6A** illustrate the levels of service for all study conditions. Synchro reports are included in **Appendix I**.

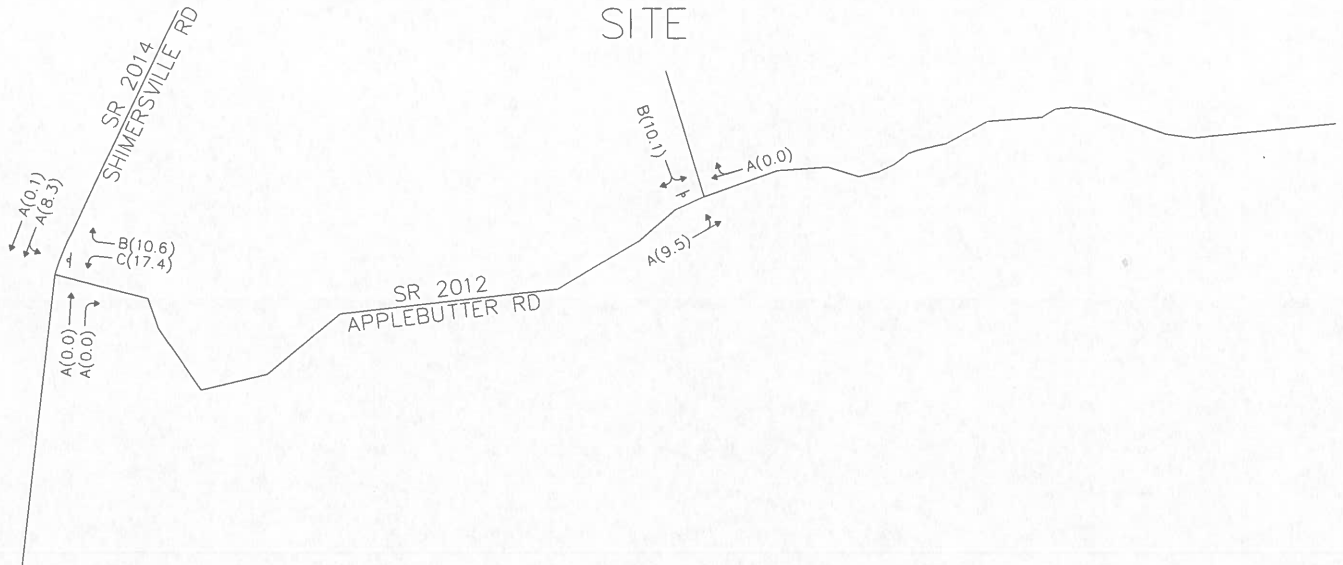
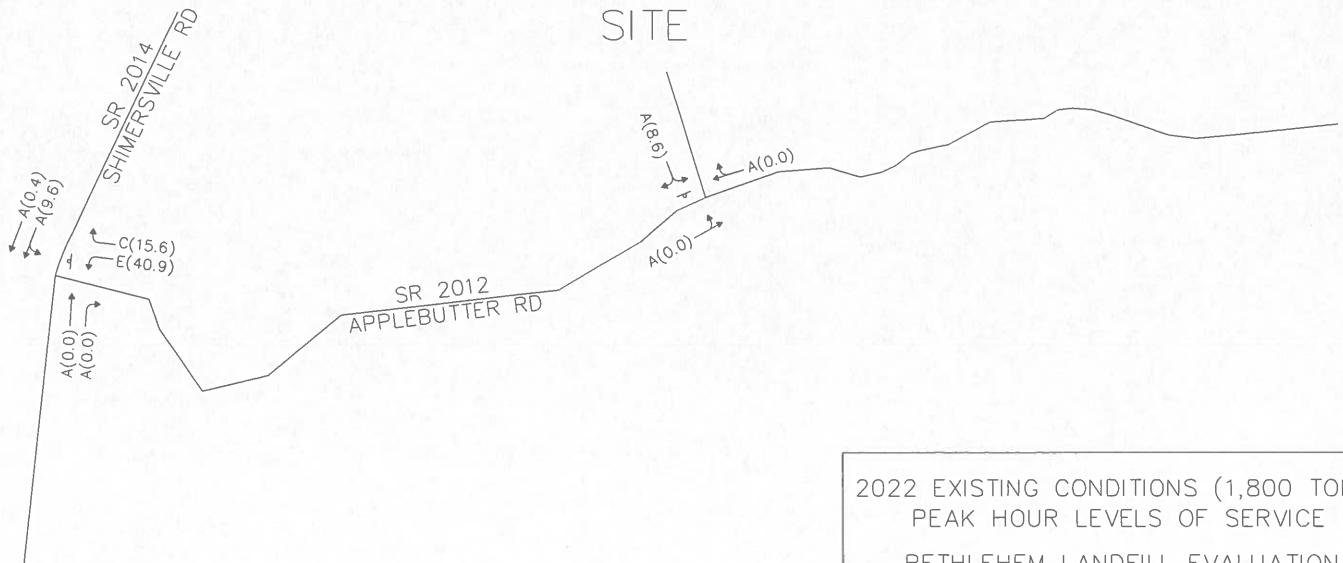
2022 EXISTING CONDITIONS (1,800 TONS)
PEAK HOUR LEVELS OF SERVICE
BETHLEHEM LANDFILL EVALUATION

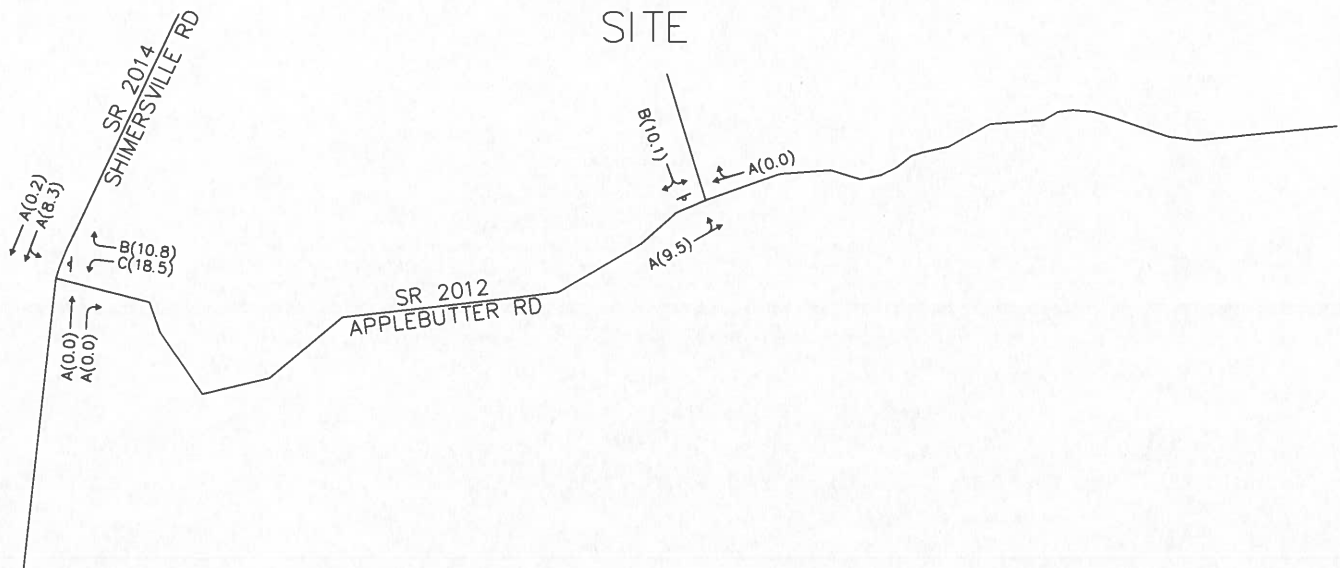
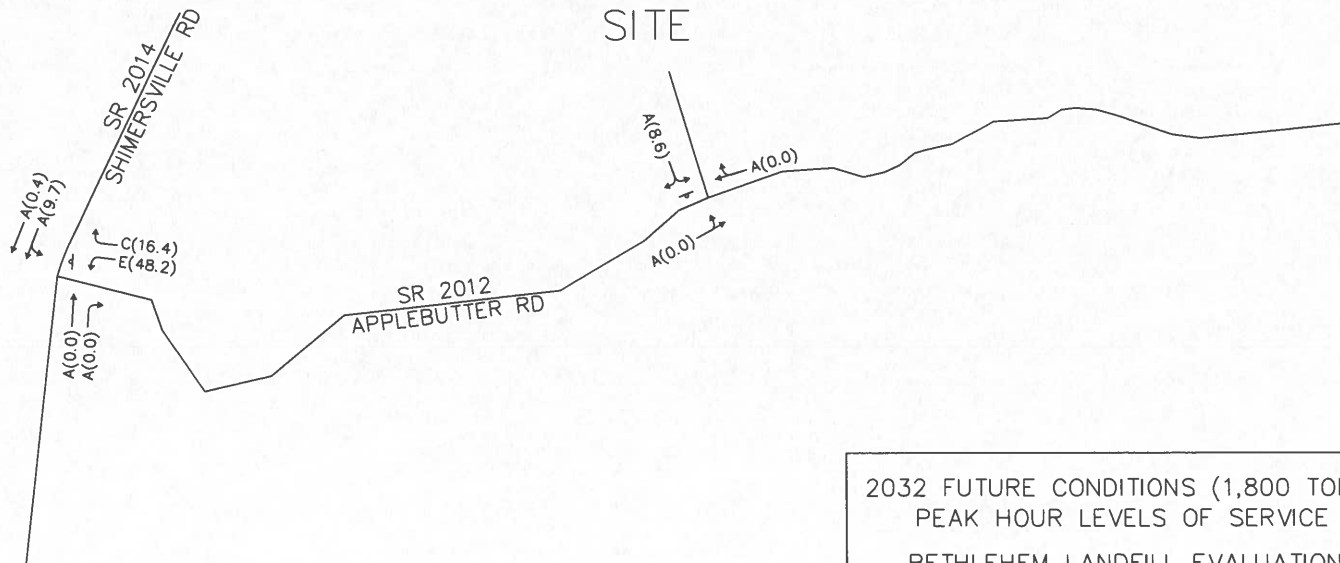
FIGURE 6A

2032 FUTURE CONDITIONS (1,800 TONS)
PEAK HOUR LEVELS OF SERVICE
BETHLEHEM LANDFILL EVALUATION

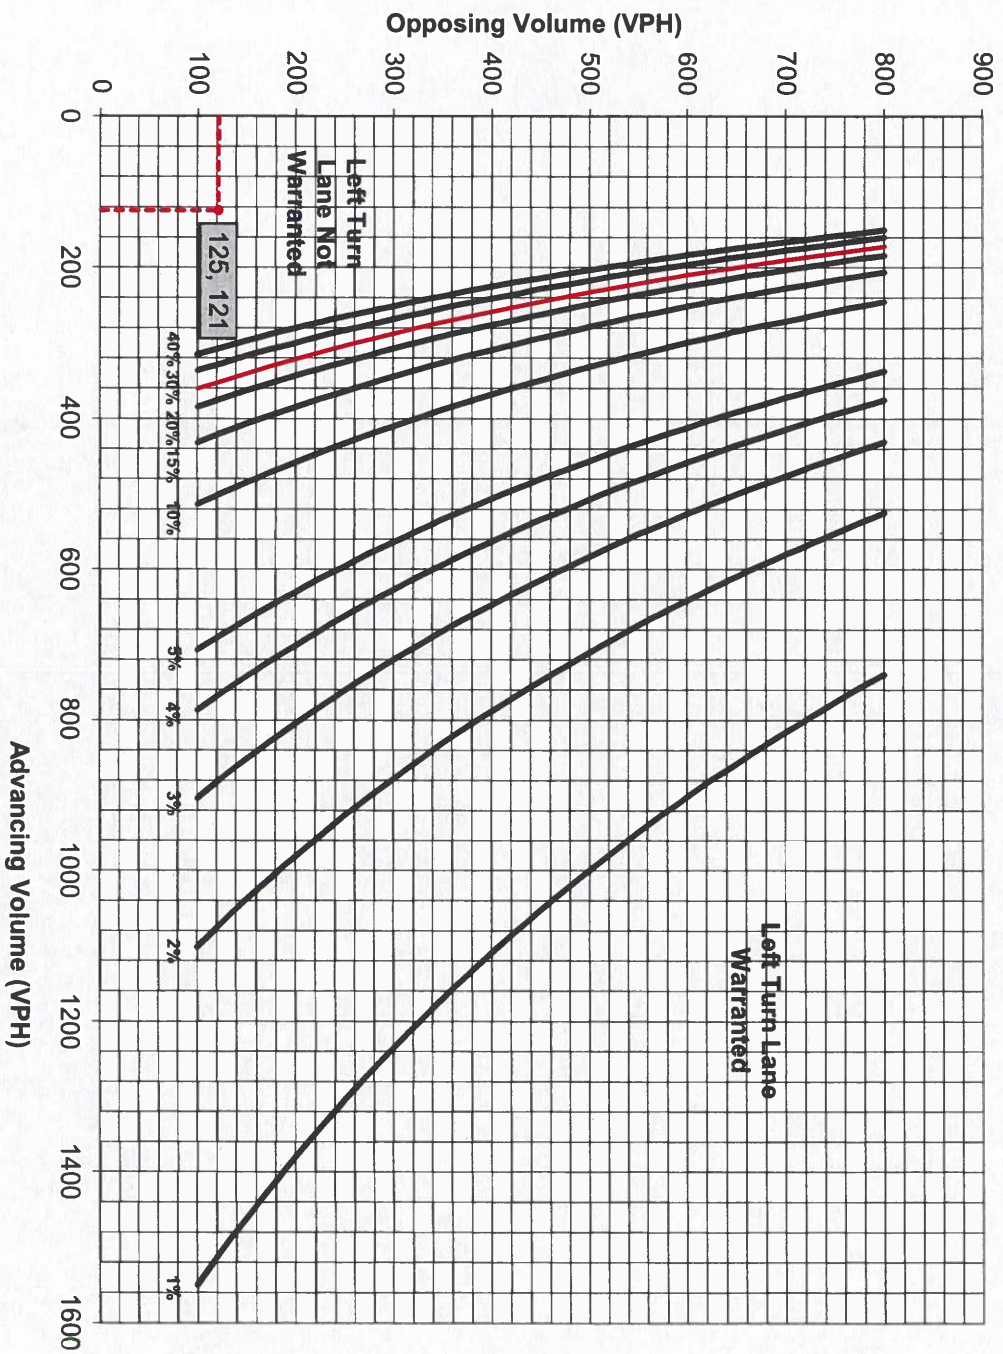
**Figure 2. Warrant for left turn lanes on two-lane highways
(40 mph speed, unsignalized and signalized intersections)**
(L = % Left Turns in Advancing Volume)

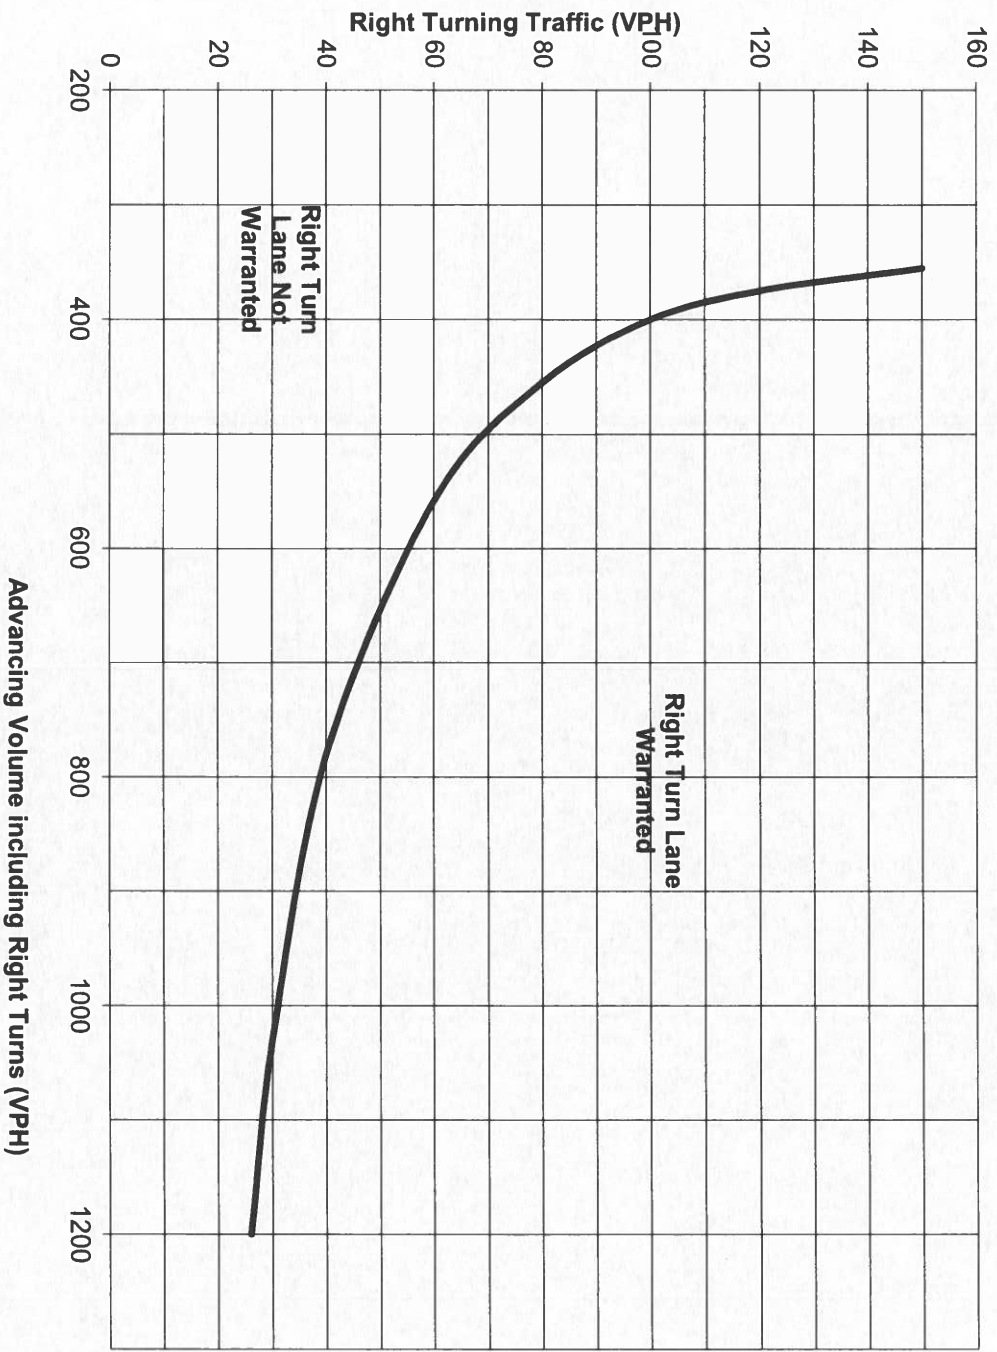
Figure 9. Warrant for right turn lanes on two-lane roadways
(40 mph or lower speeds, unsignalized and signalized intersections)

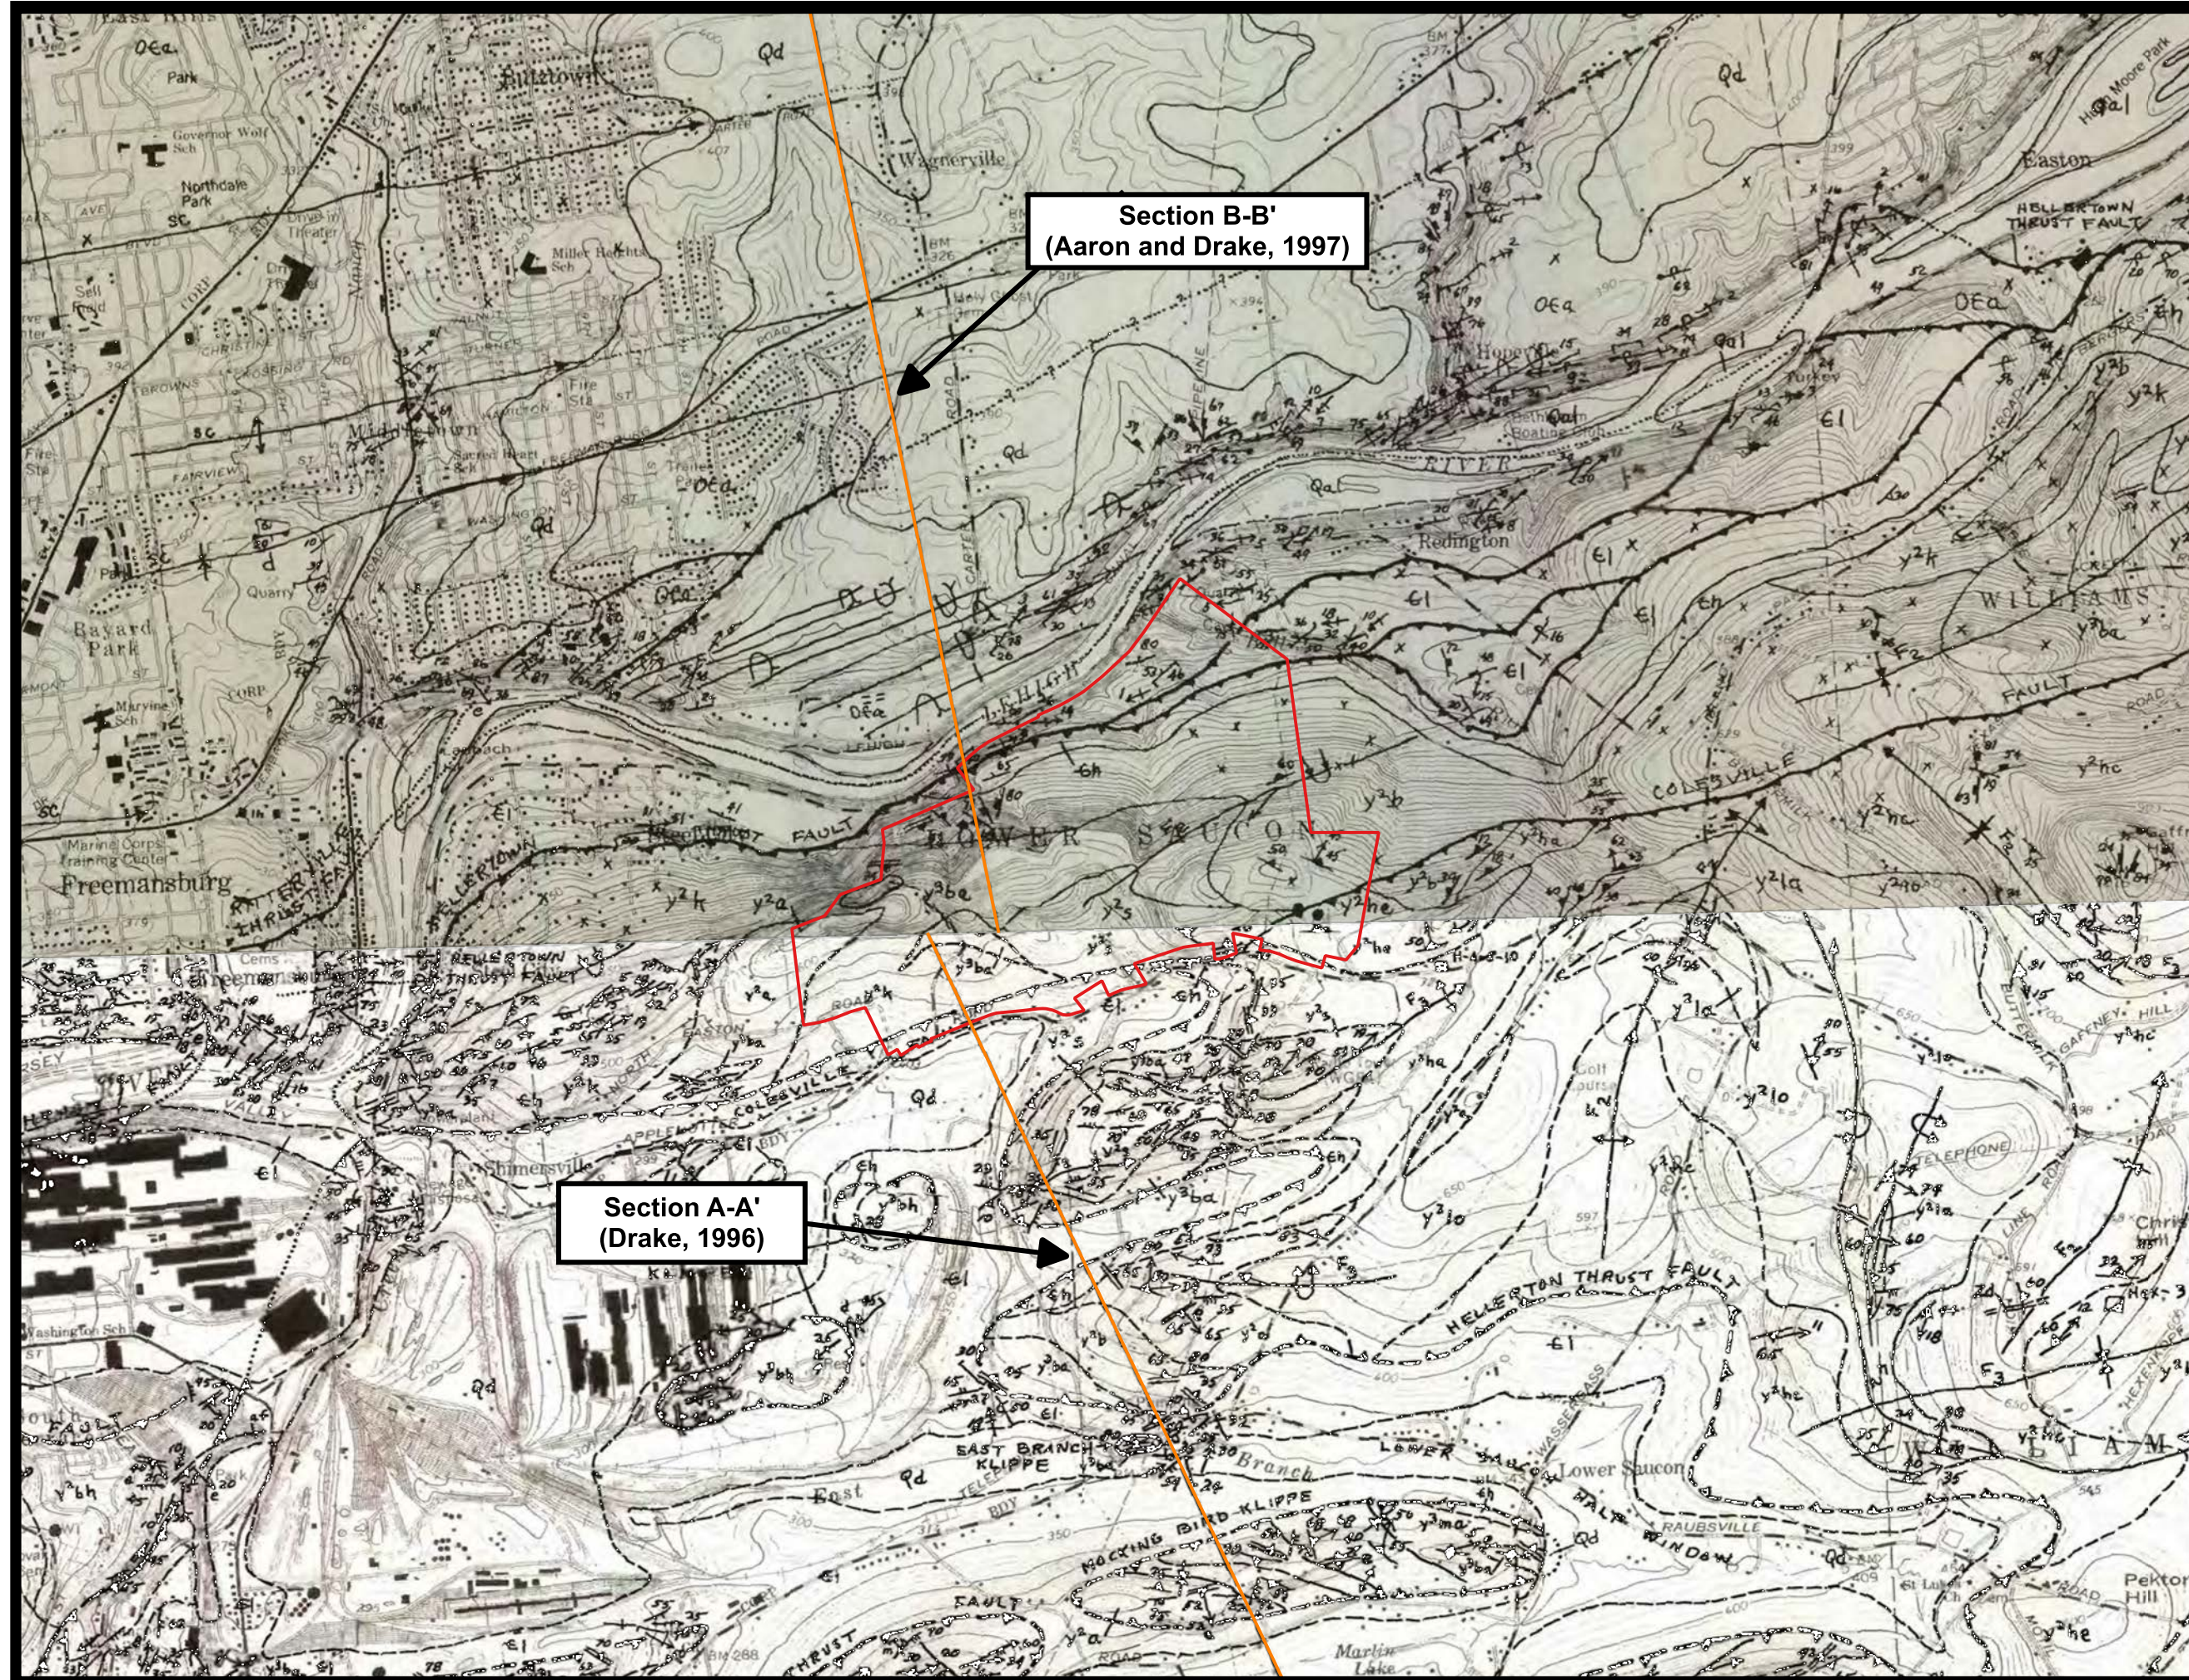
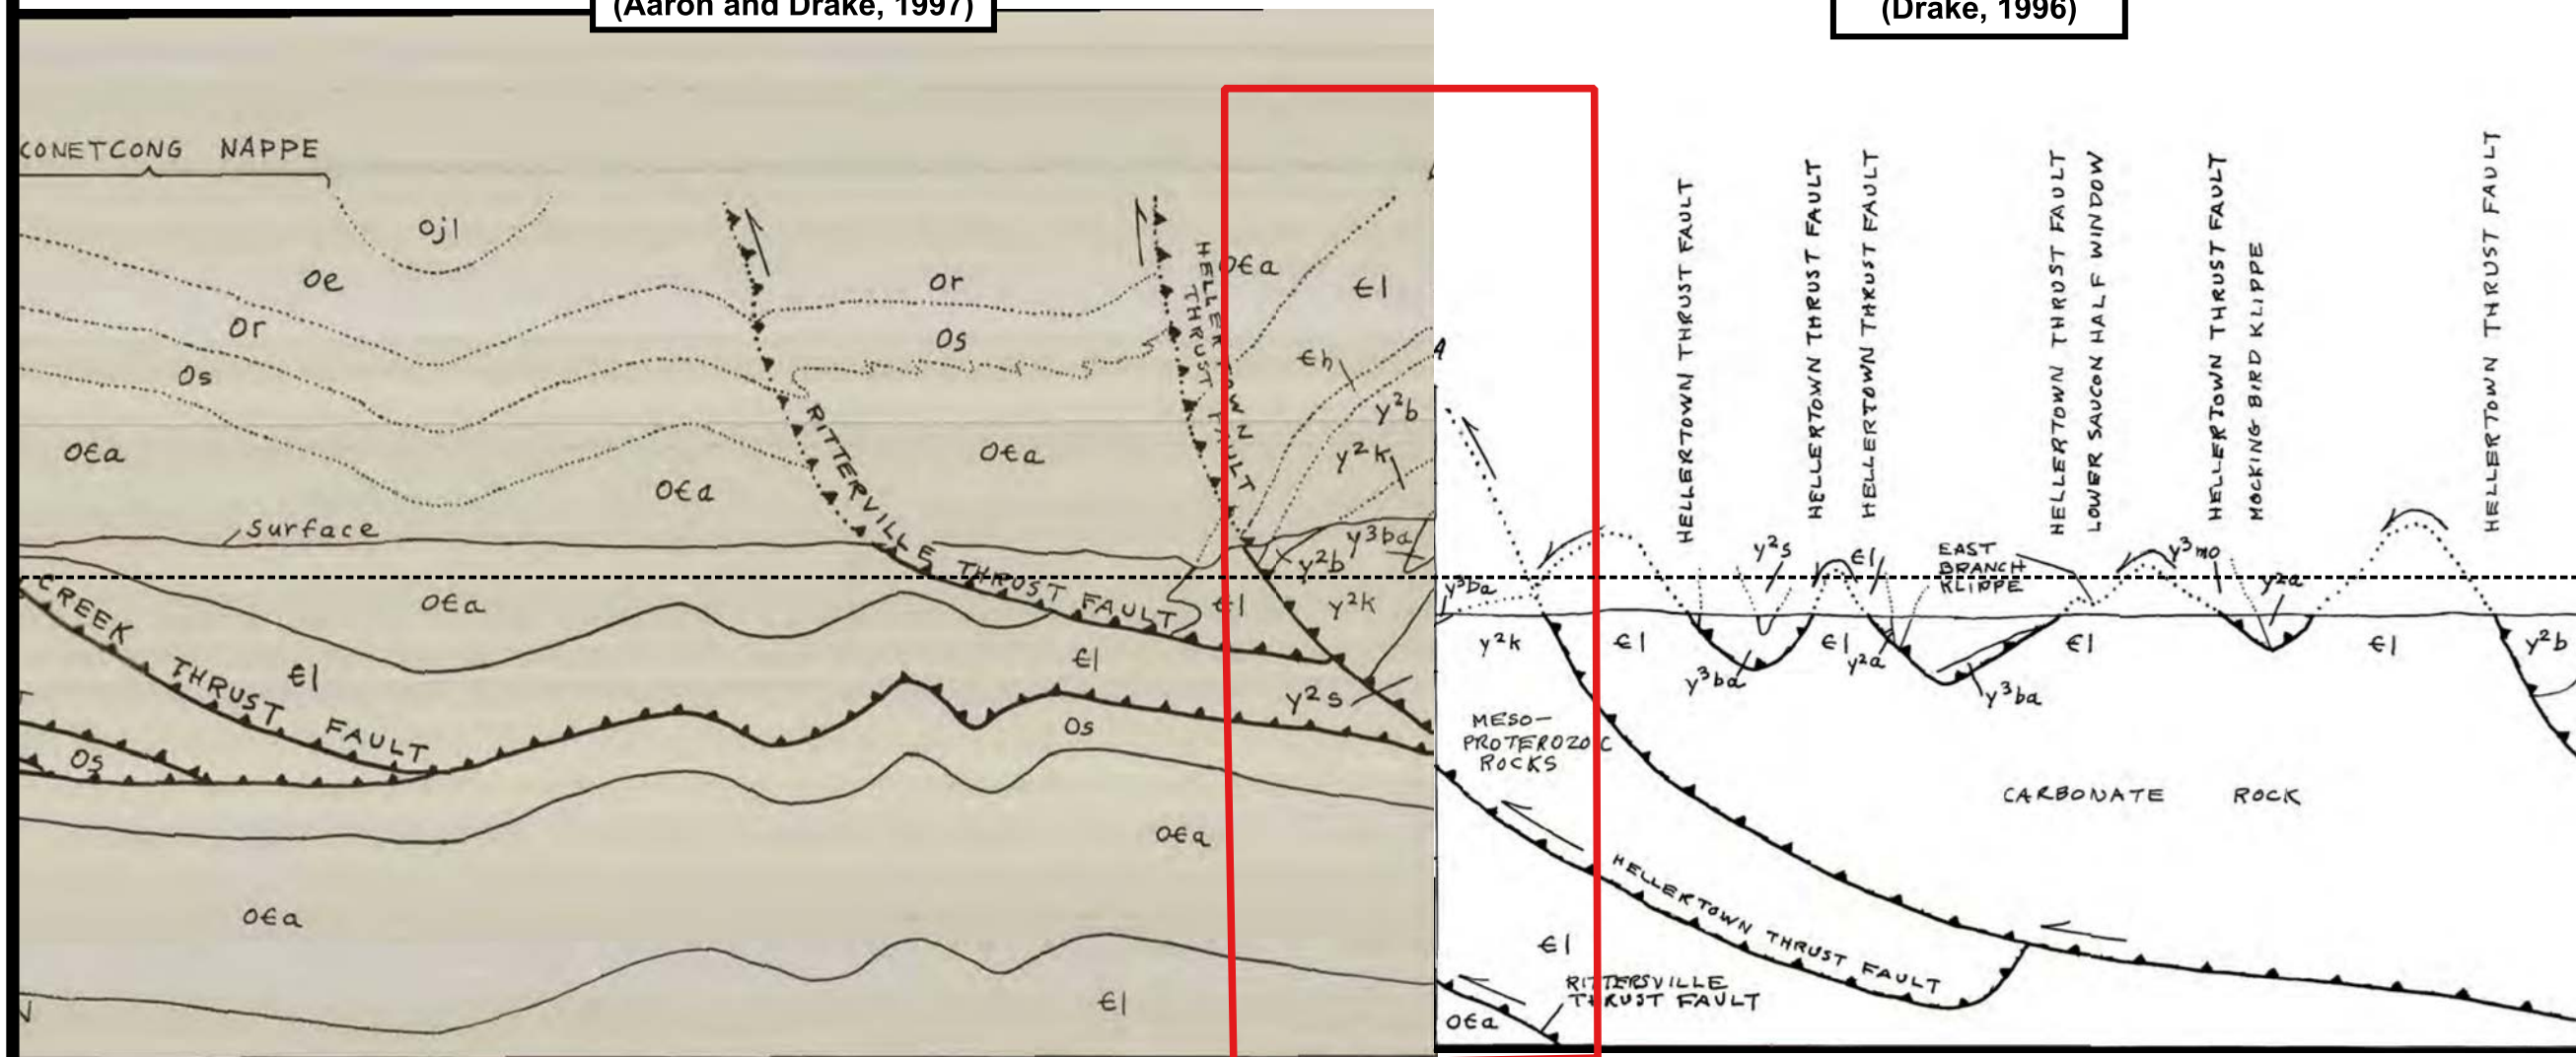
Section B-B'
(Aaron and Drake, 1997)

Section A-A'
(Drake, 1996)

- Os - Stonehenge Formation of Beekmantown Group
- OCa - Allentown Dolomite
- El - Leithsville Formation
- Ch - Hardyston Quartzite
- Y3ba - Microperthite alaskite
- Y2k - Potassic feldspar gneiss
- Y2s - Sillimanite-bearing gneiss
- Y2b - Biotite-quartz-feldspar gneiss

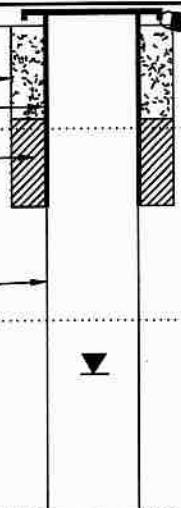
<p>10" Borehole 6" Steel casing Holeplug at bottom backfilled with cuttings 6" Borehole</p>	0
	Dark burnt orange silt/clay with chlorite (?)/Hornblende gneiss boulders.				Jasper noted at 9'.		
20	Gneiss boulders, angular quartz, jasper (rounded), red-black silt clods.						20
	Light gray phyllite/shiny (sericite?) shale, few medium-dark gray dolomite.				Tan return at 22'.		
					Brief tan return at 33'.		
40	Medium-dark gray crystalline dolomite, hard.				Leithsville Fm. 22-50'.

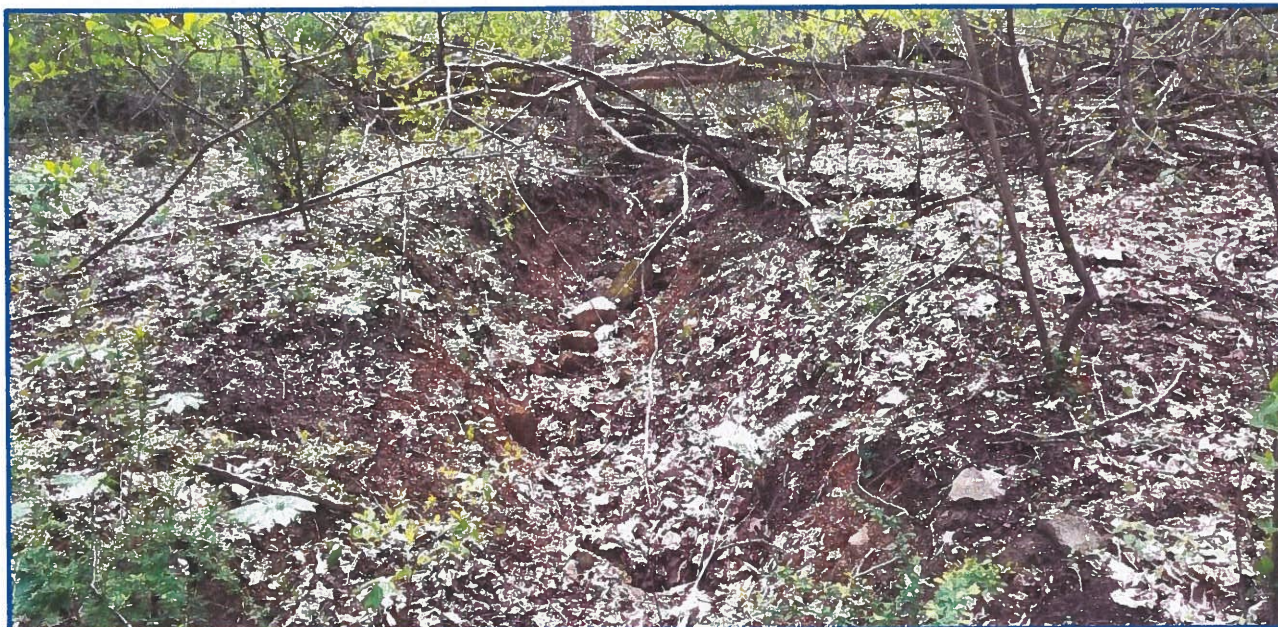
Photograph # 1 - View of a stormwater ravine in the northeastern portion of the site. Photograph location is not shown on the plan because it is beyond the limits of the inset.

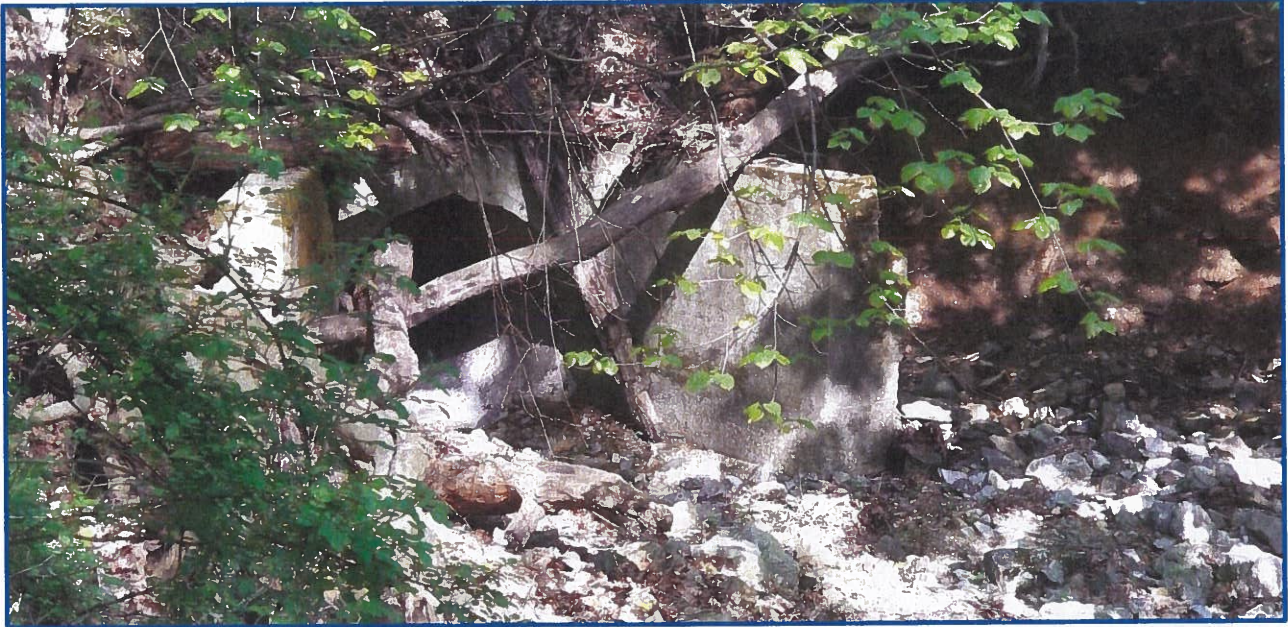
Photograph # 7 - View of Bull Run culvert inlet in the southeastern portion of the site. Photograph location is not shown on the plan because it is beyond the limits of the inset.

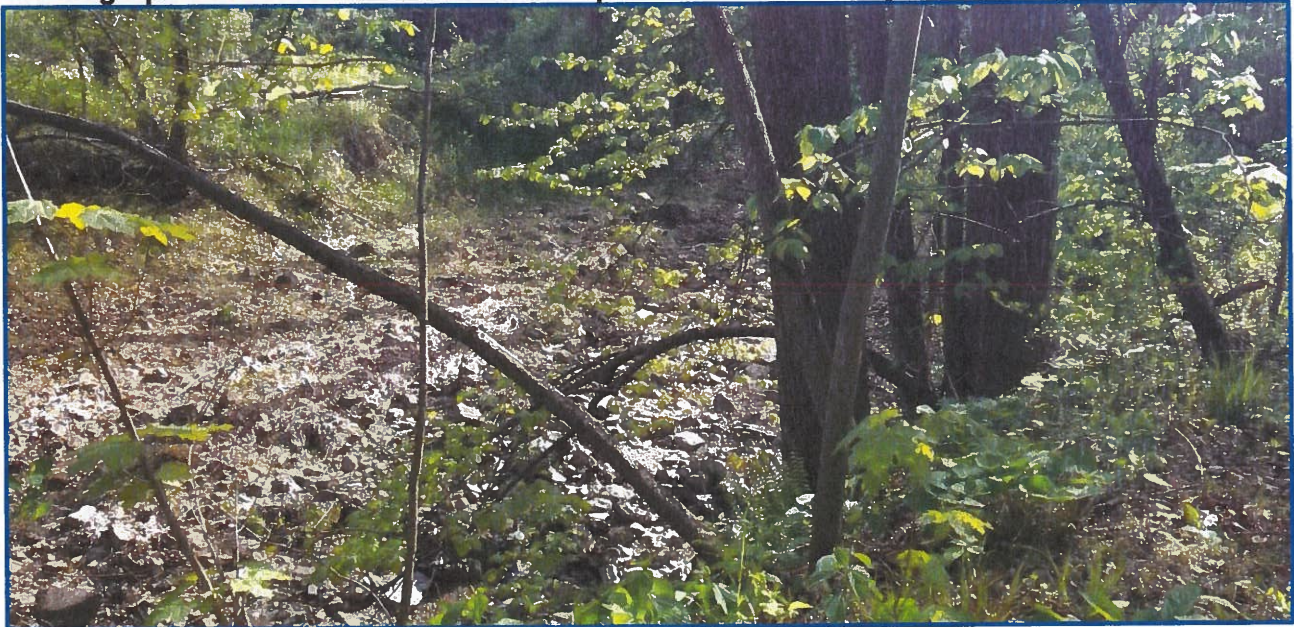
Photograph # 8 - View of Bull Run in the southeastern portion of the site. Photograph location is not shown on the plan because it is beyond the limits of the inset.
