BETHLEHEM LANDFILL COMPANY

Phase V Expansion

LAND DEVELOPMENT AND LOT CONSOLIDATION PLAN SUPPORTING DOCUMENTATION

PHASE V EXPANSION

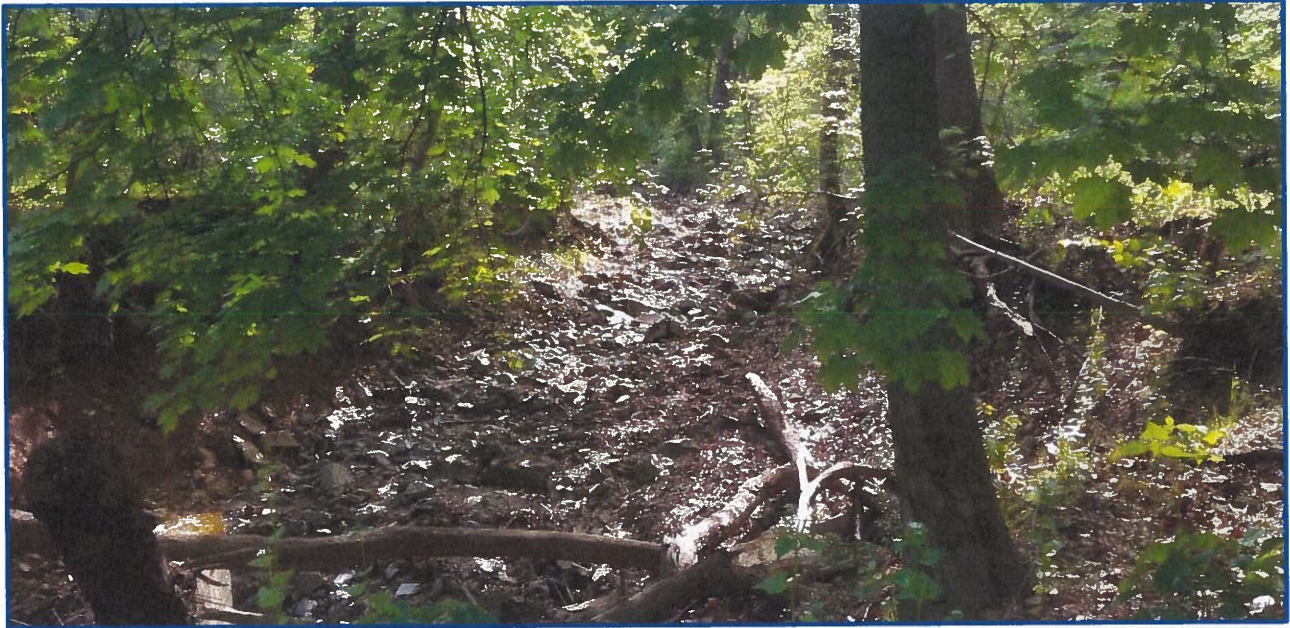
Photograph # 9 - View of Bull Run in the southeastern portion of the site. Photograph location is not shown on the plan because it is beyond the limits of the inset.

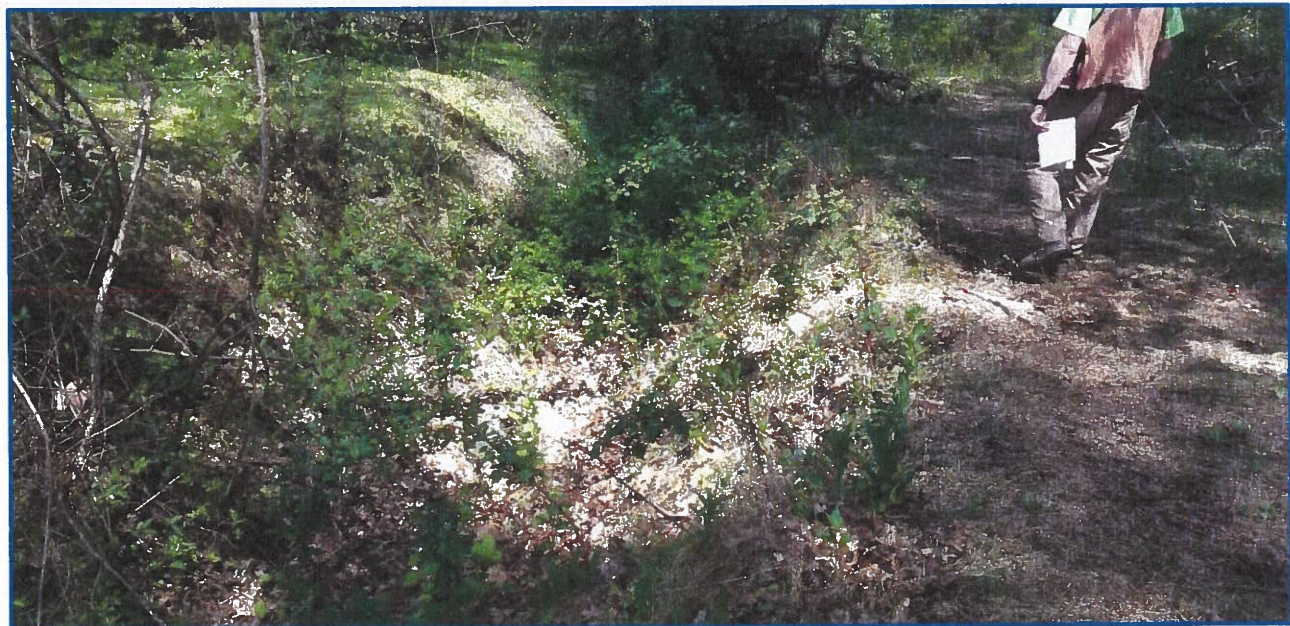
Photograph # 20 - View of a dry gully in the northwestern portion of the site. Photograph location is not shown on the plan because it is beyond the limits of the inset.

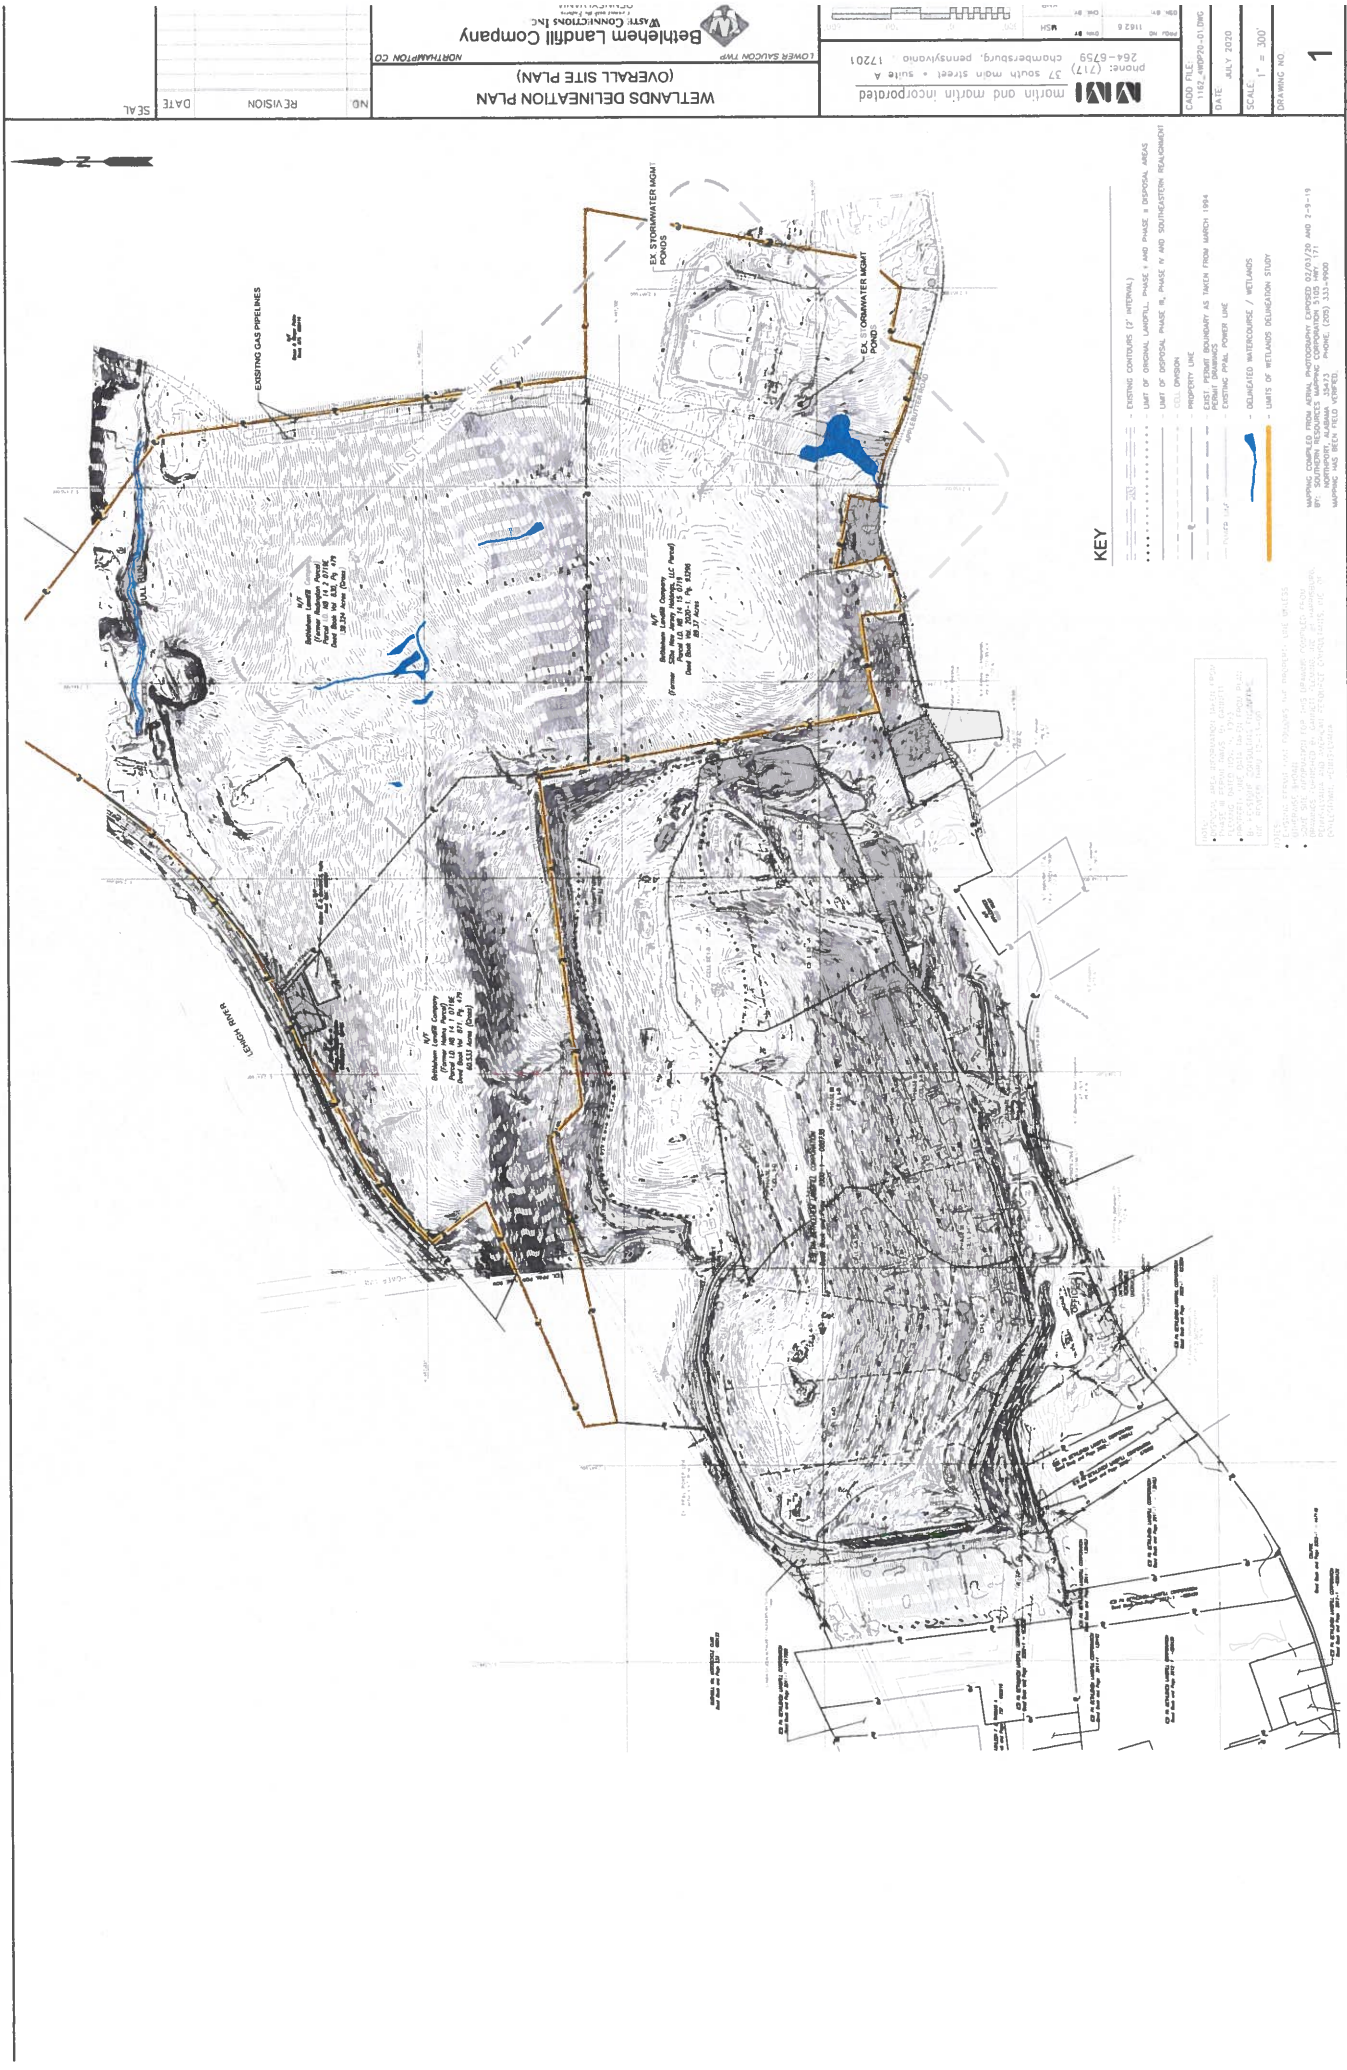
APPENDIX 3

- EXISTING CONTOURS (7' INTERVAL)
- LIMIT OF ORIGINAL LANDFILL, PHASE I AND PHASE II DISPOSAL AREAS
- LIMIT OF DISPOSAL, PHASE III, PHASE IV AND SOUTHEASTERN ALIGNMENT
- PROPERTY LINE
- EXISTING PUMP POWER LINE
- DELINEATED WATERCOURSE / WETLANDS
- LIMITS OF WETLANDS DELINEATION STUDY
