September 15, 2022

RE: Inspection Conducted on September 1, 2022
Bethlehem Landfill
Hanover Project LS90-7

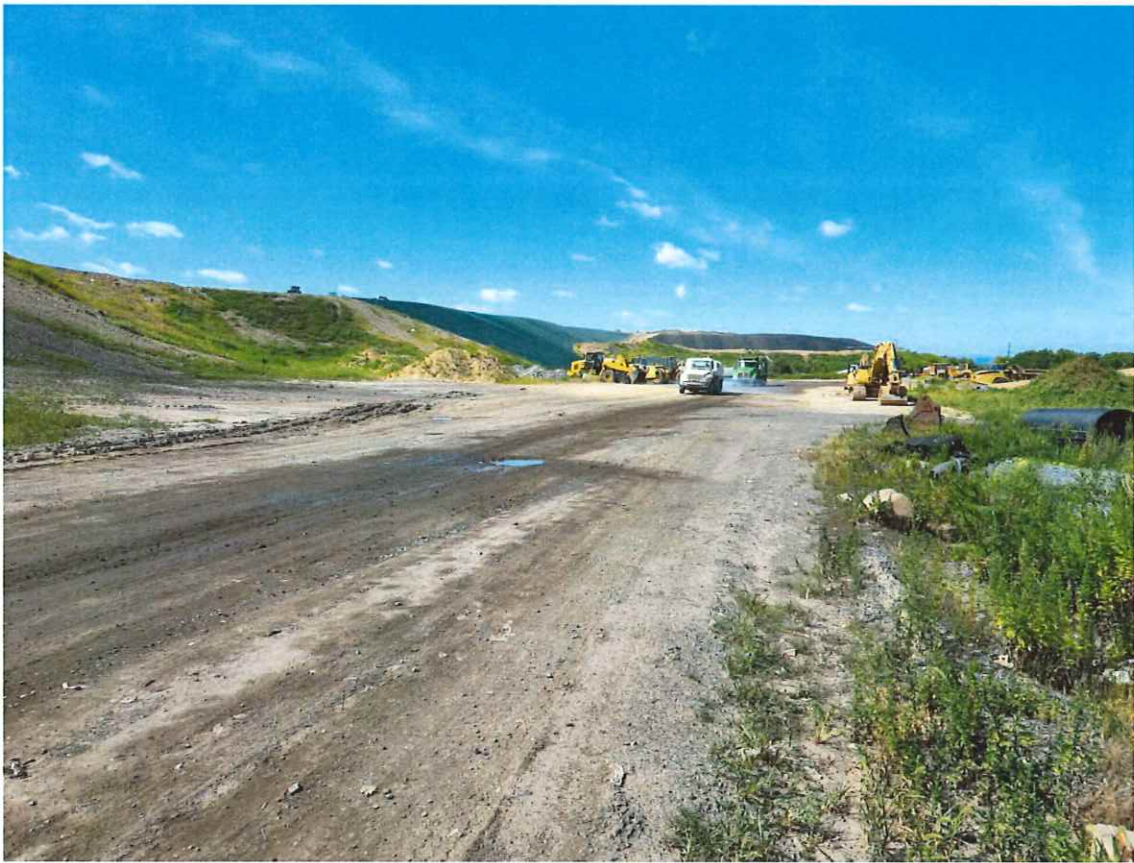
Photo 1

6. The access road from the office to the top of the landfill was in good condition and the minor erosion along the eastern edge noted during the August 18, 2022 inspection has been addressed. The entire access road from the office to the working face was free of dust and the water truck was observed in operation (see Photo 1).

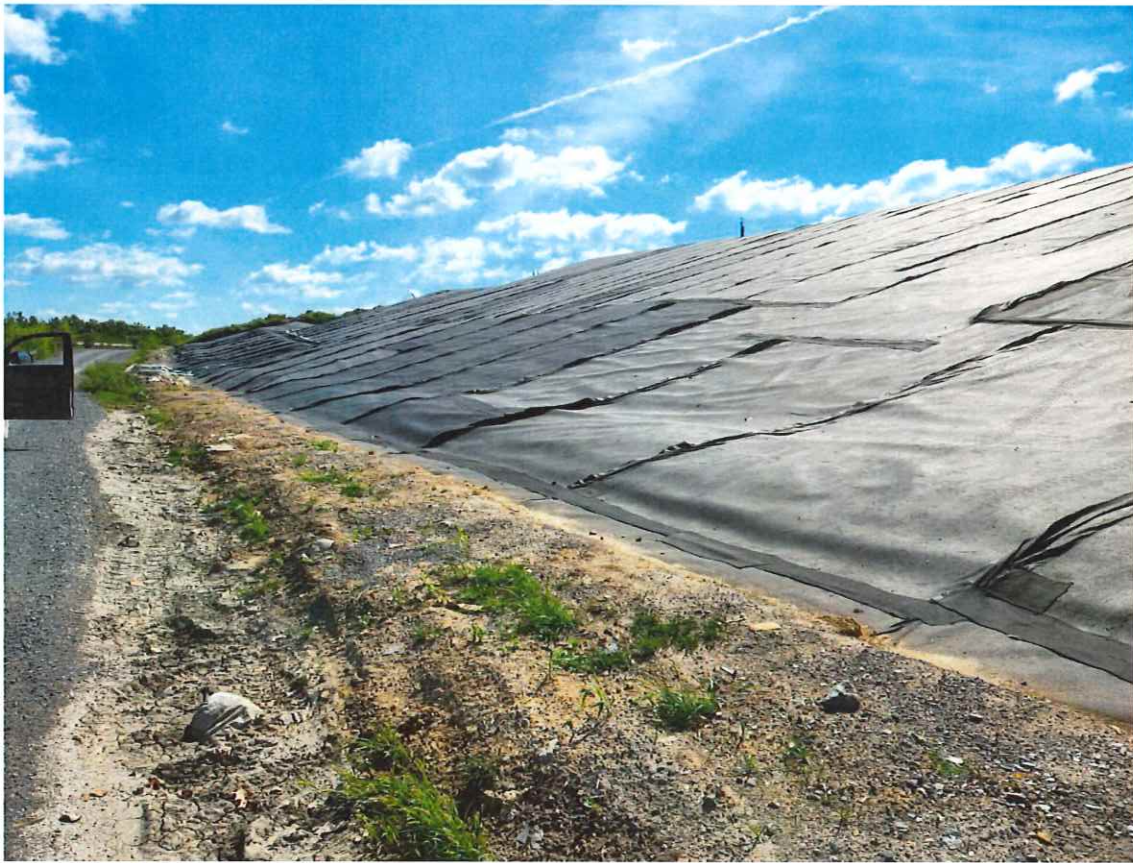
Photo 2

7. Placement of the final cap material along the north slope of cells 4-A, 4-B, 4-D and 3-C has been completed (see Photos 2 and 3). Photo 3 also shows a typical gas well and how it is sealed where it protrudes through the liner. NAPA has pulled off the site until the capping material arrives.

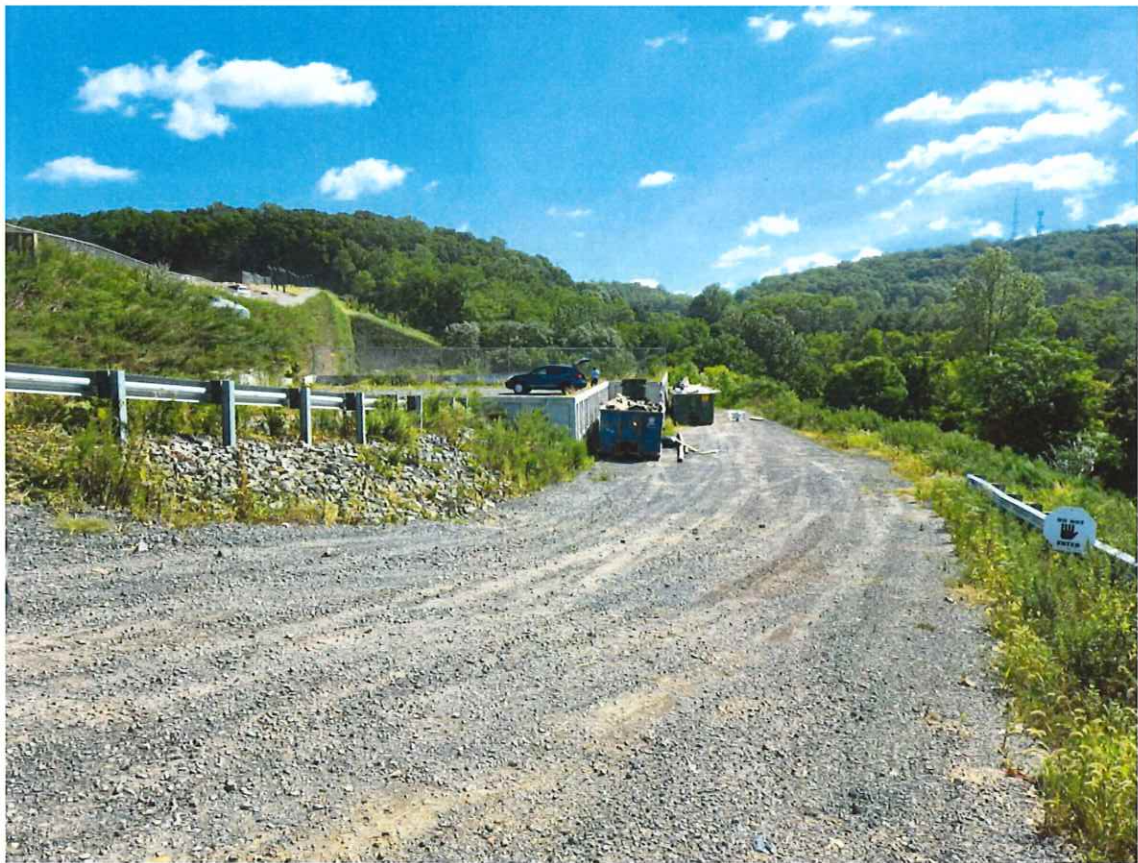
Photo 6

11. The customer convenience area has been relocated back to the original location south of cell SE-2AB (see Photo 6).
12. The north slope perimeter road was inspected and was in a passable condition and no signs of erosion channels.
