INSPECTION REPORT – MUNICIPAL WASTE LANDFILL

Bethlehem Landfill Company
100020
6/28/2022

Date of Inspection 06/28	2022	Identification Number	100020
Company/Facility/Site Nam	e _ Bethlehem Landfill Con	npany

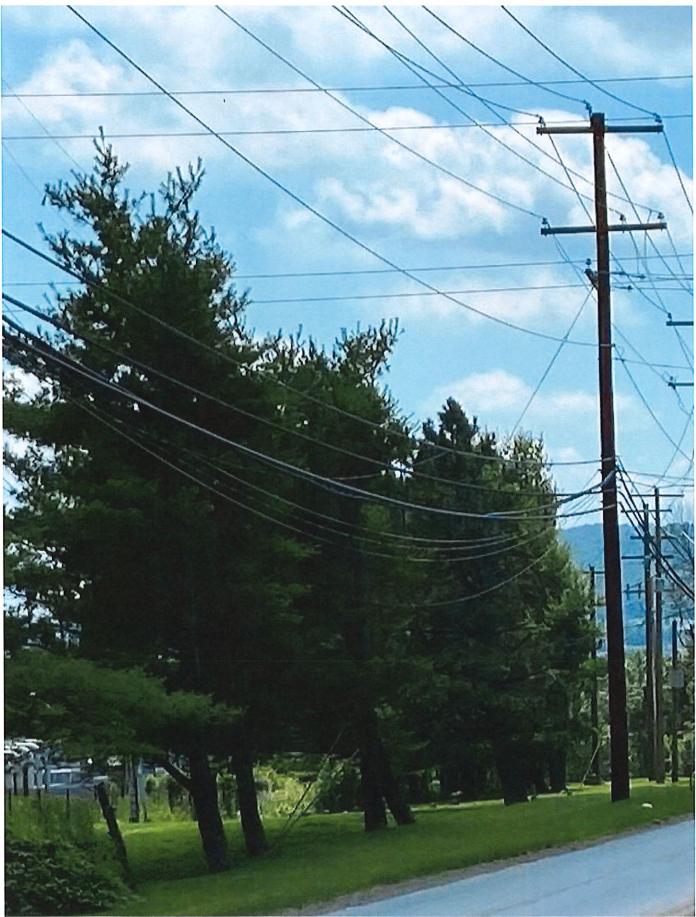
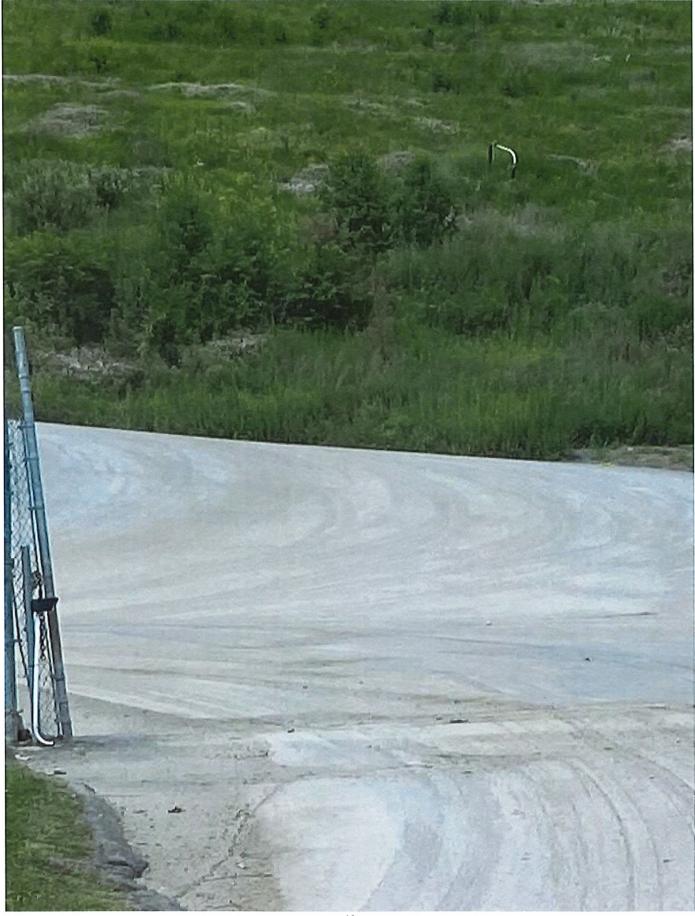
Subject: Applebutter

A few trucks have passed since the landfill owned sweeper was out on the road. I will send you some while the sweeping company is out too.
