Engineering Associates Inc

June 30, 2015

RE: Investigation of Undermined Area of
Riverside Drive at PennDOT Repair Location
Hanover Project LS90-7

SITE PHOTOGRAPHS OF AREA OF UNDERMINING

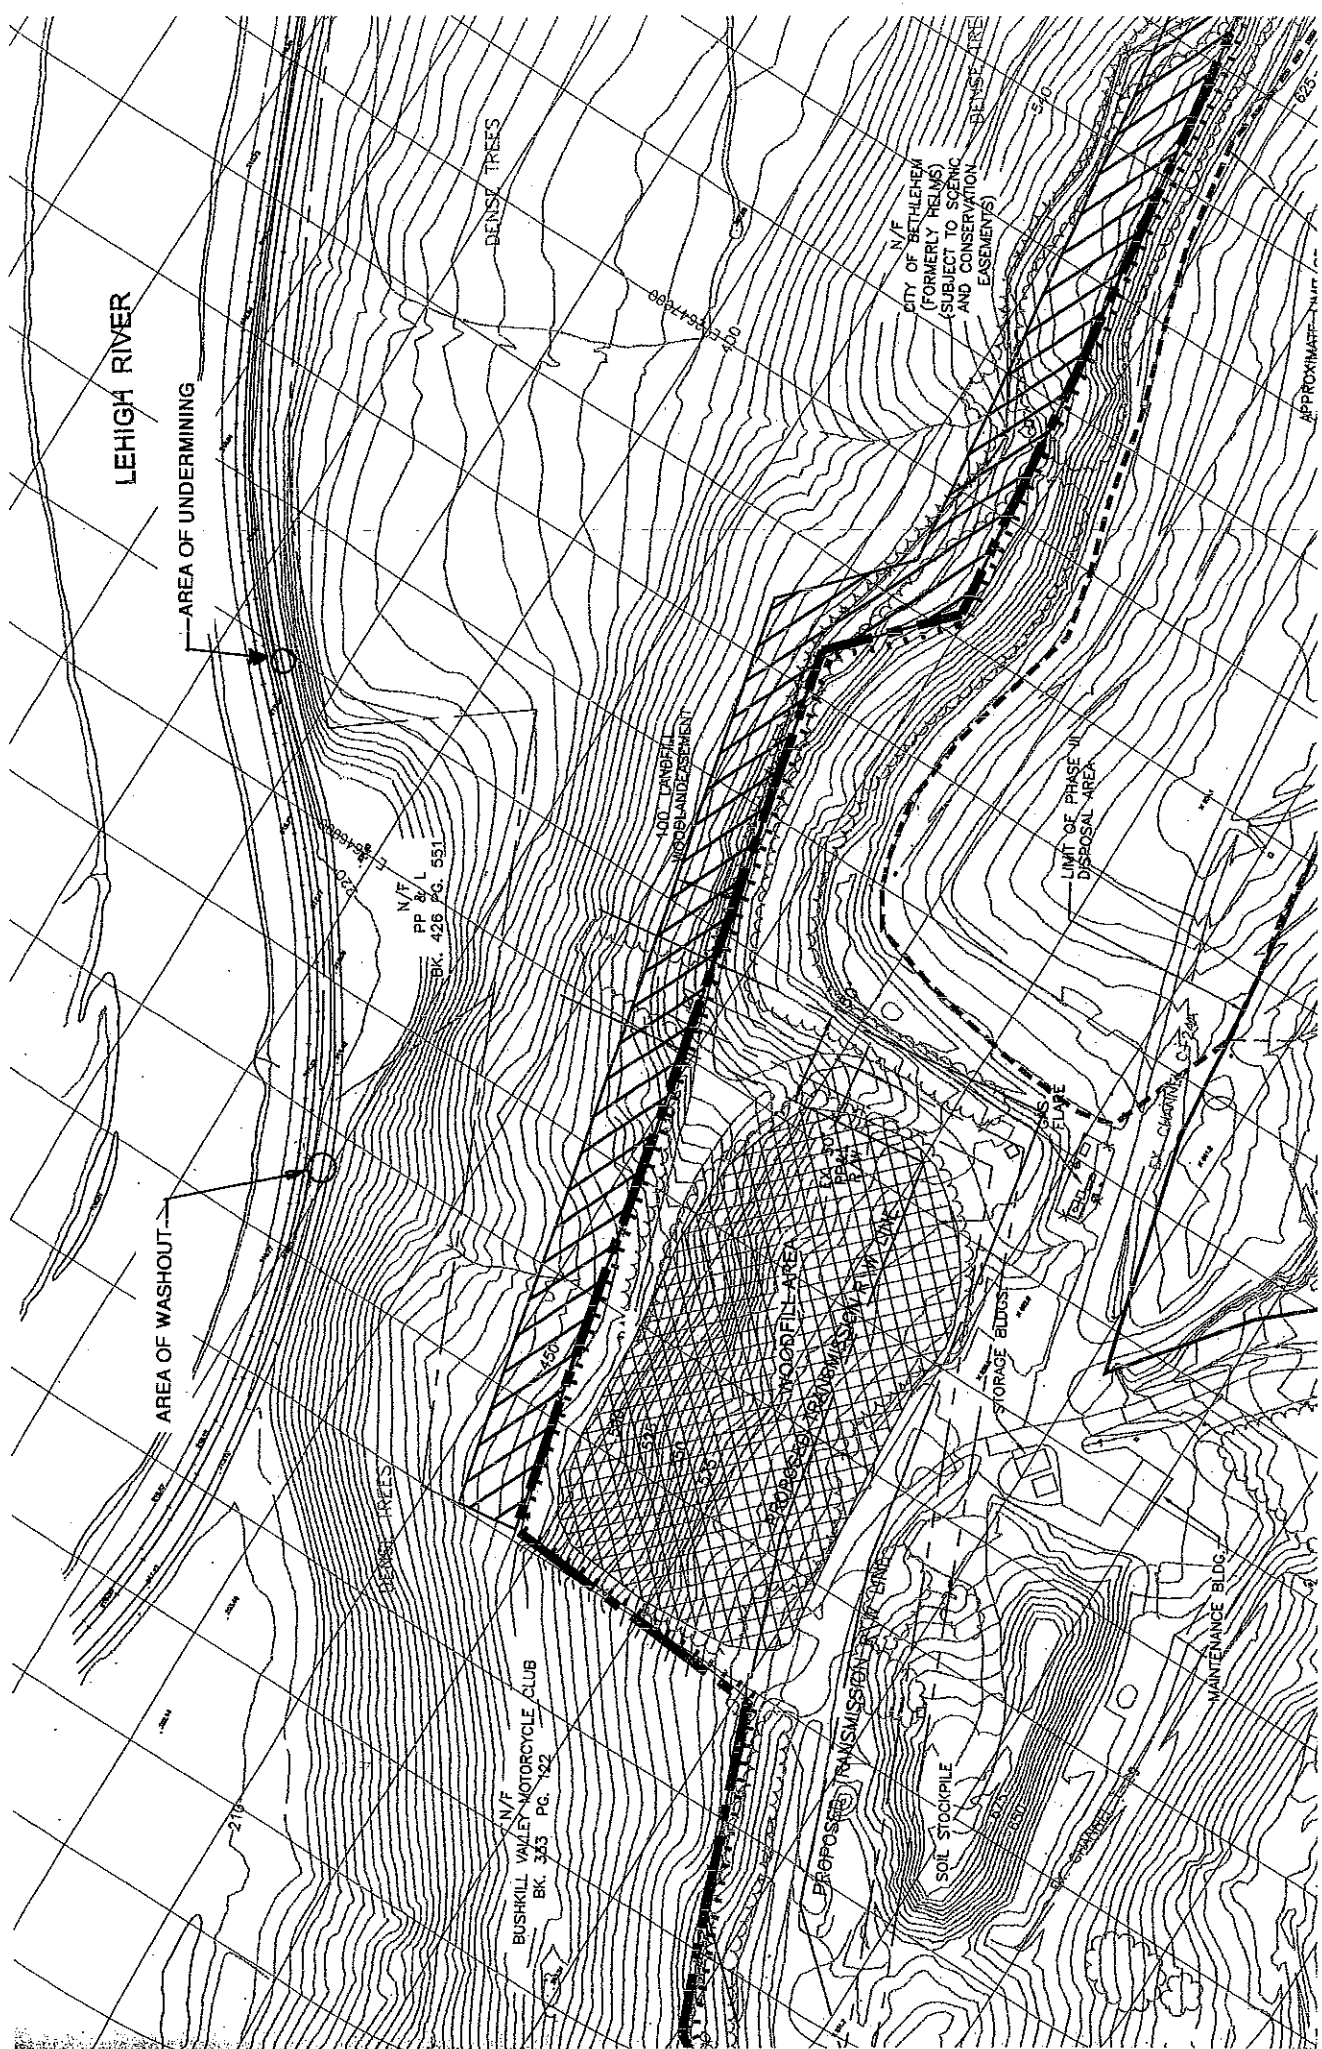
TOPOGRAPHIC PLAN

The area where the roadbed of Riverside Drive is undermined is situated approximately three hundred feet (300') to the east of the high tension electric line crossing, and is depicted on the attached topographic plan as "Area of Undermining" (see Attachment 1). This area is near a high point in the roadway, and does not contain any stormwater conveyance structures. As shown on the plan, this area is directly downslope of the landfill, but does not correspond with any channels or ravines on the slope above it that would carry runoff from the landfill to this area. Such channels are clearly depicted on the plan hundreds of feet to the east and west of this location. But the topography on the slope above this location is "raised", which would serve to shed water away from this location rather than directing it to this location.

AREA OF UNDERMINING
